# **When Creek Meets Valley Wall: Prioritizing Erosion Mitigation alongside the Oshawa Landfill**

**TRIECA conference**

**March 22-23, 2017**

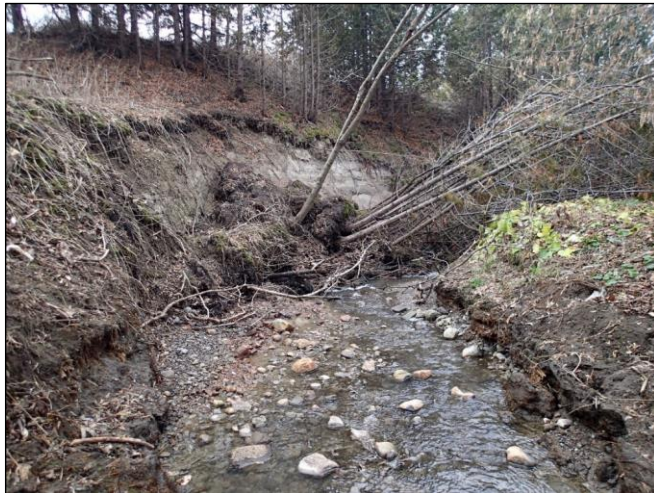
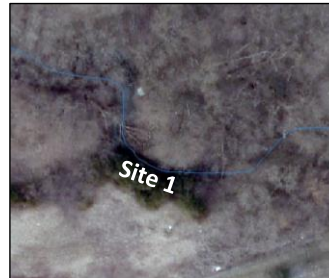
Toe-slope failure

Moderate [Seep B (i), (ii)]

Undercutting of the toe of the valley wall, along the outer bank of a meander, has led to shallow slumping within interbedded glaciofluvial sands and gravels underlain by laminated glaciolacustrine silt. Groundwater seeps from the bank at the contact between the glaciofluvial and glaciolacustrine sediments. Without intervention, continued erosion of the valley wall may pose a risk to landfill embankment stability.
