Stantec

March 22, 2018

To Pipe or Not to Pipe -
Erosion Issues and
Solutions in an Urban
Watercourse in
Edmonton

Heather Amirault

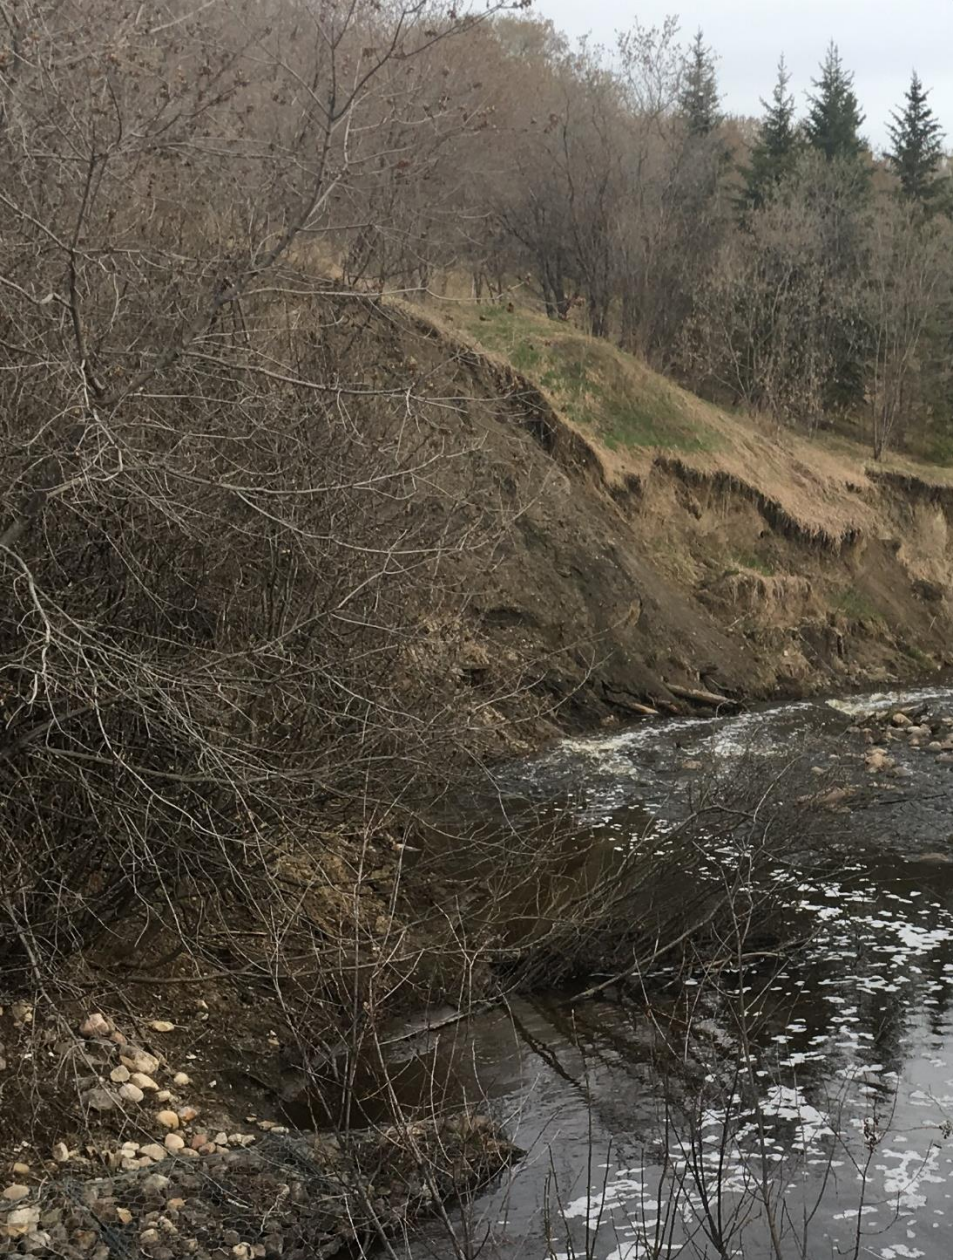
Gabions and Bank Erosion

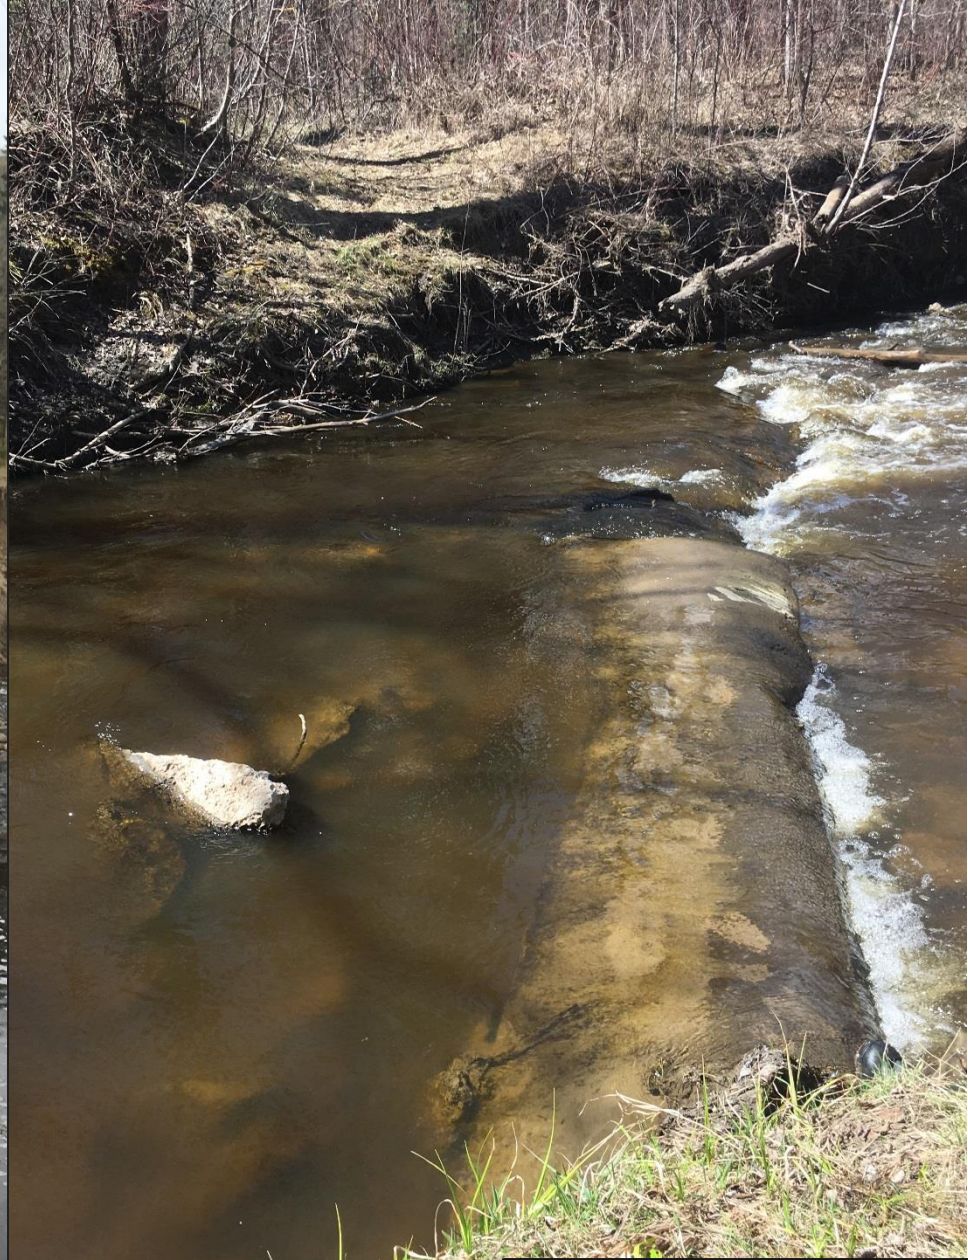
Downcutting and Widening

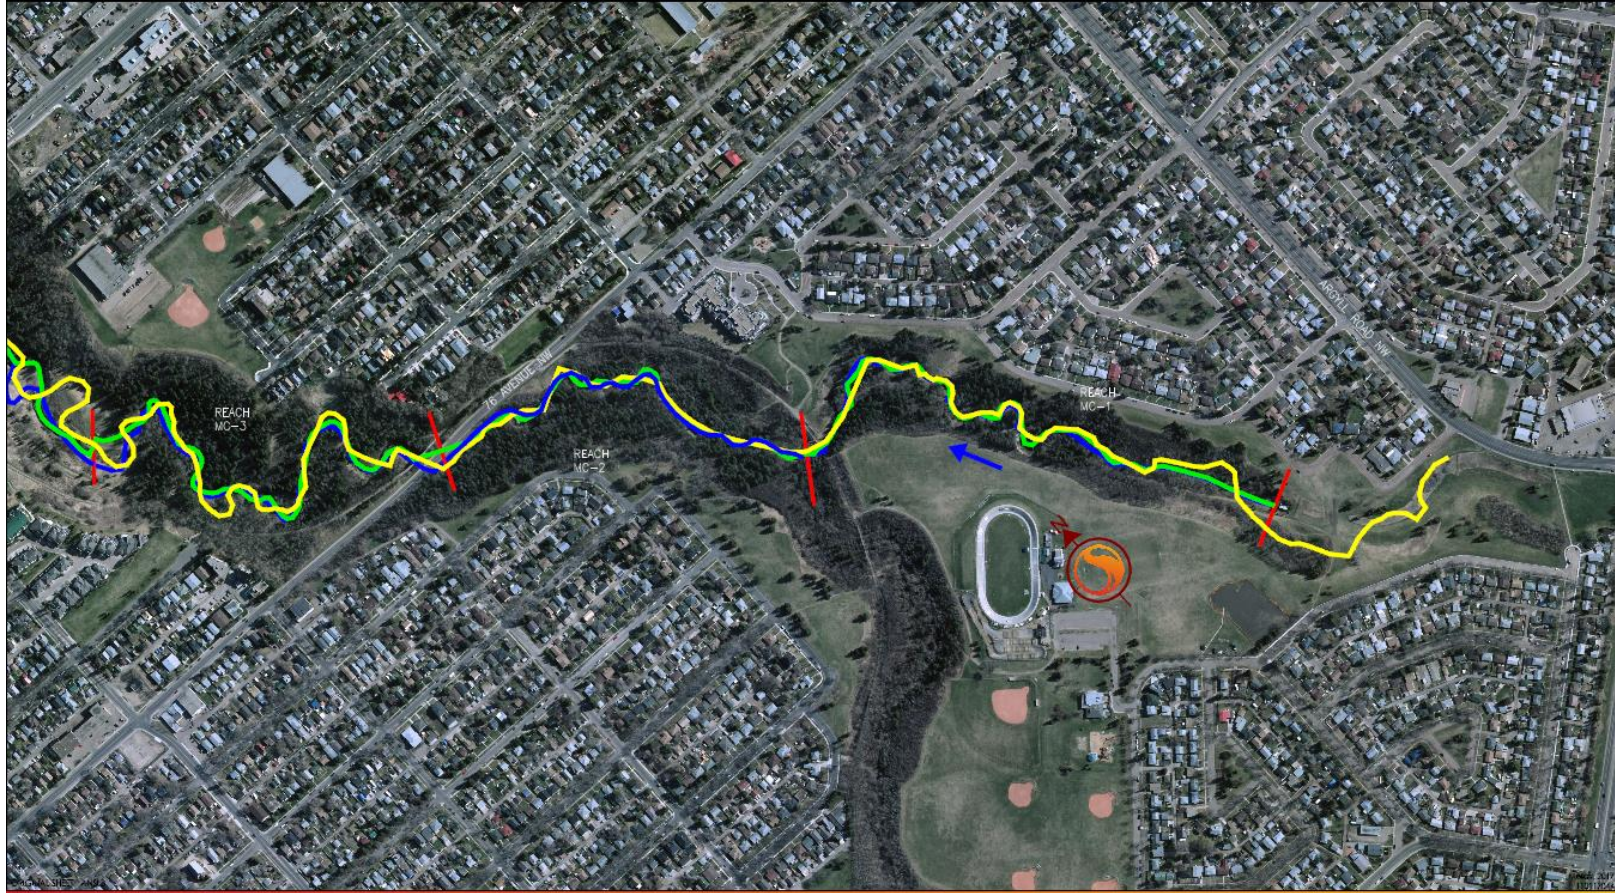
Figure No.
5

Title
Mill Creek Planform
Reaches MC-1, MC-2 and MC-3

- Upstream of Diversion Tunnel
 - Erosion rates 0.12 m/yr
- Downstream of Diversion Tunnel
 - Erosion rates 0.09 m/yr

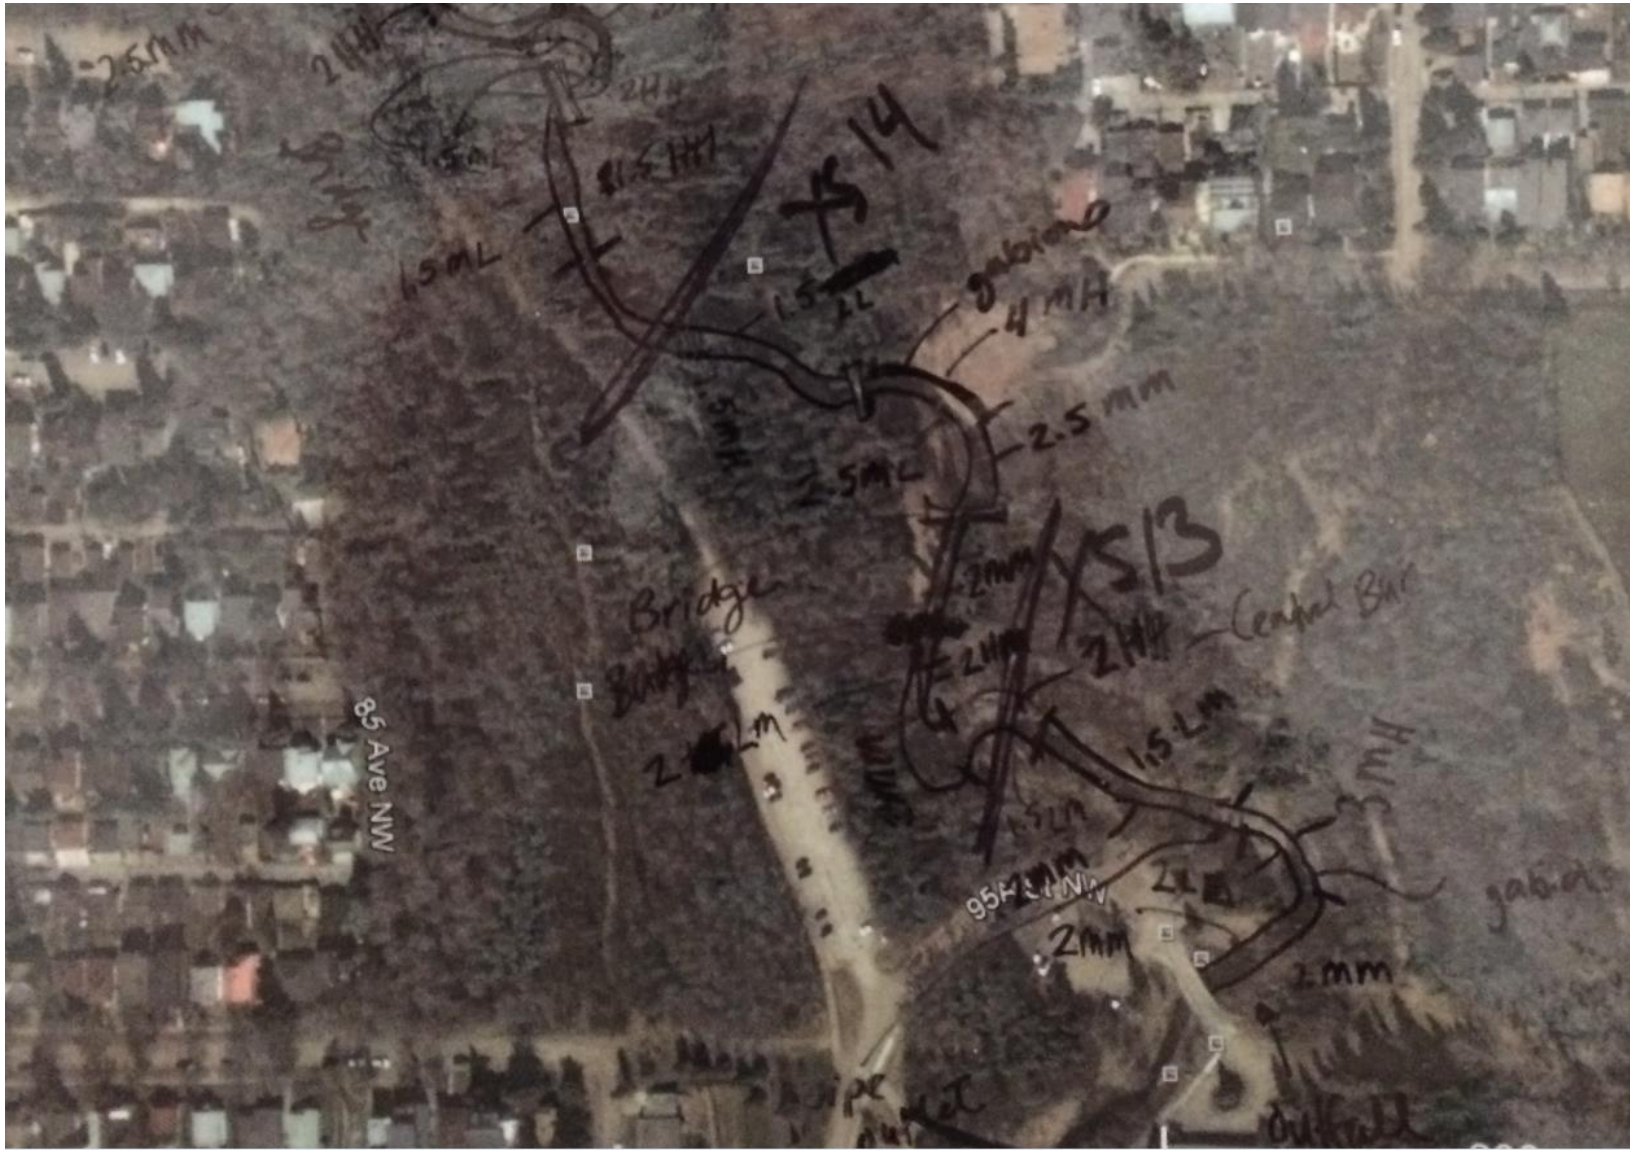
Bank Erosion Hazard Index – field notes

Study Bank Height / Bankfull Height (C)				BEHI Score (Fig. 3-7)	
Study Bank Height (ft) =	9 (A)	Bankfull Height (ft) =	1.5 (B)	(A) / (B) = 6 (C)	10
Root Depth / Study Bank Height (E)					
Root Depth (ft) =	0.5 (D)	Study Bank Height (ft) =	9 (A)	(D) / (A) = 0.06 (E)	10
Weighted Root Density (G)					
Root Density as % =	27 (F)	(F) x (E) =	0 (G)	10	
Bank Angle (H)					
Bank Angle as Degrees =		(H)		10	
Surface Protection (I)					
Surface Protection as % =	0 (I)			10	
Bank Material Adjustment:					
Bedrock (Overall Very Low BEHI)					
Boulders (Overall Low BEHI)					
Cobble (Subtract 10 points if uniform med. to large cobble)					
Gravel or Composite Matrix (Add 5-10 points depending on percentage of bank material that is composed of sand)					
Sand (Add 10 points)					
Silt/Clay (No adjustment)					
Bank Material Adjustment					
Stratification Adjustment					
Add 5-10 points, depending on position of unstable layers in relation to bankfull stage				5

Very Low Low Moderate High Very High Extreme					
3 - 9.5 10 - 19.5 20 - 29.5 30 - 39.5 40 - 45 46 - 50					
Adjective Rating and Total Score				Extreme 55	
Bank Sketch

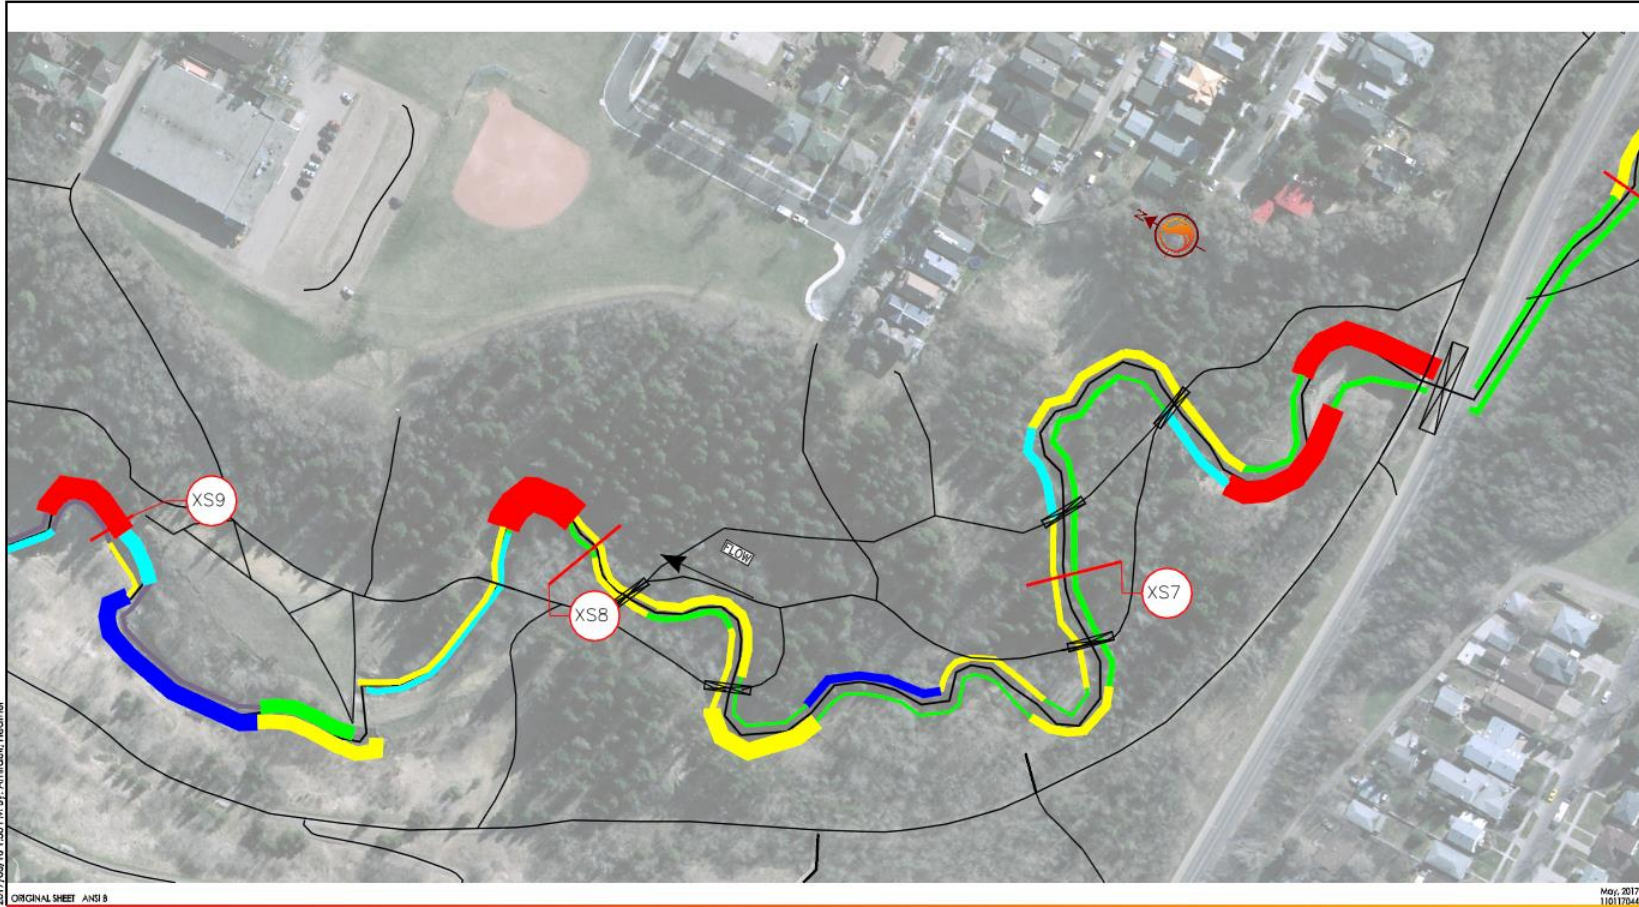
Figure No.
15

Bank Erosion Hazard Index – upstream of diversion

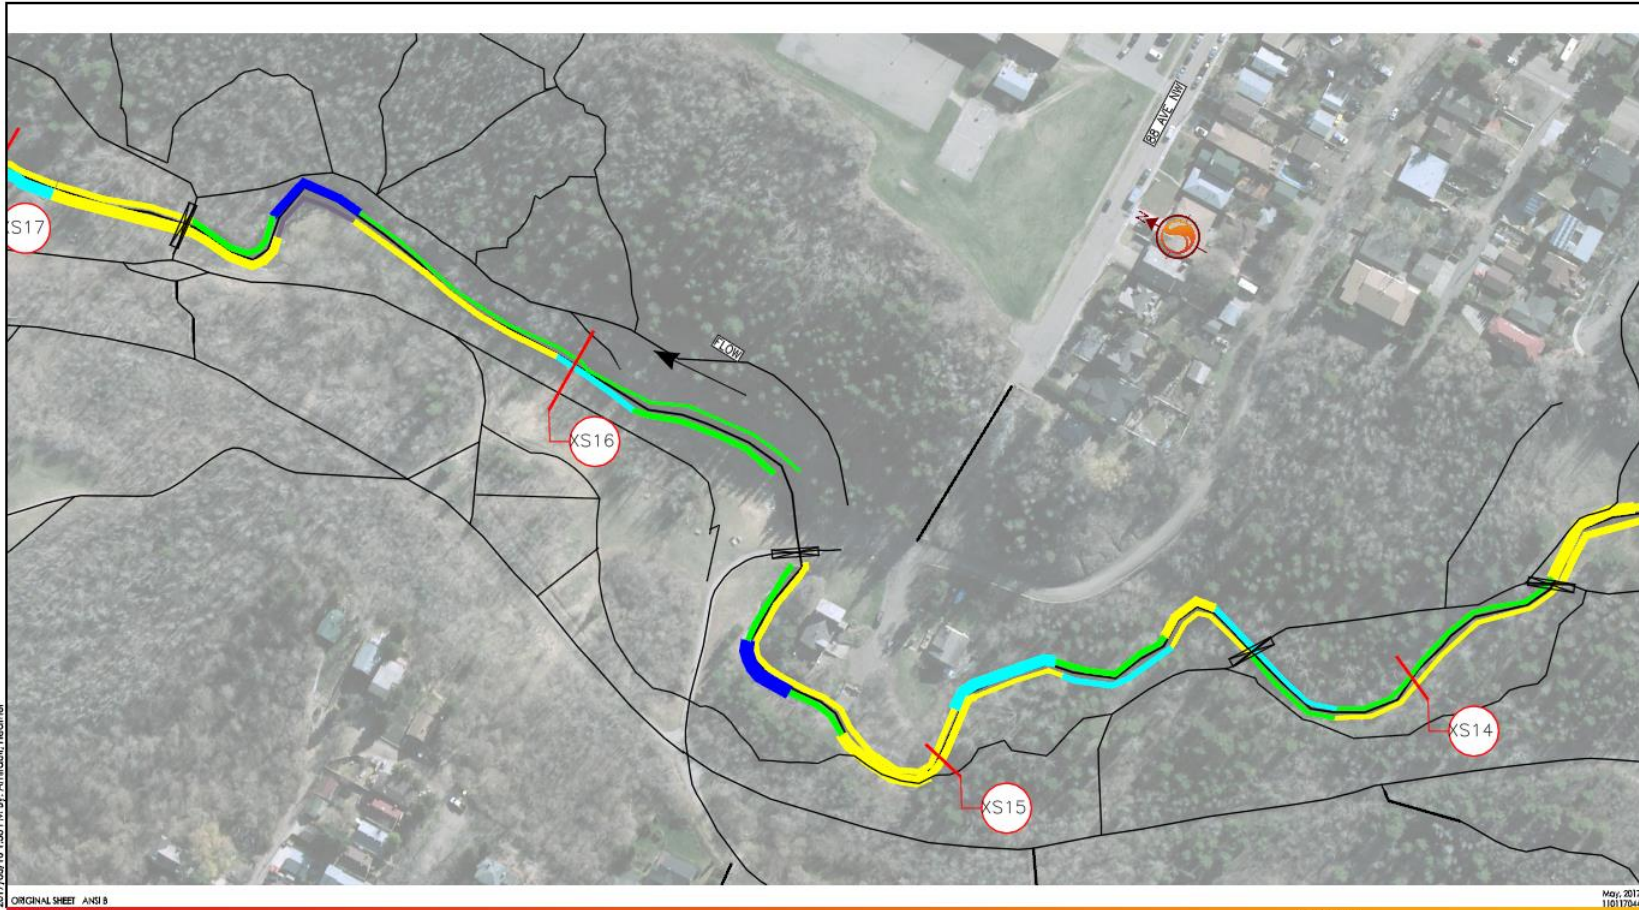
Figure No.
13

Bank Erosion Hazard Index – downstream of diversion

- Upstream Reach
 - 3.0 m³ sediment/ m of bank /year
- Downstream Reach
 - 1.7 m³ sediment/ m of bank /year
- Upstream reach losing 184% more sediment

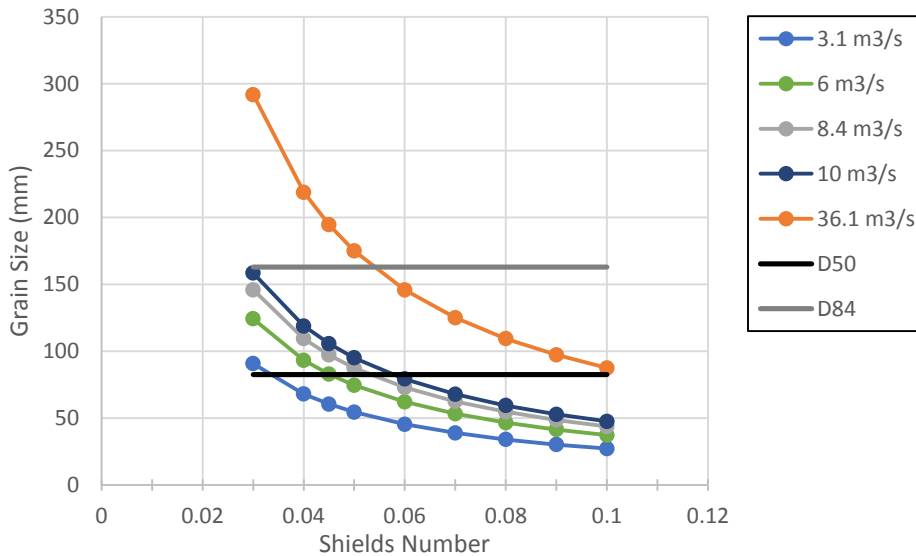
Cross-Section 4 Shields Numbers and Grain Mobility

Discharge (m³/s)	Sediment Size Range (mm)	D50 Stable (Y/N)*	D84 Stable (Y/N)*
3.1	27.2 – 90.7	Y	Y
6	37.3 – 124.2	Y	Y
8.4	43.7 – 70.8	N	Y
10	47.5 – 158.4	N	Y
36.1	87.5 – 291.8	N	N

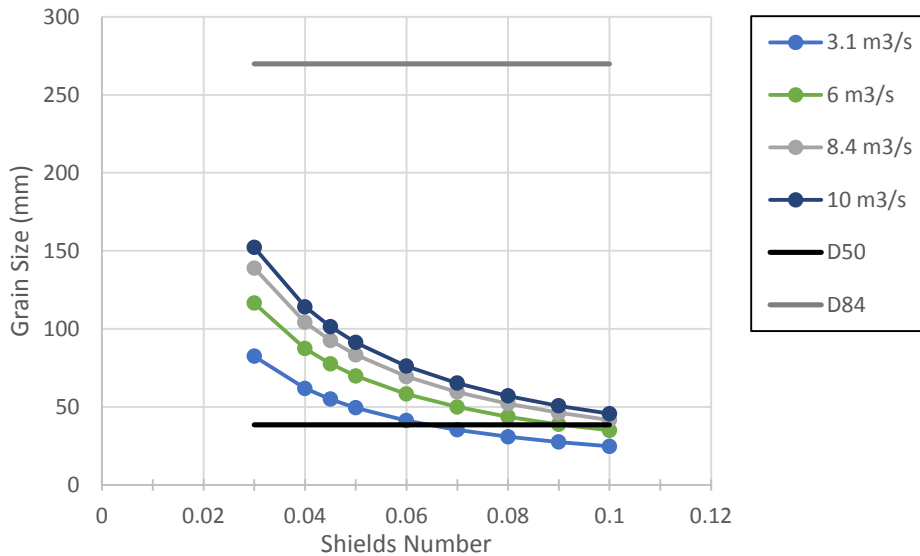
Cross-Section 16 Shields Numbers and Grain Mobility

Discharge (m³/s)	Sediment Size Range (mm)	D50 Stable (Y/N)*	D84 Stable (Y/N)*
3.1	24.7 – 82.5	N	Y
6	35.0 – 116.5	N	Y
8.4	41.7 – 138.93	N	Y
10	45.7 – 152.2	N	Y
