# Assessing and Mitigating Bedrock Erosion along Realigned Lower Albion Creek

**Robin McKillop, P.Geo. & Brian Greck, P.Eng.**

**TRIECA Conference, March 25-26, 2015**

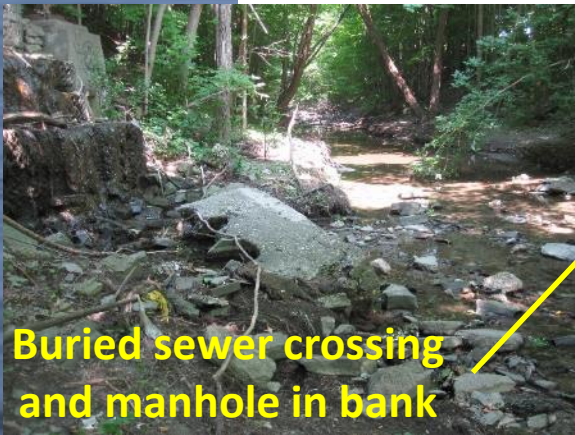
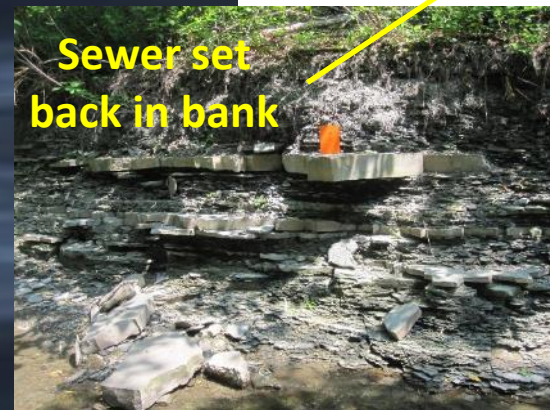
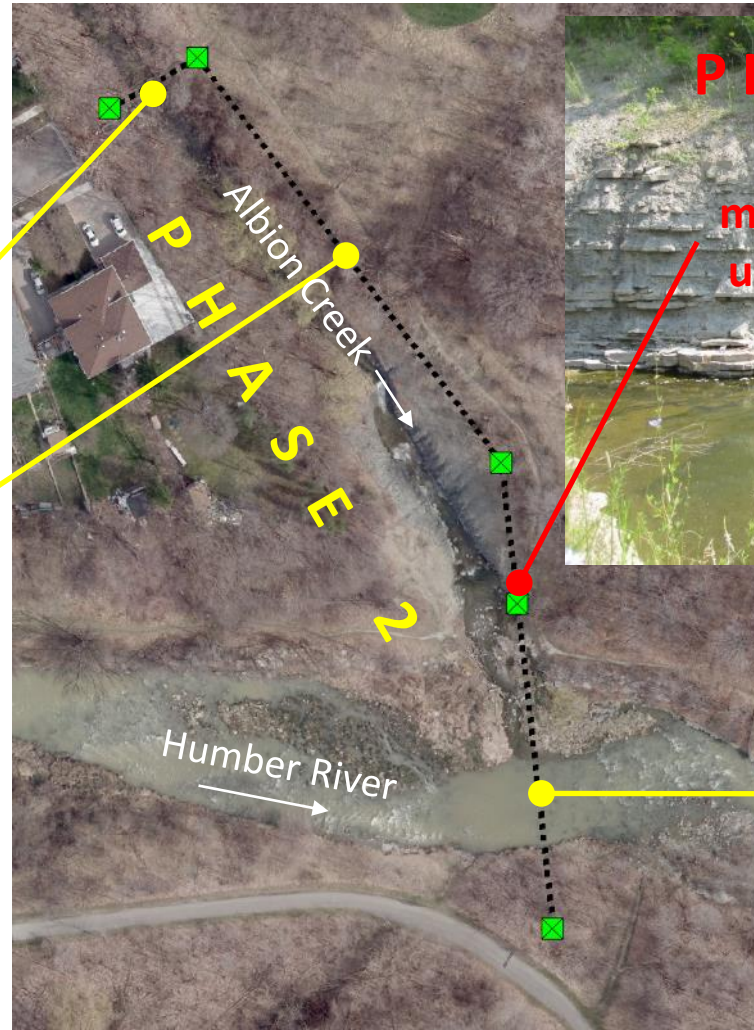
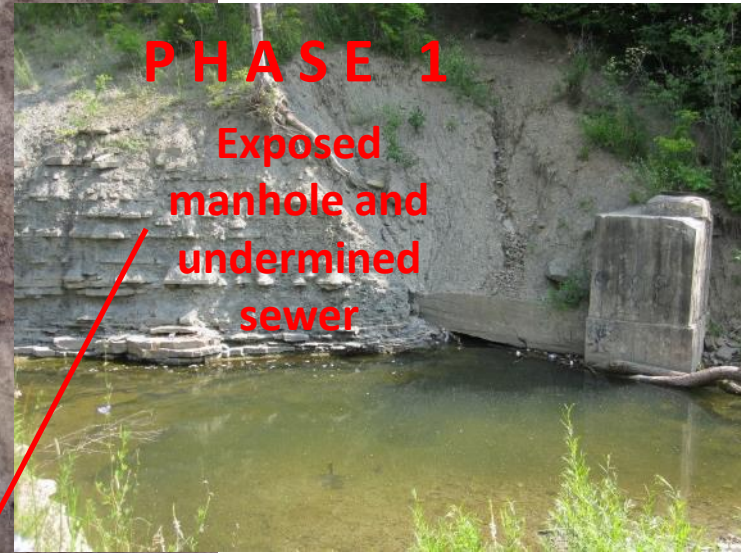
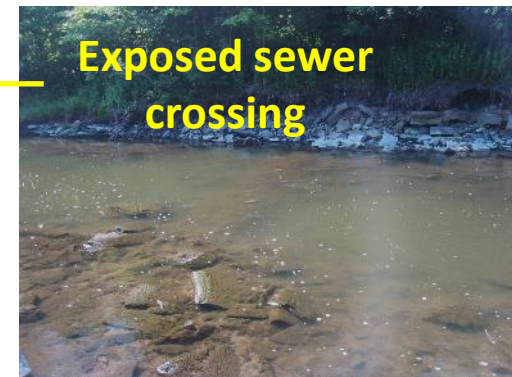
# At-risk sewer infrastructure

- At-risk sewer infrastructure identified through TRCA monitoring
- Two principal objectives:
  - PHASE 1: Mitigate risk to exposed manhole and undermined sewer
    - Preliminary and detailed design
  - PHASE 2: Assess risk to sewer in banks and at crossings
    - a) Lower Albion Creek
    - b) Humber River at confluence

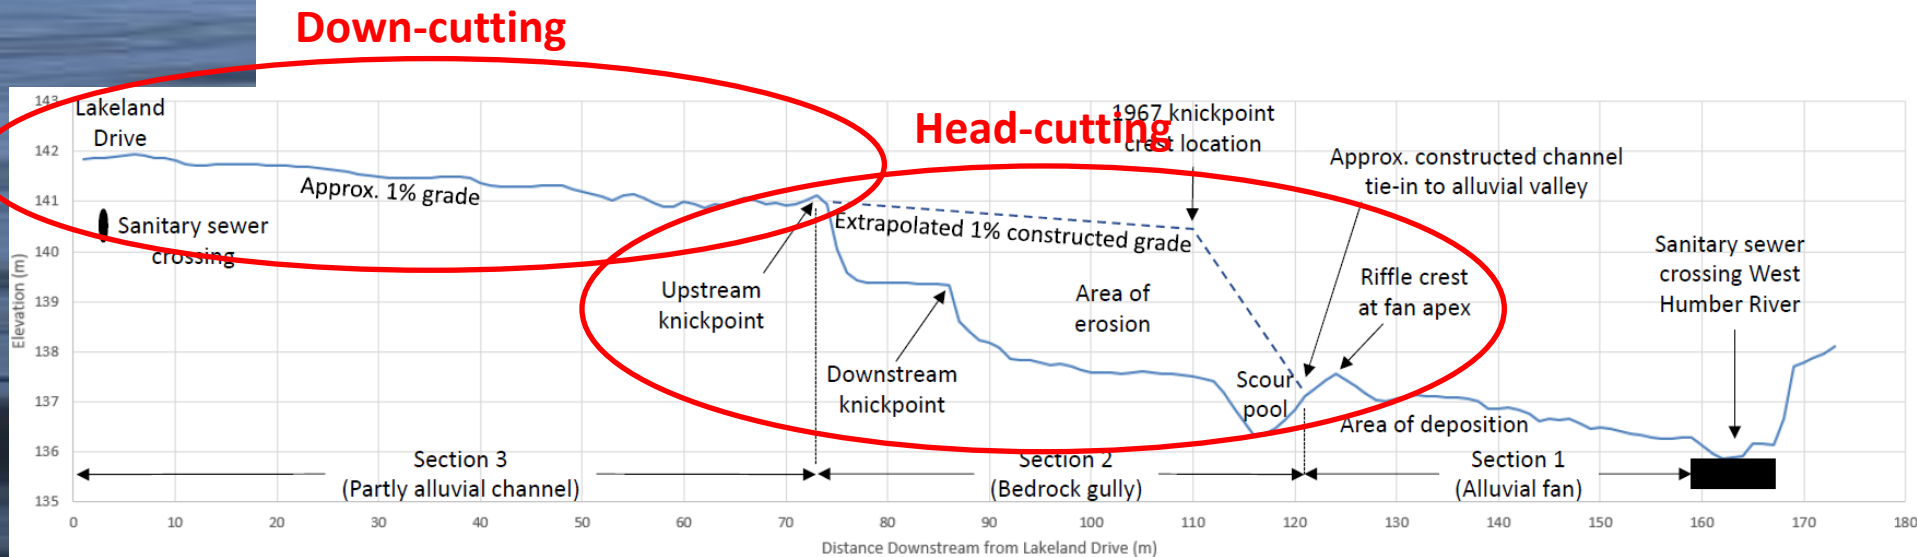
## Lower Albion Creek Longitudinal Profile

Notes:  
5X Vertical Exaggeration  
Profile from 2013 TRCA survey data (Profile H-H')

- Bed incision relative to fixed infrastructure
  - 0.0064 m/yr since realignment → 0.45 m cover likely to remain over upstream sewer crossing (Lakeland Dr) after 100 years of continued down-cutting
- Compares well to values reported in literature (e.g., Tinkler & Parish, 1998)

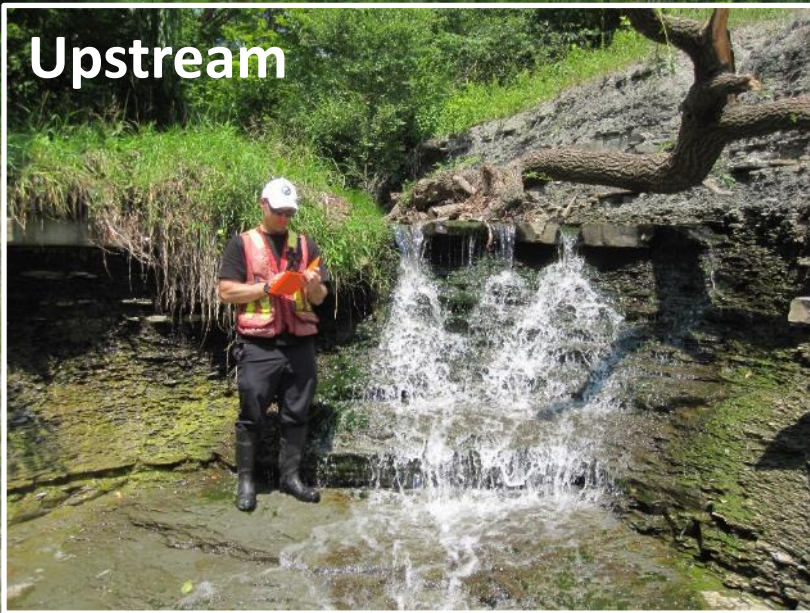
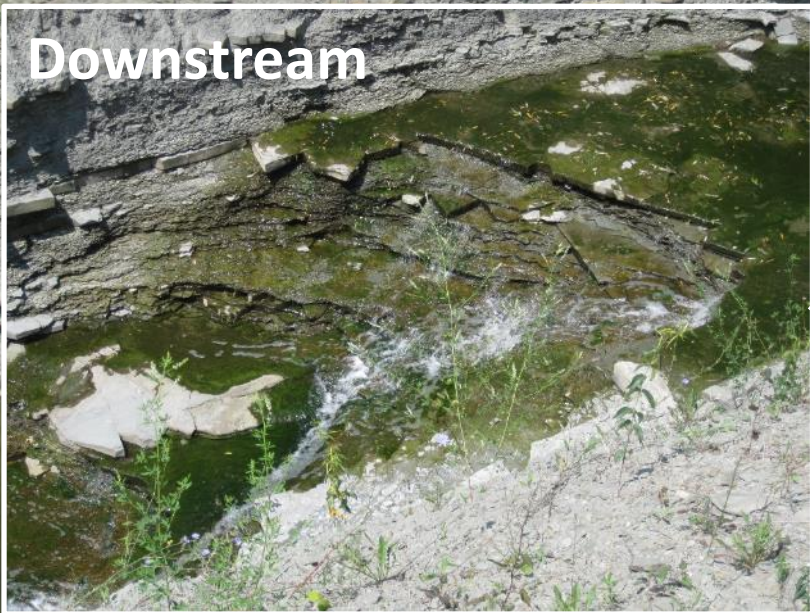
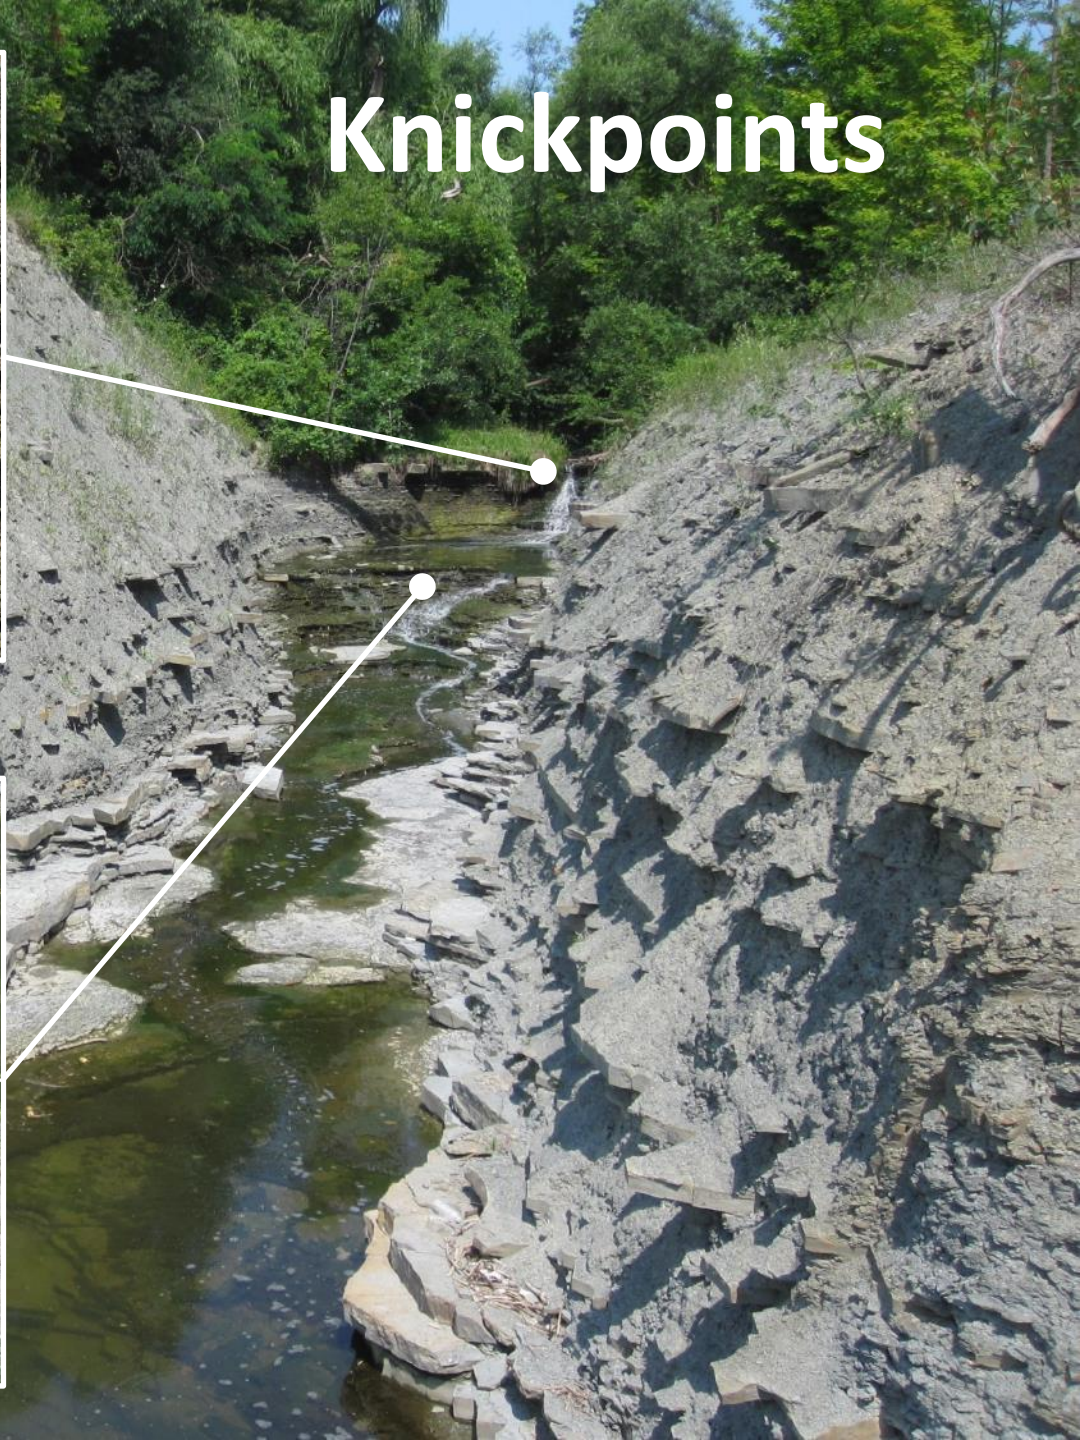
- Channel incising retrogressively from downstream end

**Upstream**

**Downstream**

**Knickpoints**

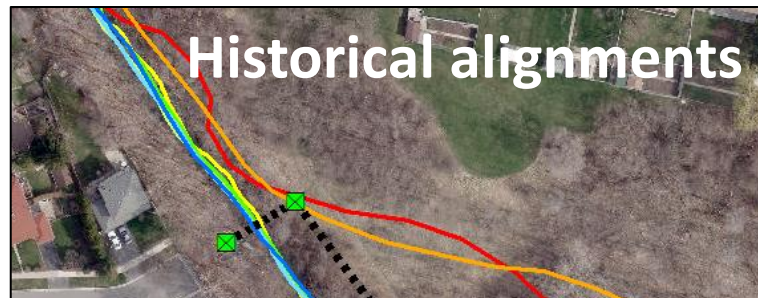
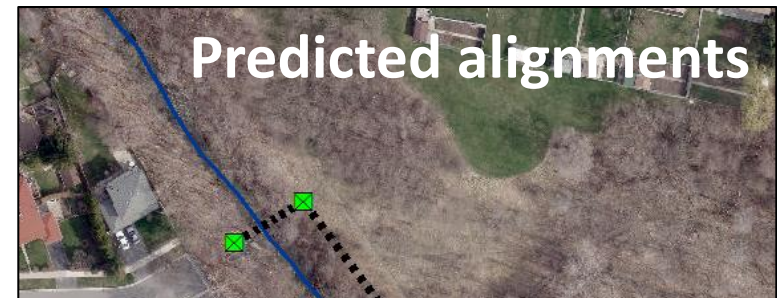
# Lateral Erosion

Pistol-butt trees

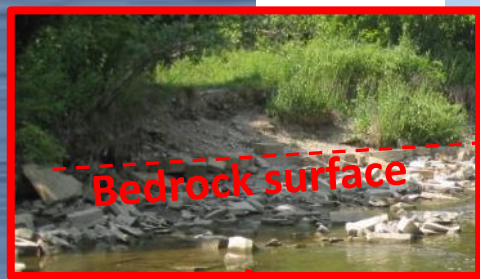
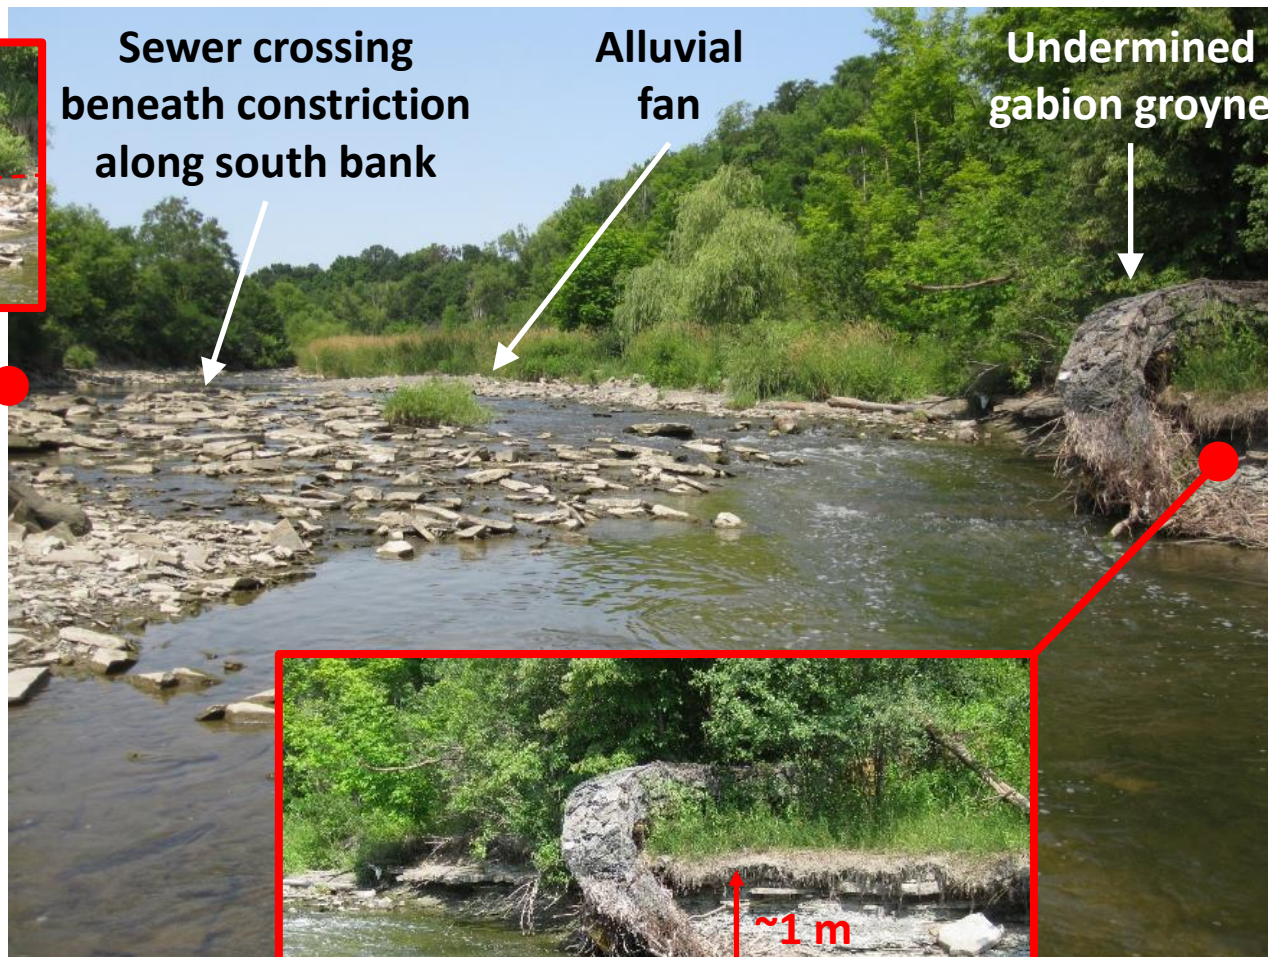
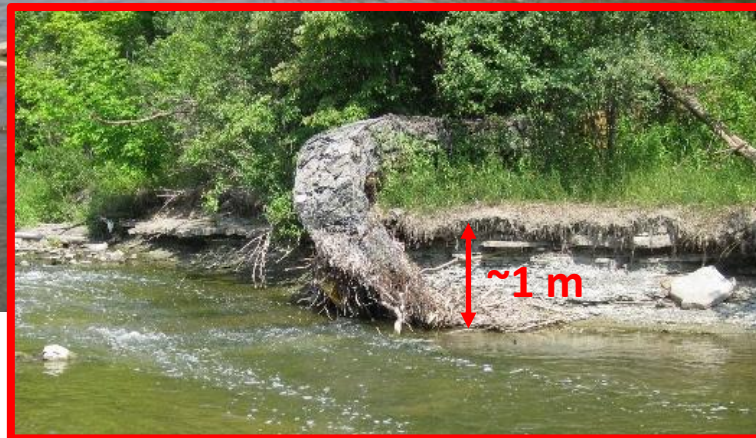
# Humber River Down-cutting

Sewer crossing  
beneath constriction  
along south bank

Alluvial  
fan

Undermined  
gabion groyne

- **PHASE 1:** How to address undermined sewer pipe and exposed manhole along lower Albion Creek?
  - Stabilization, protection & deflection
- **PHASE 2a:** How to address knickpoint migration along lower Albion Creek?
  - Periodic knickpoint monitoring
- **PHASE 2b:** How to address exposed sewer pipe crossing Humber River?
  - Regularly monitor condition of sewer and d/s riffle crest
  - Allow for continued growth of alluvial fan
  - Consider excavating south bank to restore more natural river width before in-stream rock placement
