Watercourse Collector App

Results from a multi-year watercourse deficiency monitoring program

Hector Quintero, City of Hamilton

Meghan Sauro, AECOM

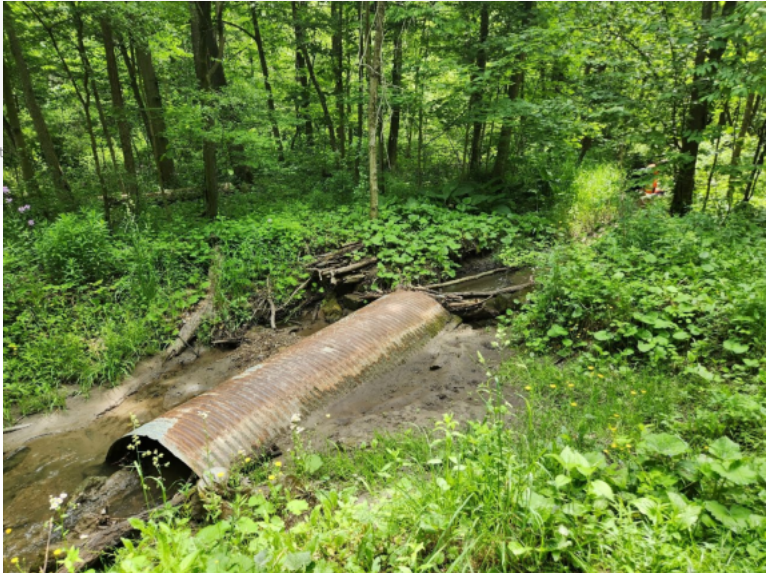
WC_Deficiency2024: trail	
Access Distance	5.00
Access Name	trail
Accessibility To Site	yes
CreationDate	6/4/2024, 11:49 a.m.
Creator	Aecom
Deficiency Height / Depth (m)	2.00
Deficiency Length (m)	10.00
Deficiency Width (m)	3.00
EditDate	
Editor	
Maintenance Rating	1 - Fair
Nearest Asset ID	
Notes	large csp pipe displaced and buried in channel, parallel, woody debris at inlet, disrupting flow
ReachID	SULSCH3217T11
Type of Deficiency	Major Obstruction/Debris Jam
Watercourse ID	Sulphur creek
Wetted Depth (m)	0.10
Wetted Width (m)	2.00
Attachments:	
Photo 1.jpg	
Photo 1.jpg	
Photo 2.jpg	
Photo 3.jpg	
Photo 4.jpg	
Edited by hw128839 on 10/7/24 at

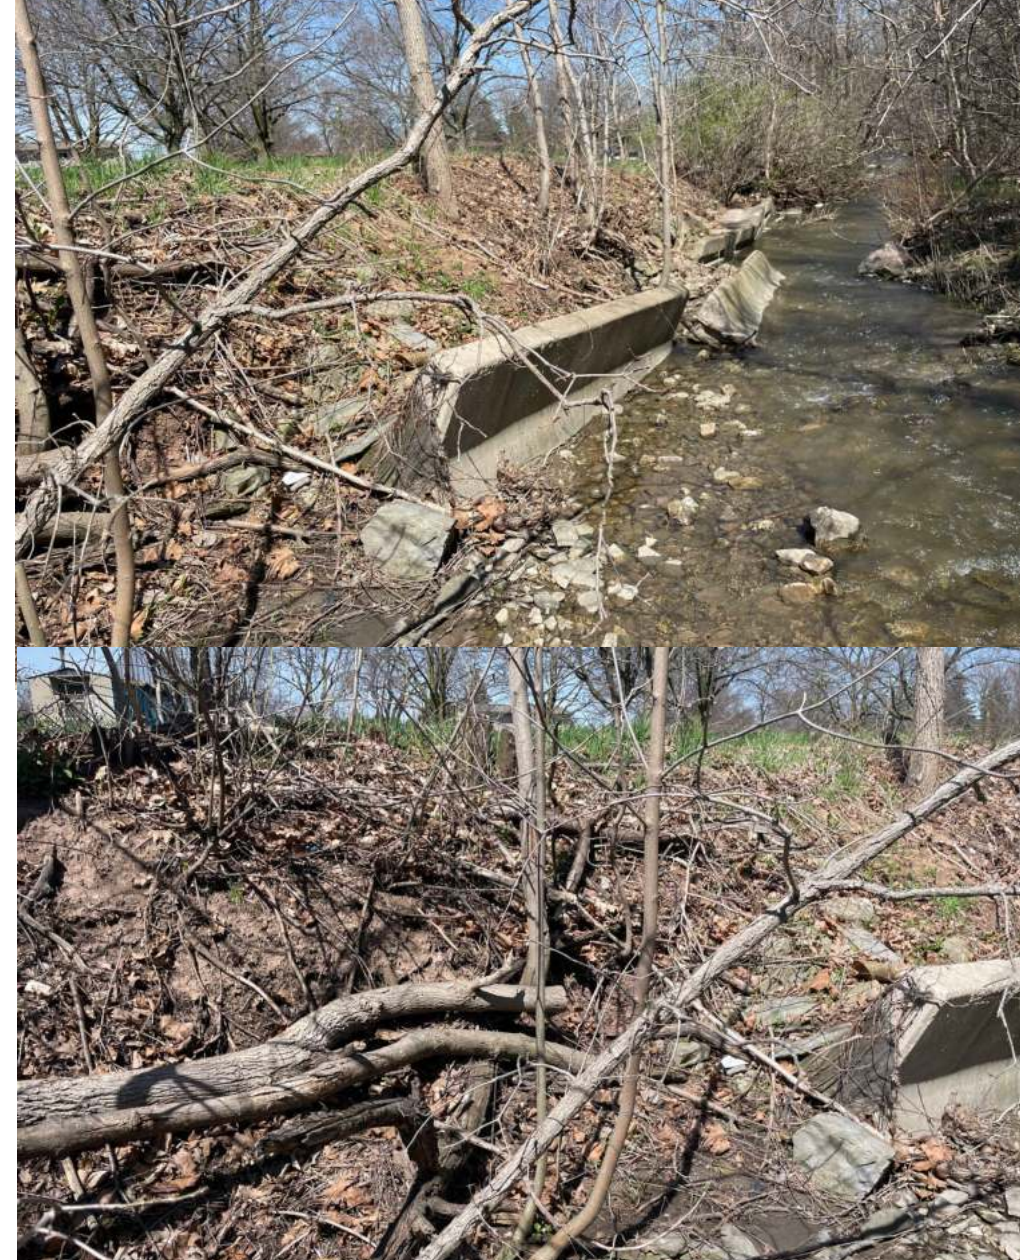
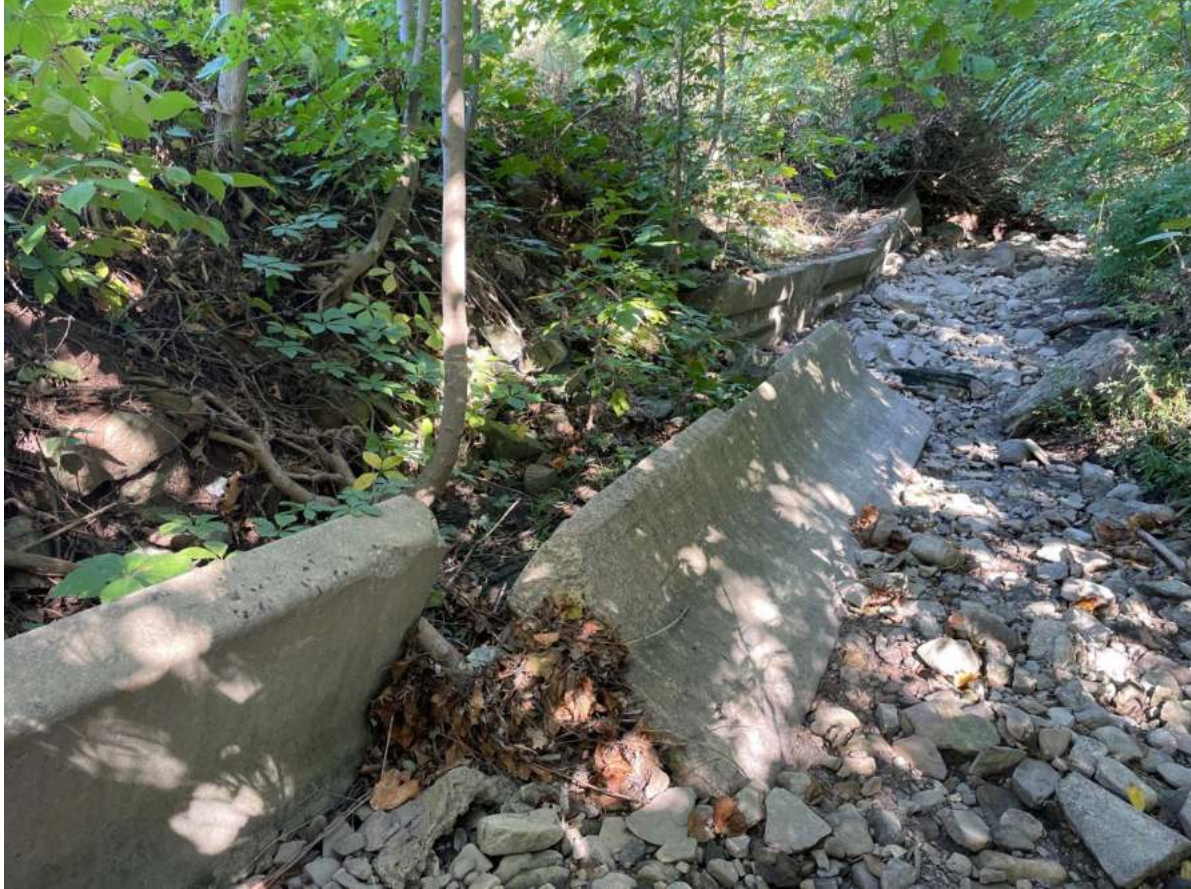
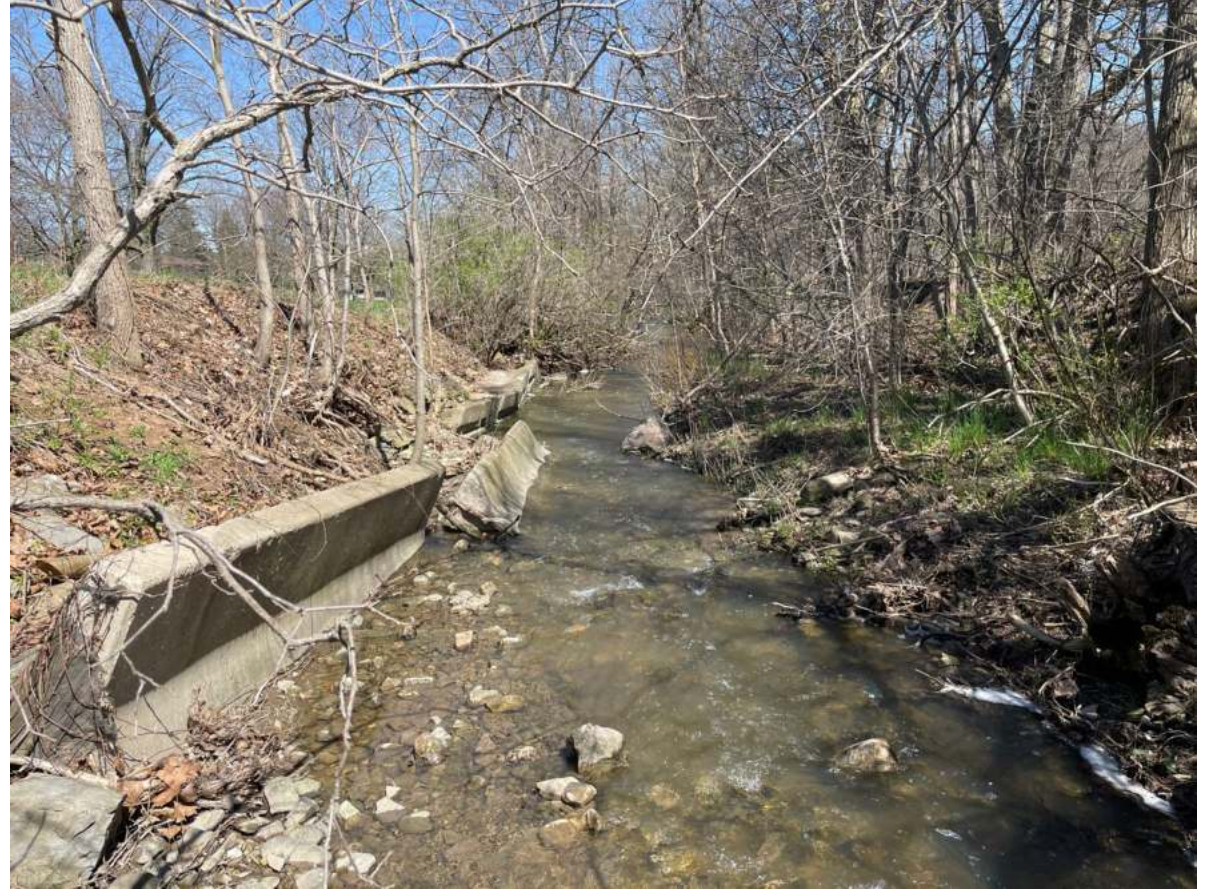
Case Study 1: Low (10 + Years)

- Adjacent to pedestrian trail and park
- Bank erosion with structures displaced
- Minimal change since previous inspection (2022)
- Recommended bank rehabilitation and structure replacement

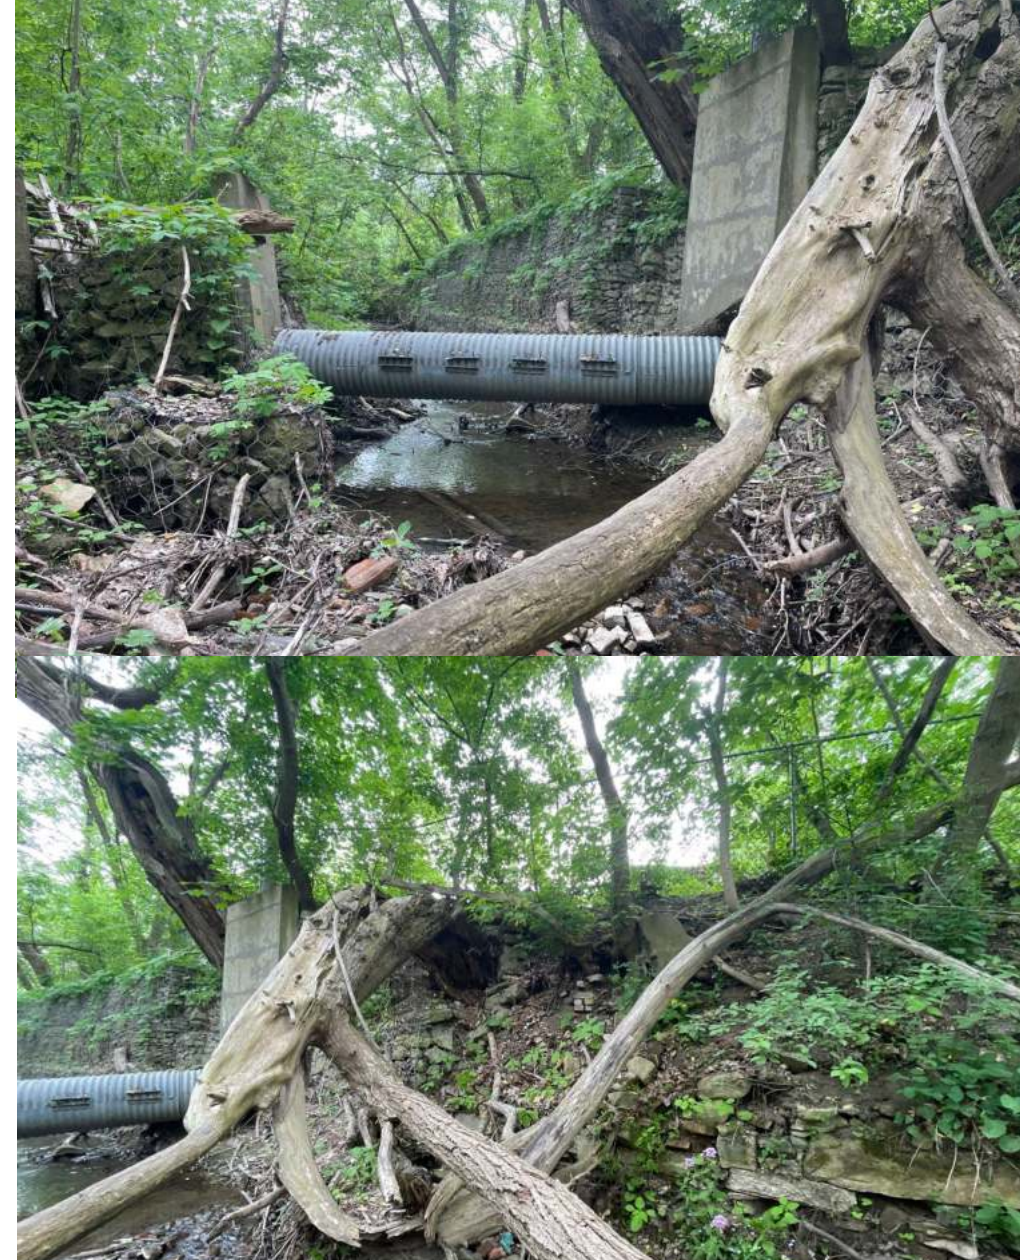
Case Study 2: Medium (3 - 5 Years)

- Sewer pipe exposed across creek
- Significant downcutting and widening through reach
- Consequent LWD jams
- Recommended debris jam maintenance and creek reconstruction

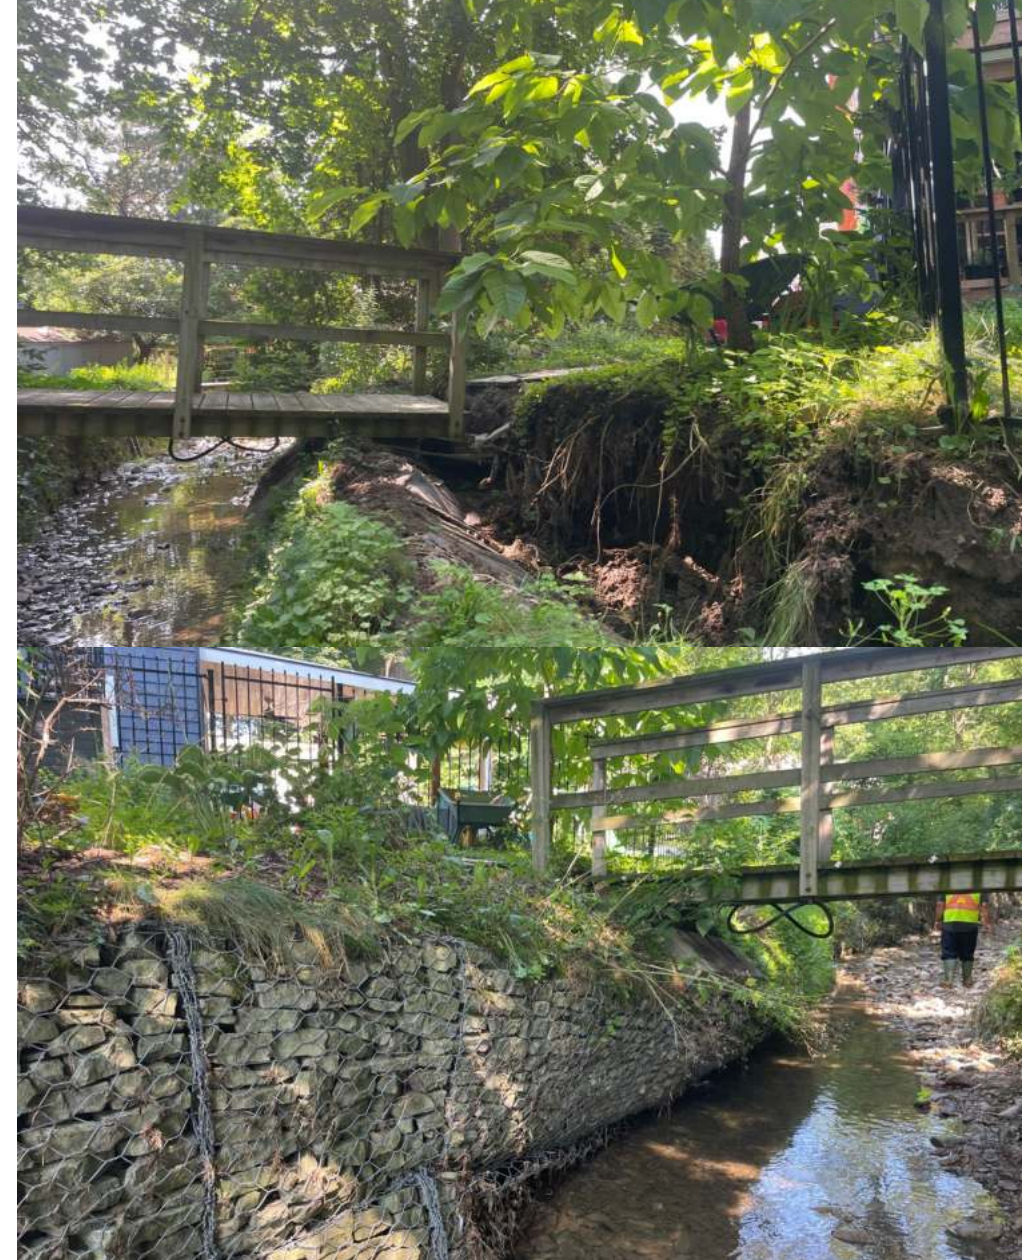
Case Study 3: High (~ 1 Year)

- Gabion wall collapse 1 m away from private property
- Potential failure of upstream Gabion walls that are currently sloped
- Residents voiced concern
- Recommended rehab of slopes and gabion walls
