# Unmaintained Stormwater Outfalls: Draining Water or Draining Resources?

# Case Study: Holland Bloorview Outfall

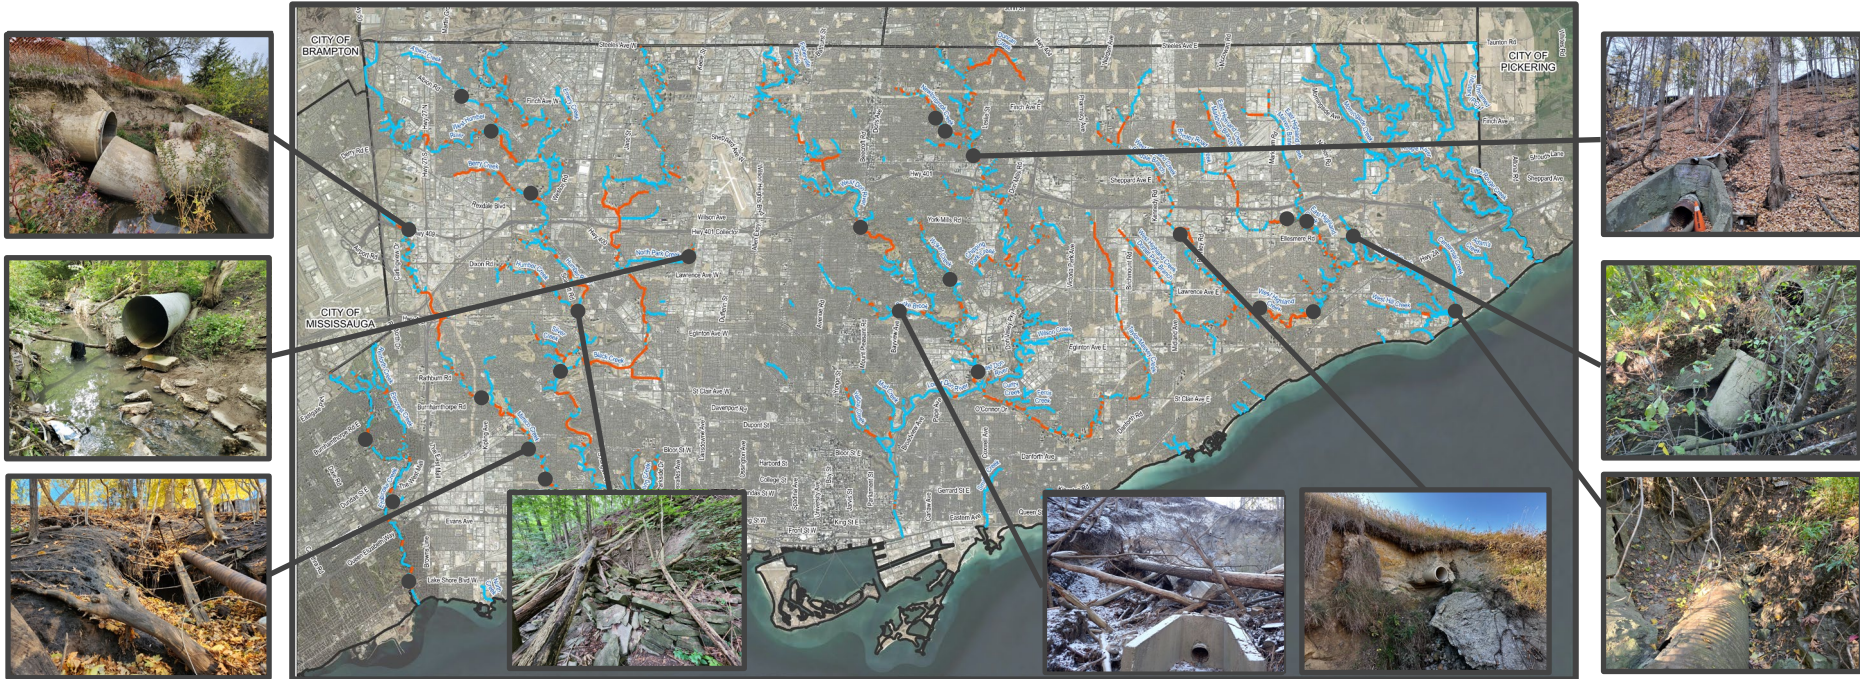
- Abundant throughout urbanized areas, stormwater outfalls are capable of extreme failure, causing mass erosion and risks to property and infrastructure

*Numerous Drastically Failed Stormwater Outfalls Across Toronto*

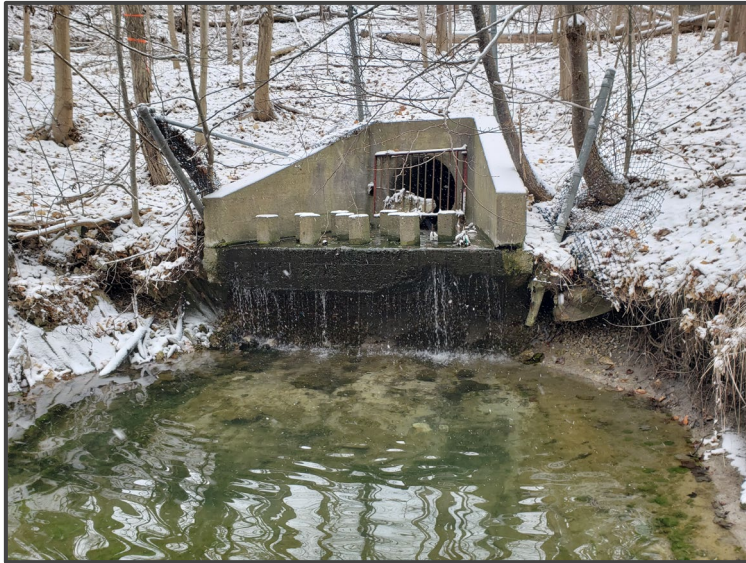
Insufficient Erosion Protection → Scour → Collapse of Headwall → Failure of Upstream Pipe

*Undermined Stormwater Headwall Structure  
at Risk of Collapse*

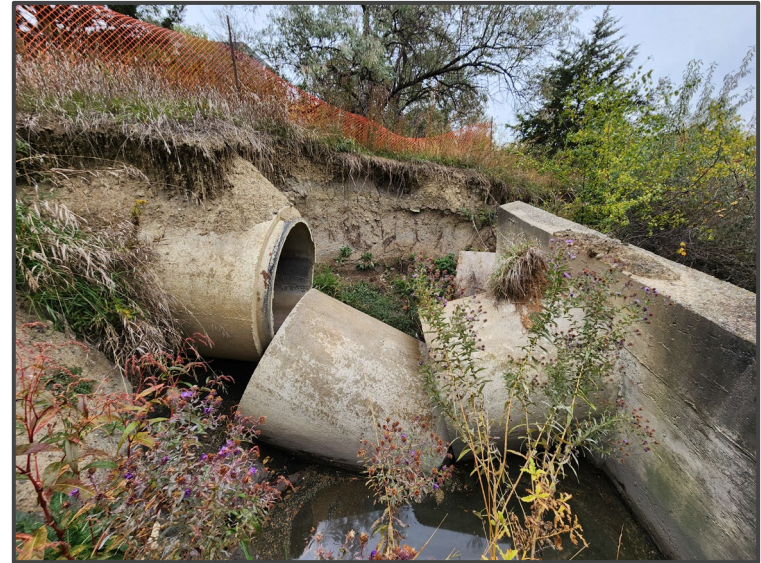
*Collapsed Concrete Headwall Structure and  
Failed Upstream Pipe Segments*

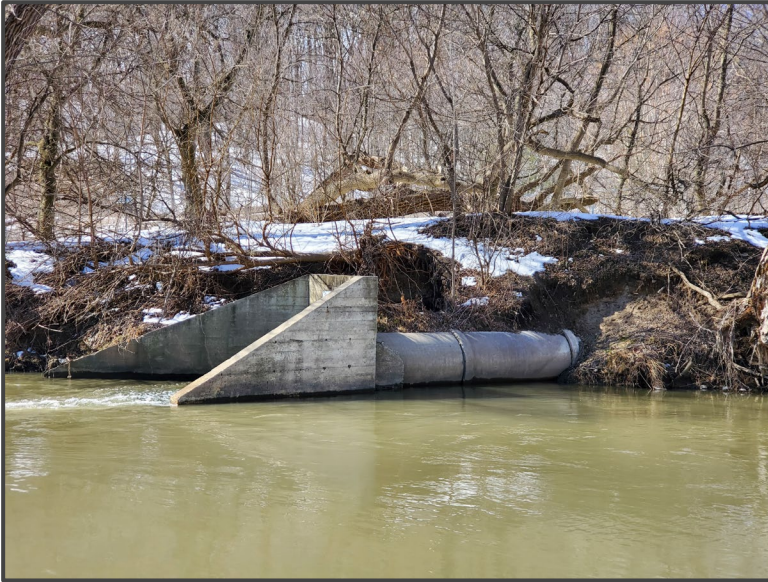
Erosive Watercourse Flows → Lateral Erosion → Outflanked Outfall

*Outflanked Concrete Headwall  
Structure and Upstream Pipe*

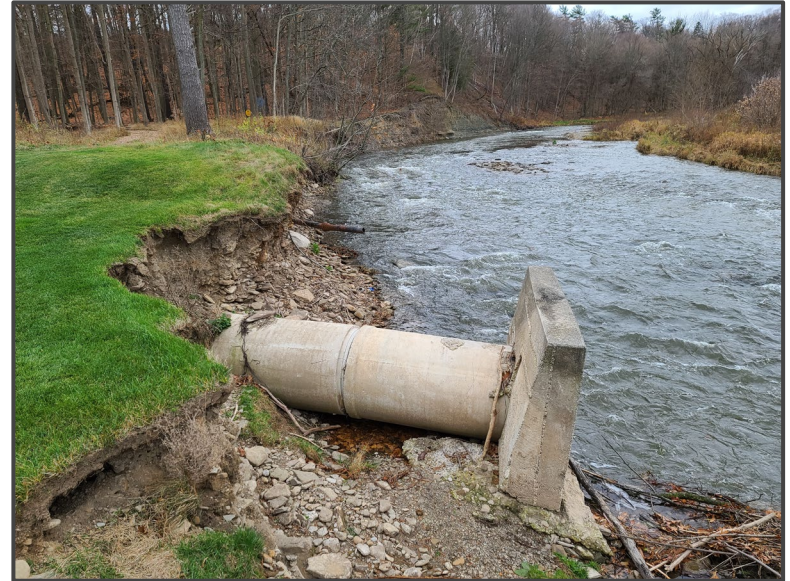
*Outflanked Headwall Structure and  
Upstream Pipe Segment*

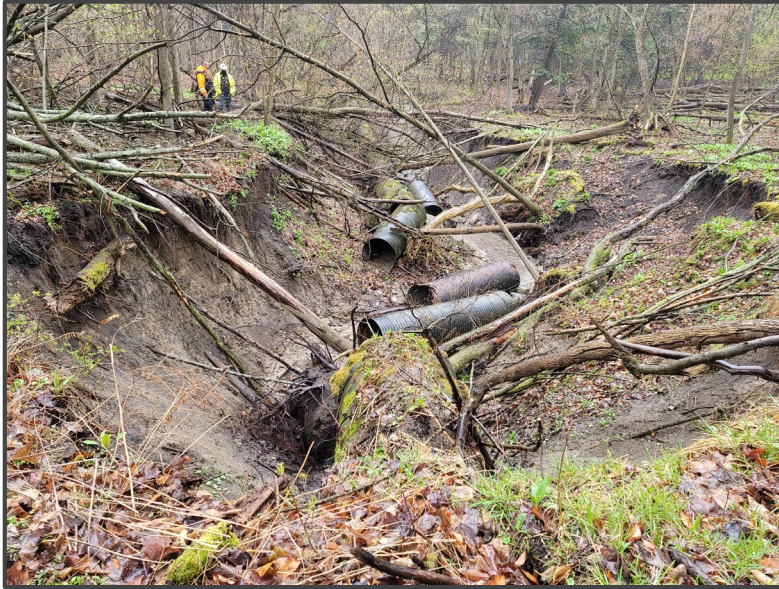
Corrosion of Upstream Pipe → Flows Bypass Headwall Structure → Erosion Gully Formation

*Erosion Gully Formation Along Stormwater Outfall*

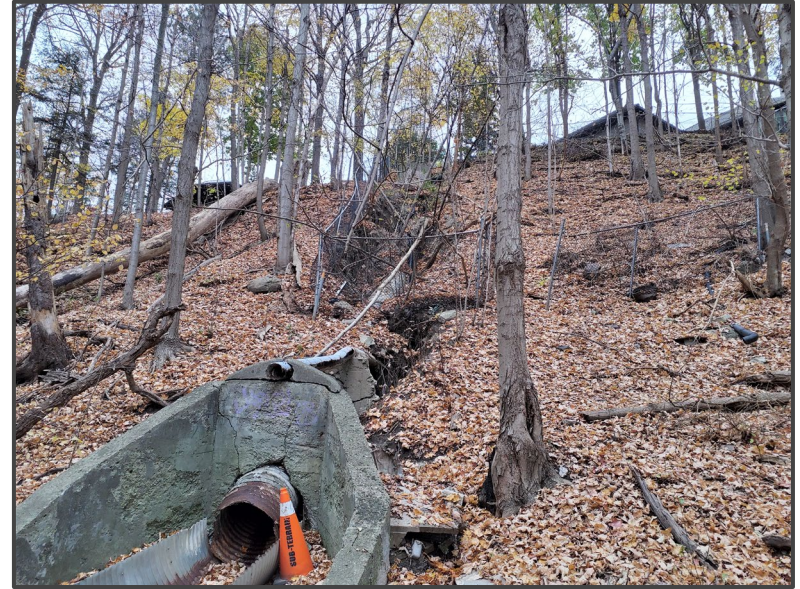
*Erosion Gully Formation Along Valley Slope*

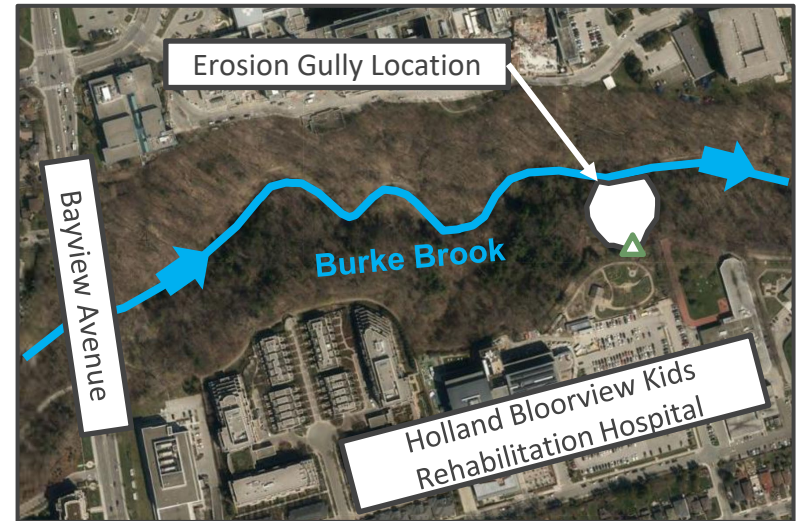
*Stormwater Outfall Failure Location*

- Extreme example of stormwater outfall failure leading to mass erosion gully
- Located in Burke Brook Ravine, within the Don River Watershed
- Over 5750 m<sup>3</sup> of soil released across a 10-year timeline
- Mature vegetation loss and severely degraded aquatic habitat
- Risks to top of slope infrastructure, including Canada's Largest Children's Rehabilitation hospital
- Rapid Failure Progression over less than 14 years

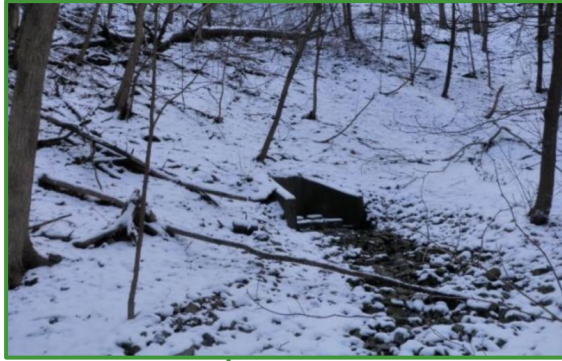
**2010**  
0 m<sup>3</sup>

1000 m<sup>3</sup>  
**2018**

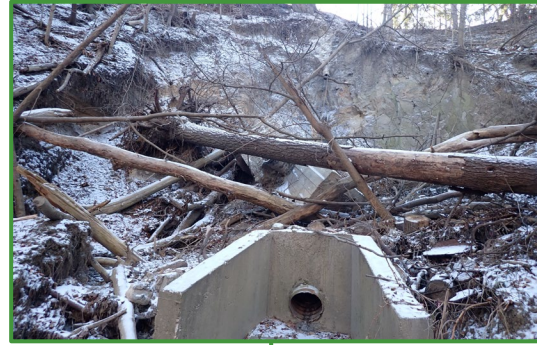
**2020**  
3000 m<sup>3</sup>

5750 m<sup>3</sup>  
**2023**

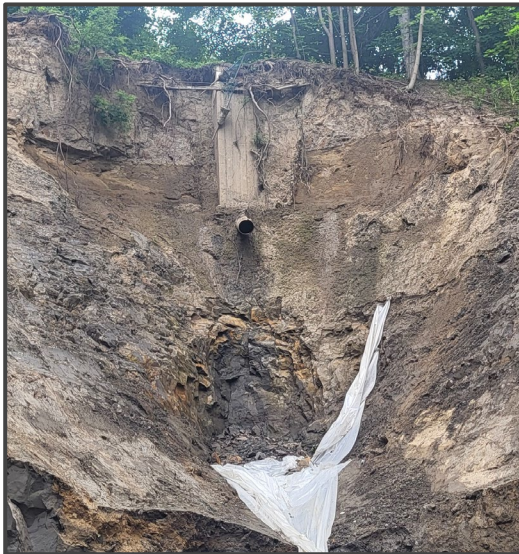
*Manhole at Imminent Risk of Failure*

- Installation a new storm sewer network, with a series of maintenance hole drop structures
- Reconstruction of the slope with imported material to fill in erosion gully
- Slope stabilization through armourstone retaining walls and vegetated gabion baskets
