The Stream Failed. Or Did It? Expectations for Natural Channel Design After Construction

Jeff Muirhead

The Project

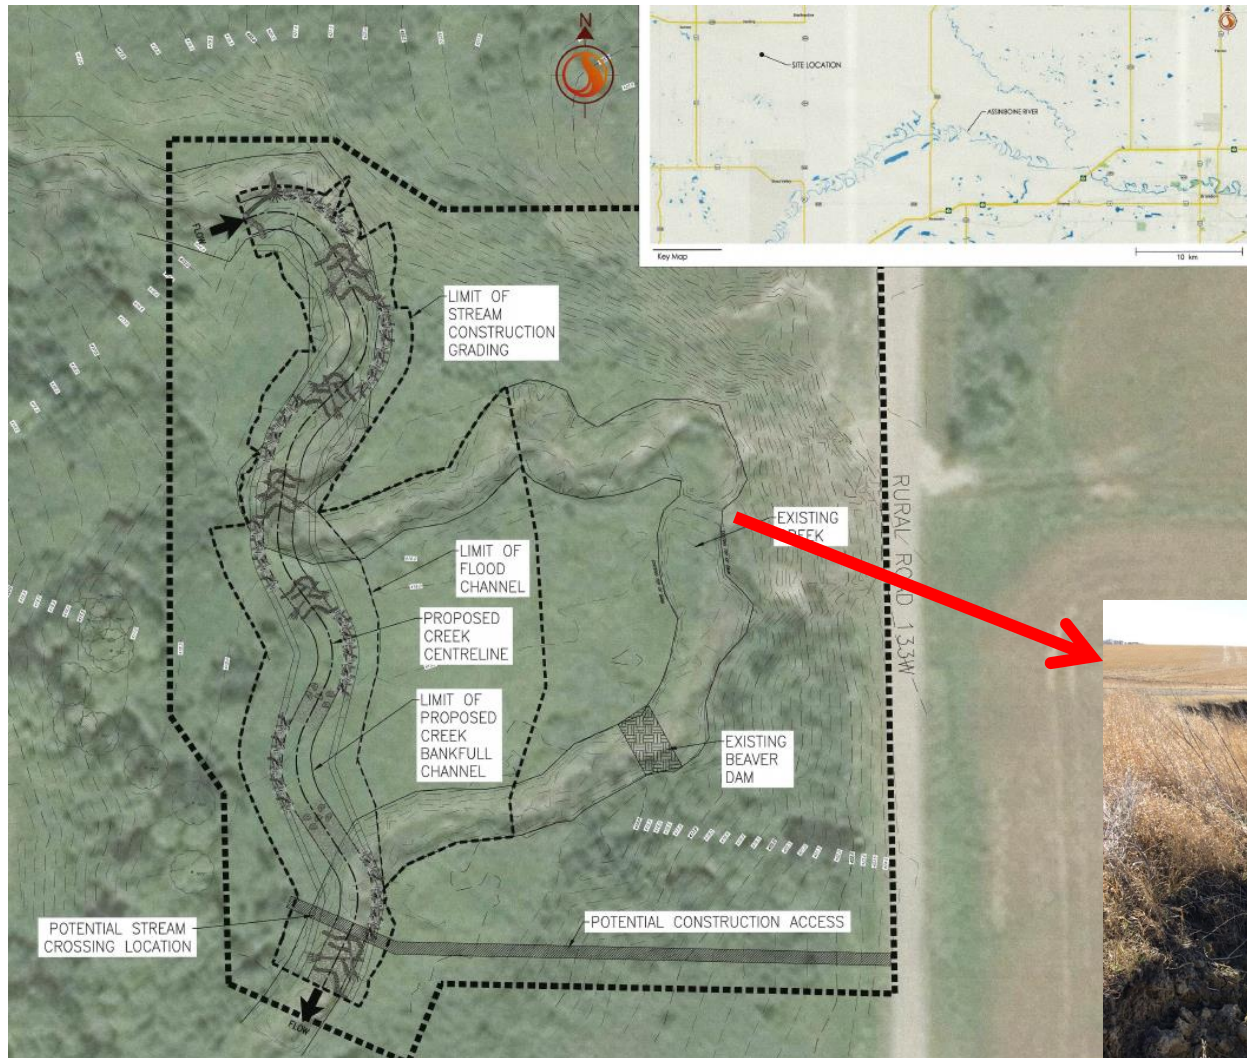
Erosion on outer meander bend threatening rural road

1. Stabilize embankment
2. Realign creek

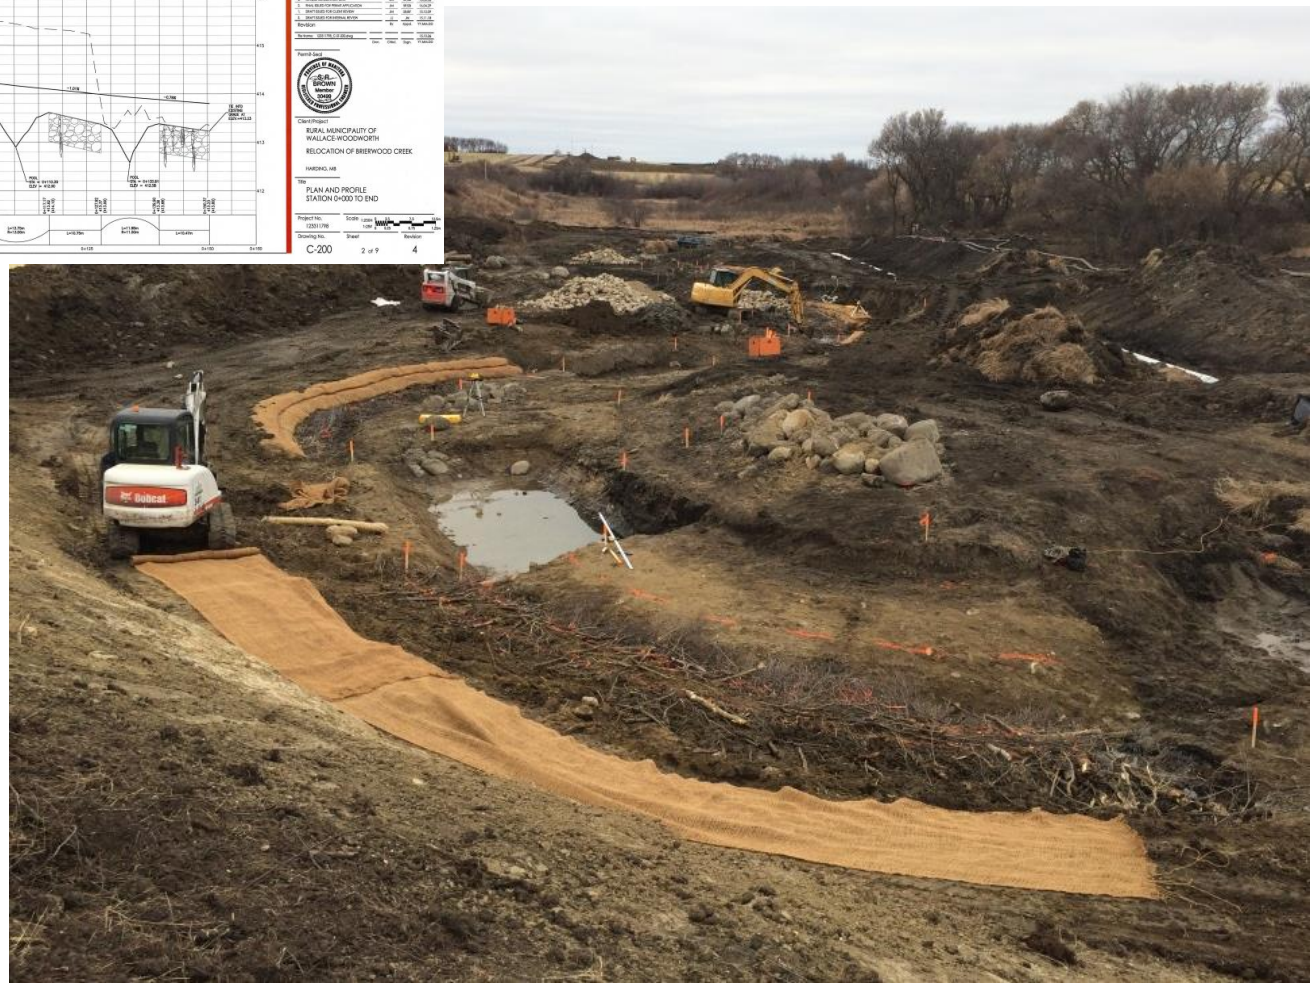
Stable Plan and Profile

150 m of natural
channel design

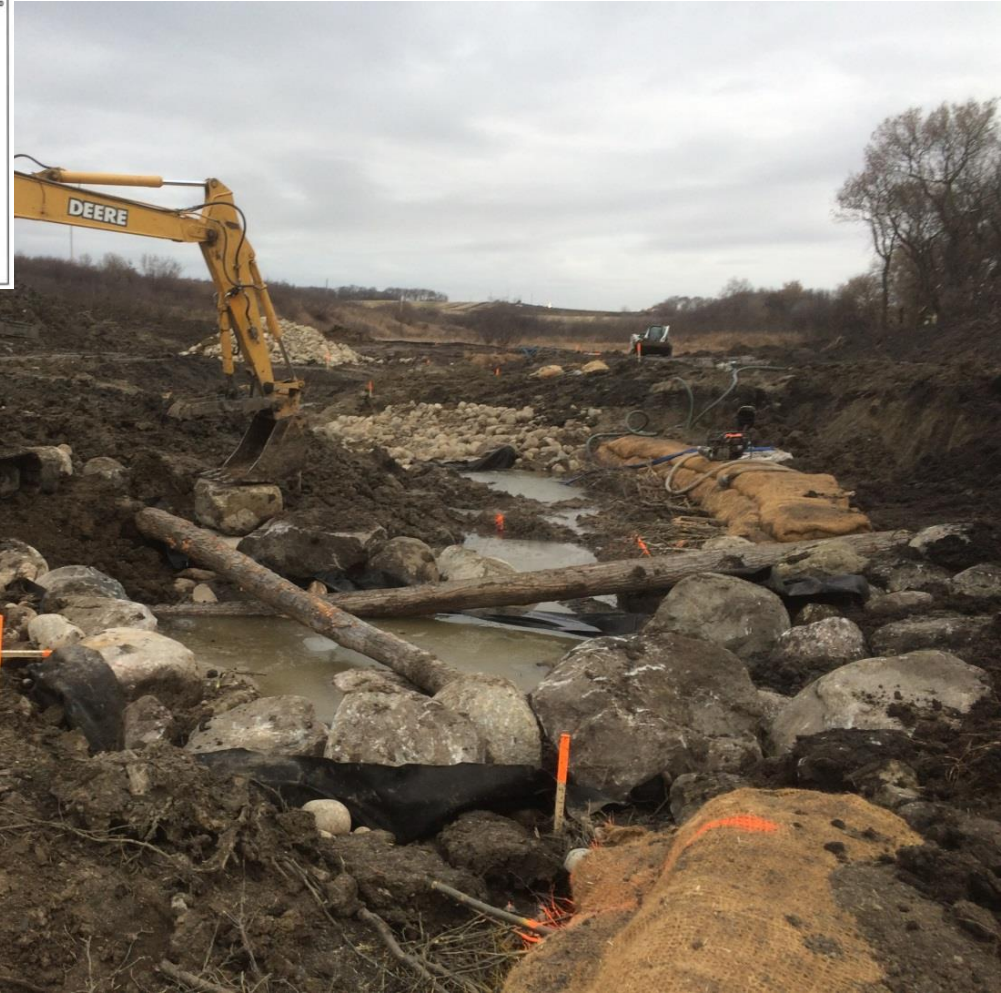
8 Log and Boulder Constructed Riffles for aquatic habitat and grade control

7 pools with
Wood Debris Toe
Protection for
aquatic habitat
and bank
stability

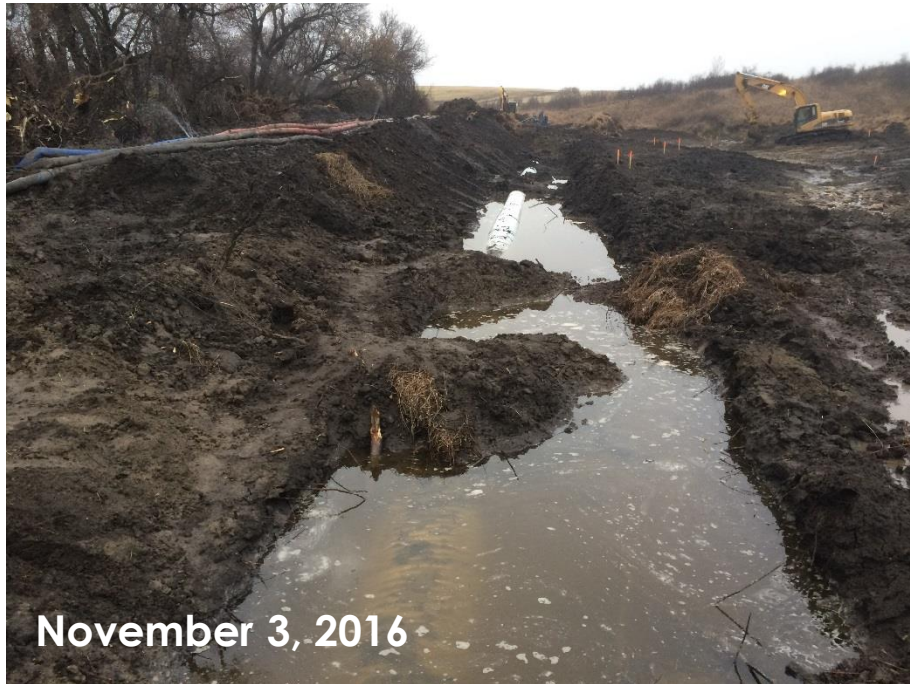
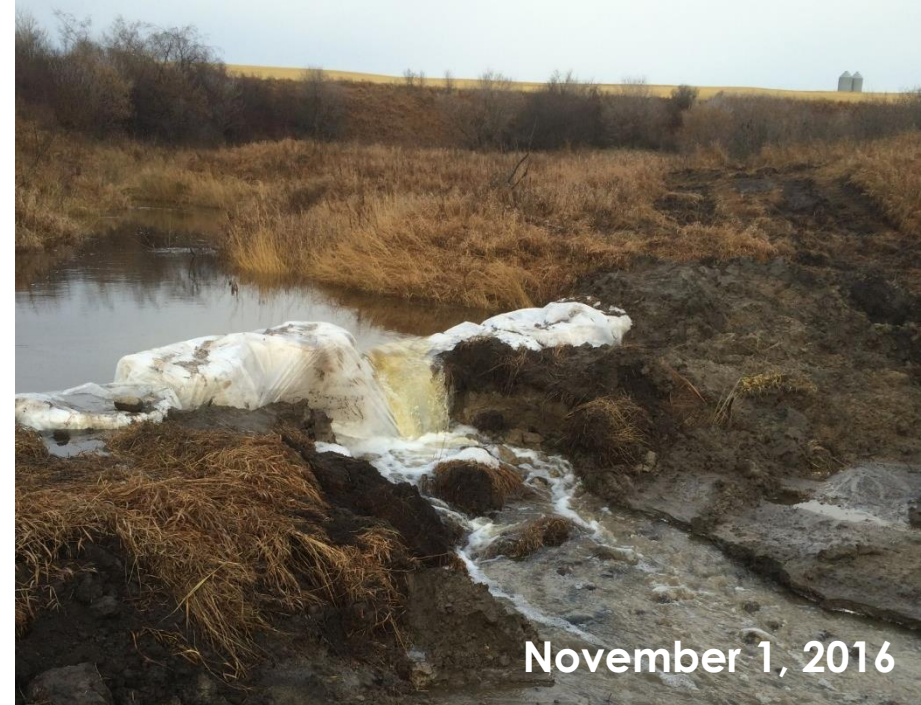
Wet Conditions

100 mm of rain in 4 days in
early November

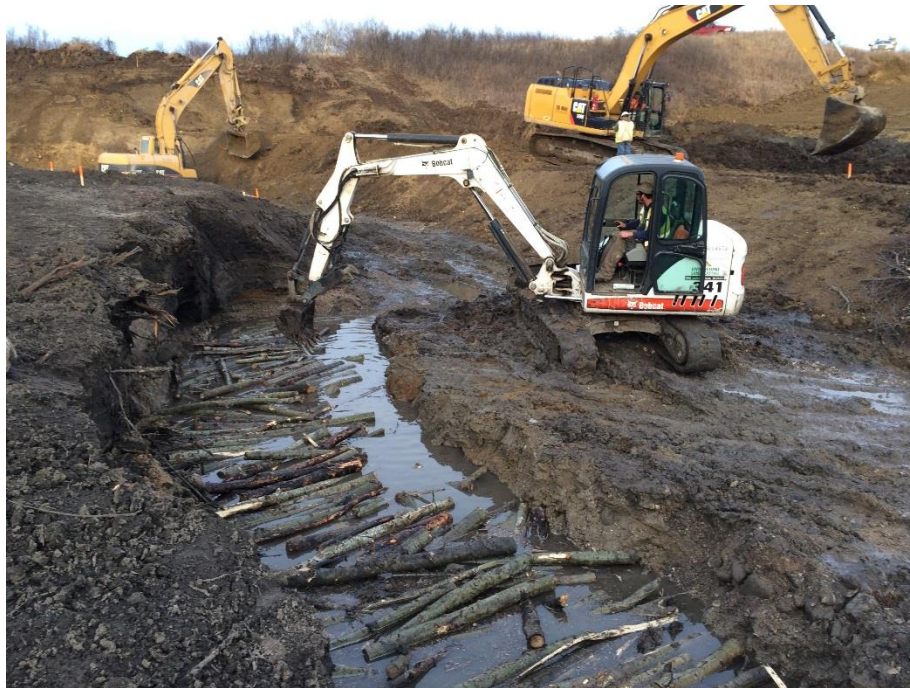
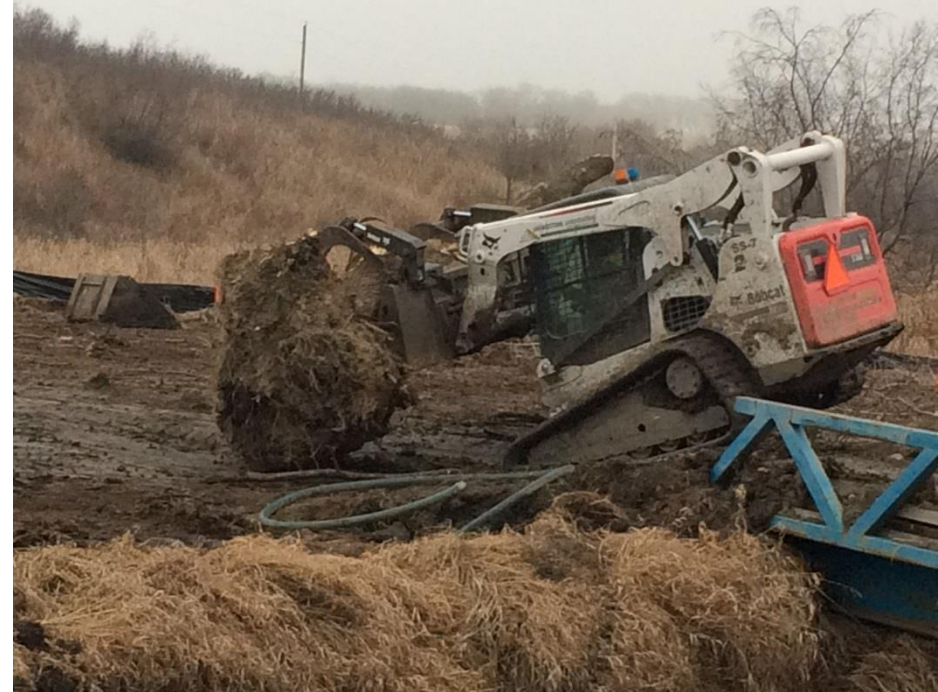
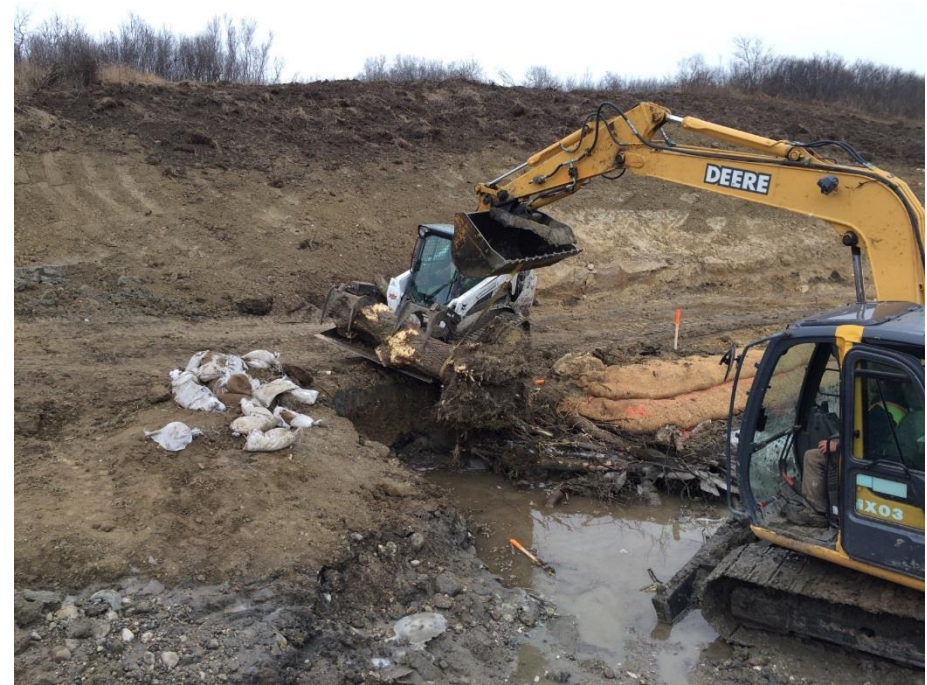
New Contractor

Slow going, but we got it right

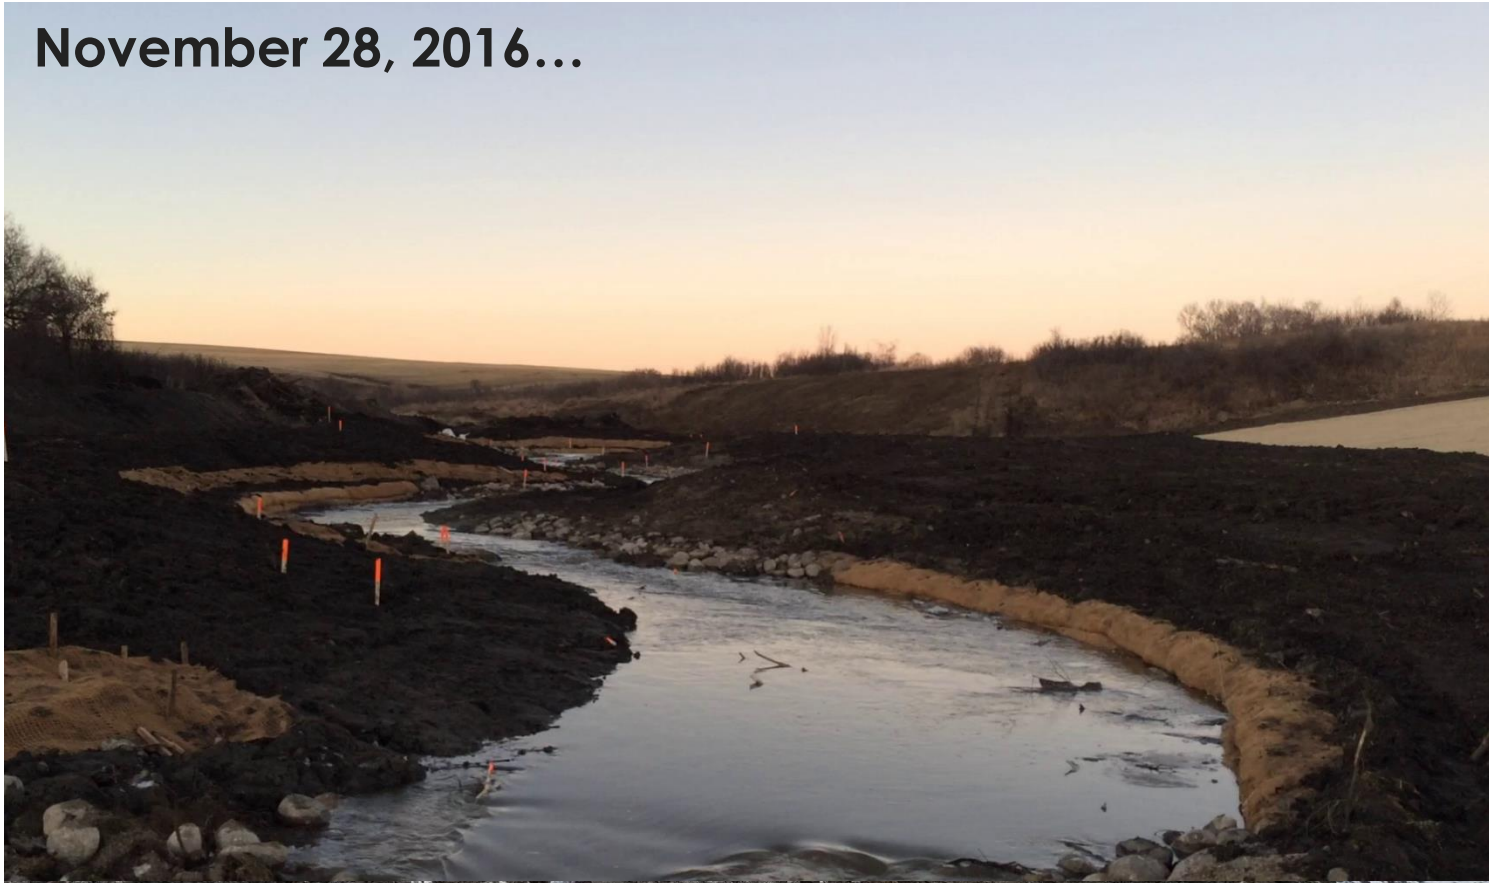
Stream completed despite some difficult conditions

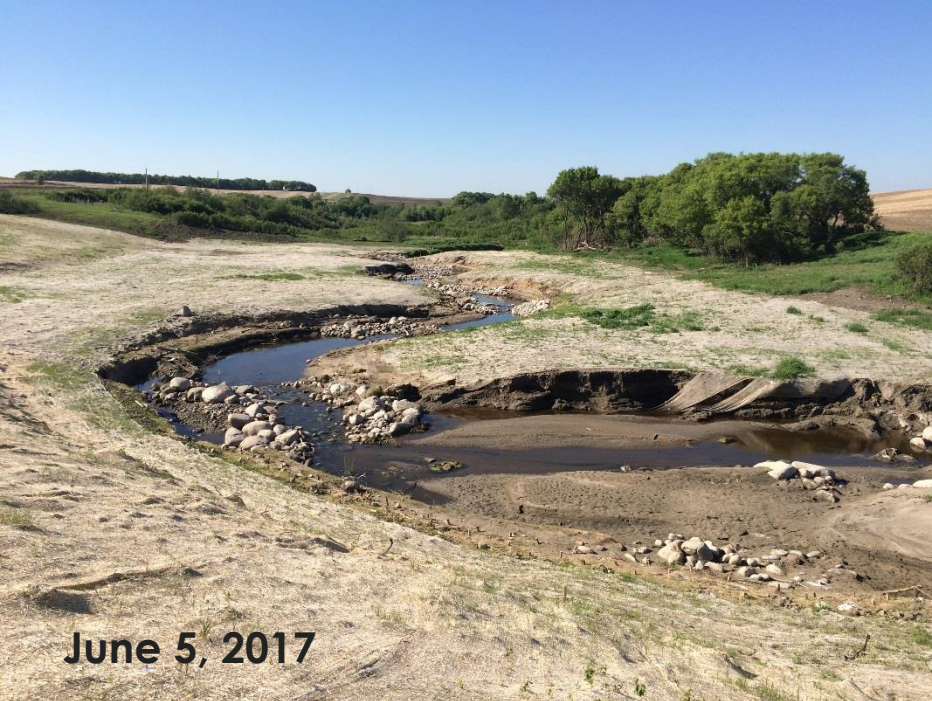
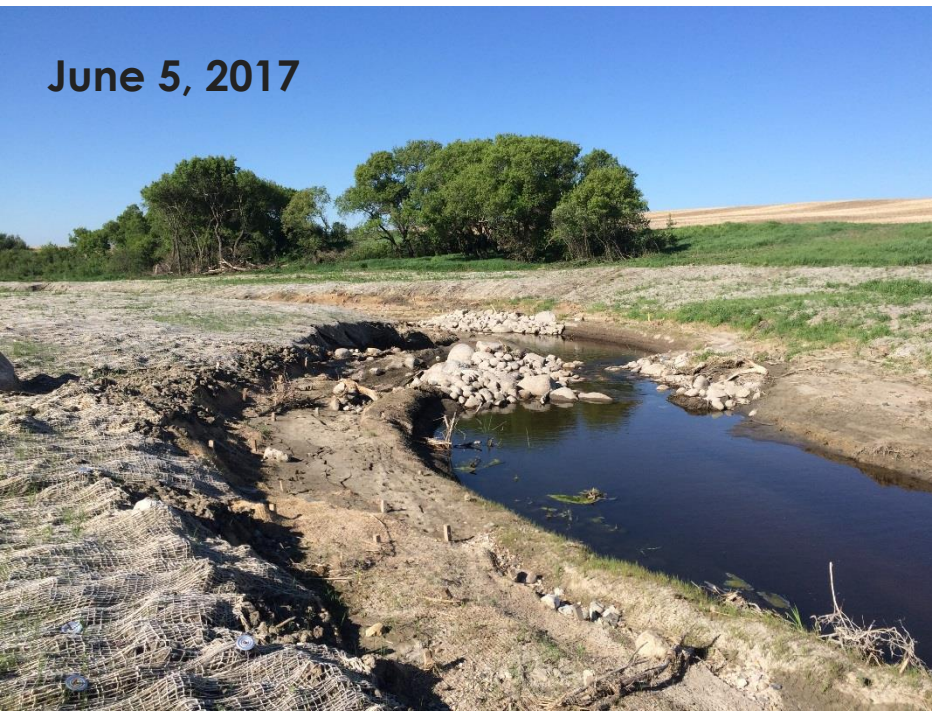
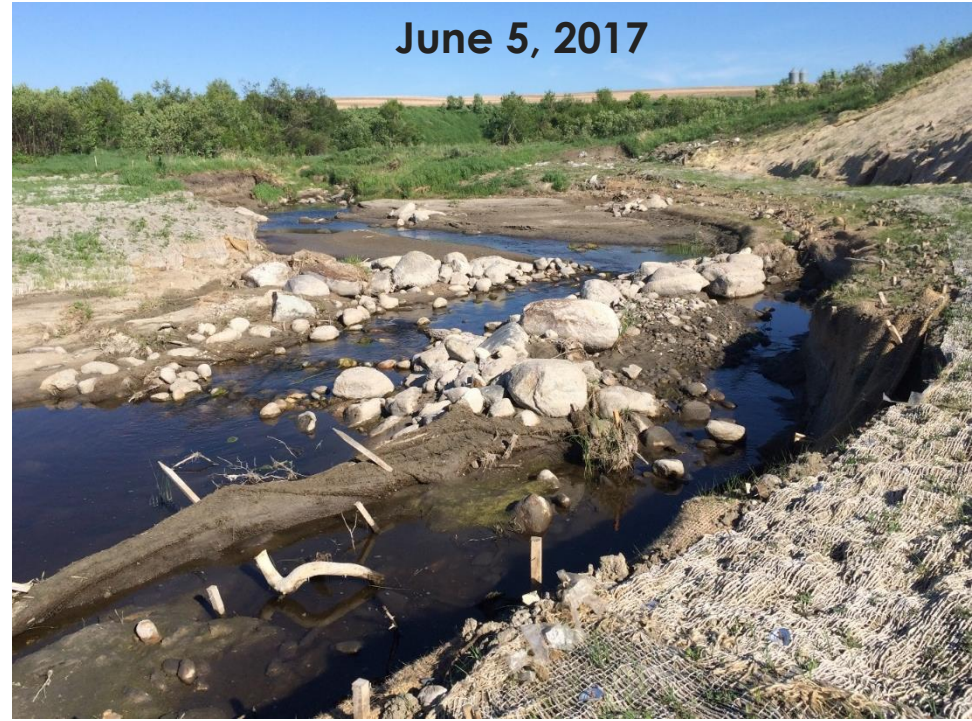
Flood Damage

- 25 – 50 year flood
- No vegetation on frozen, unconsolidated soils

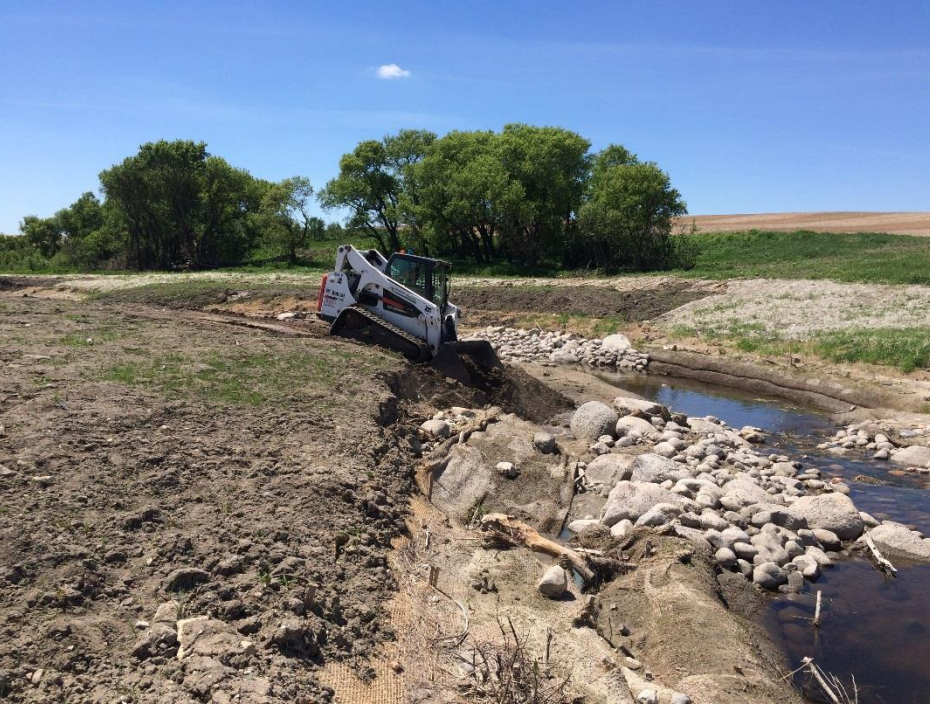
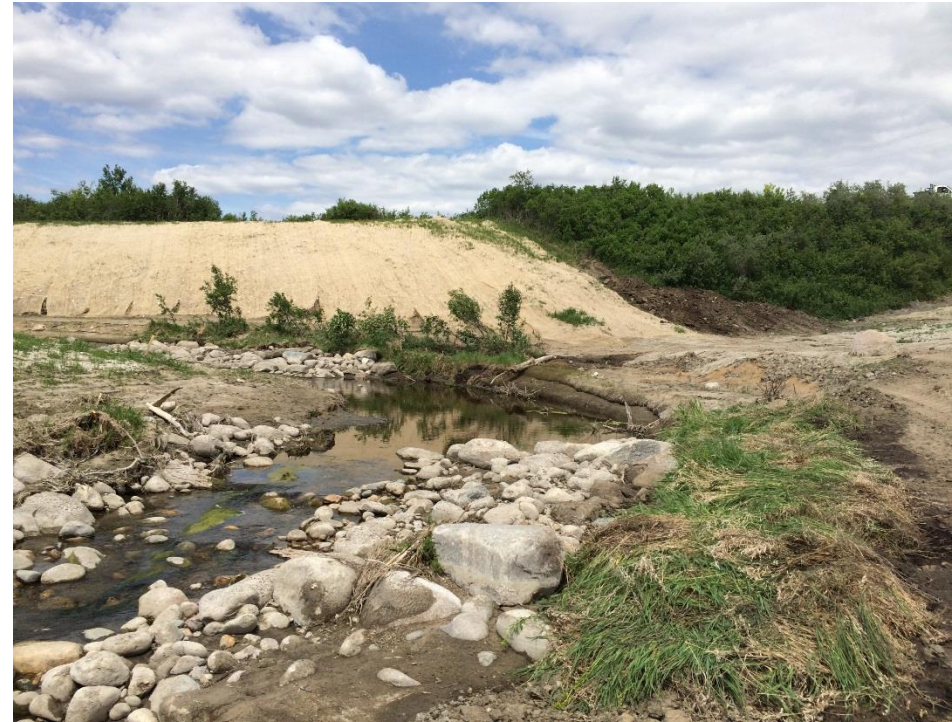
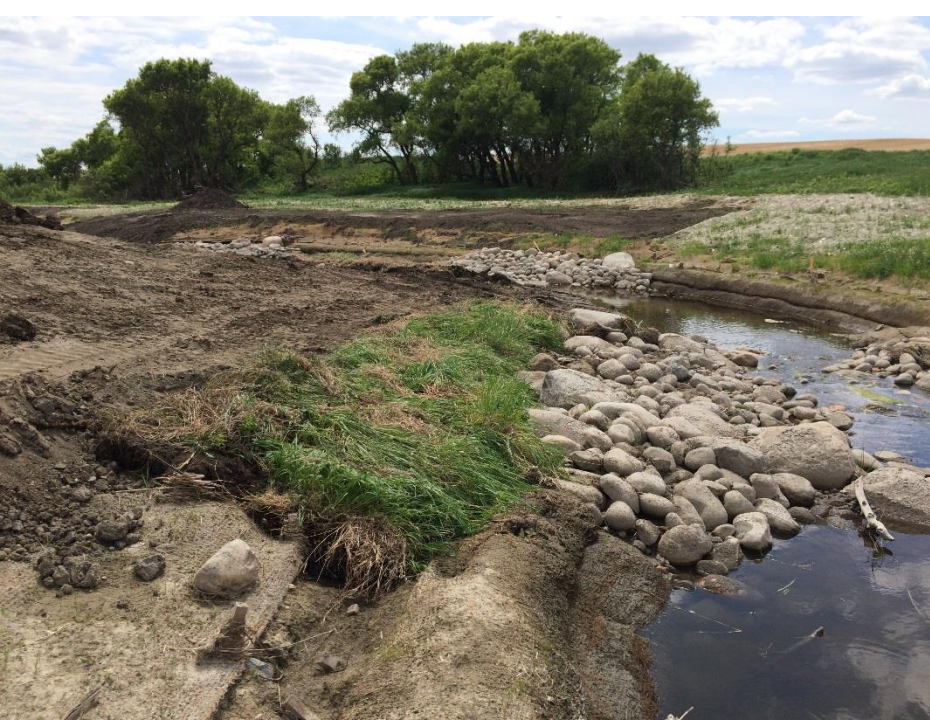
Repairs

Washed out banks throughout reach

Re-grading, re-vegetation,
design for interim conditions
