Litigation Related to Failed Stream Restoration Projects – IT'S CLOSER THAN YOU THINK

TRIECA Conference

March 22-23, 2017

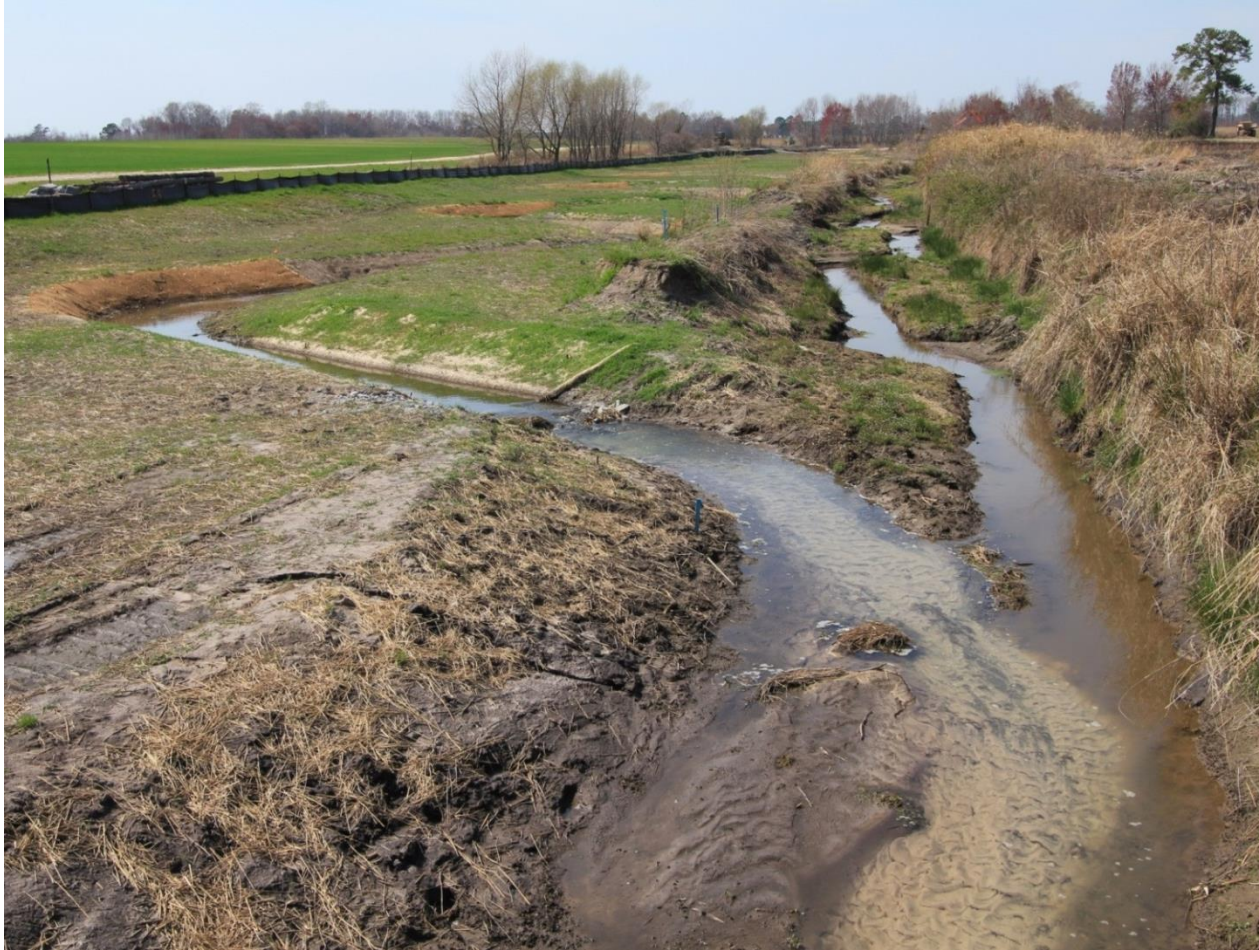
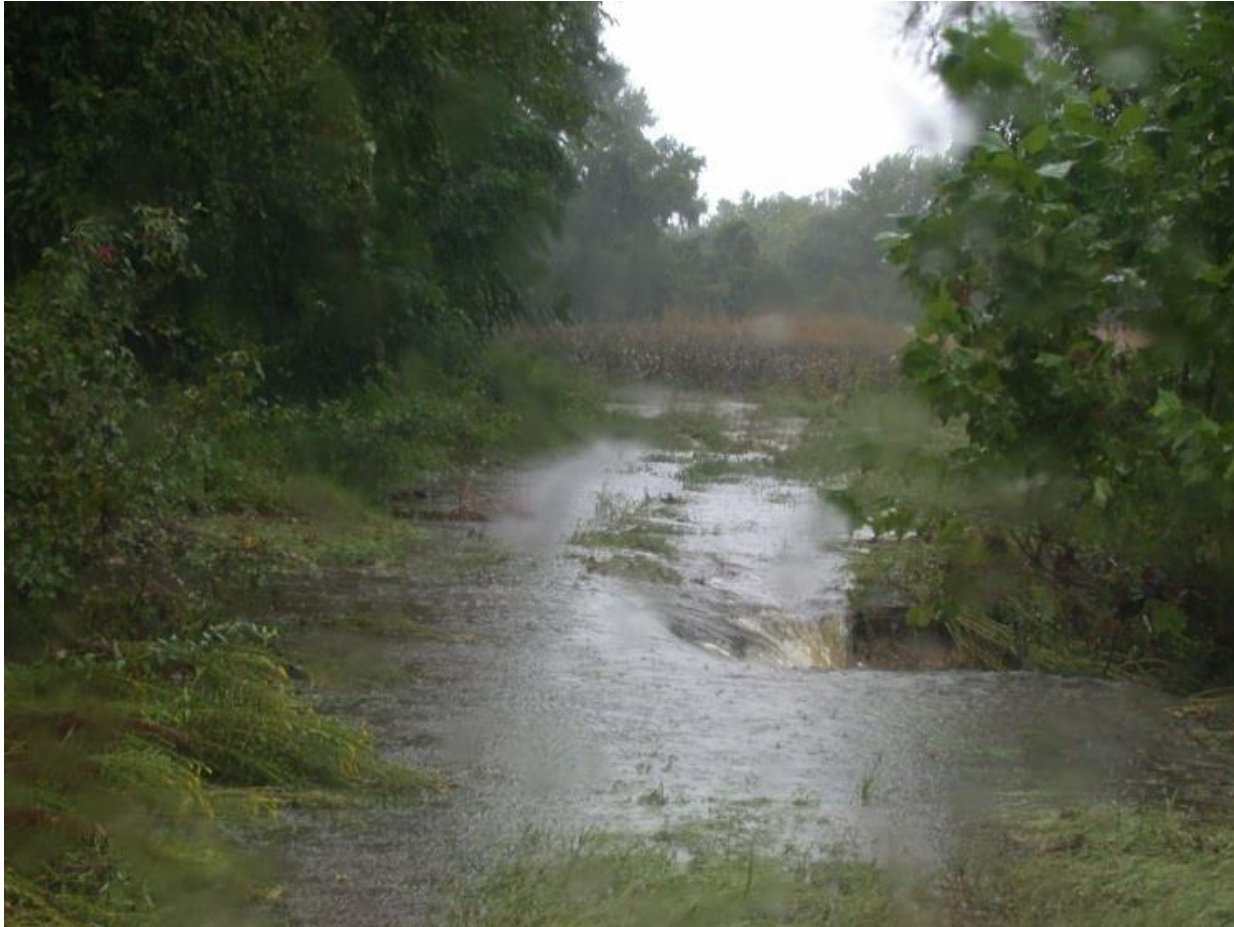
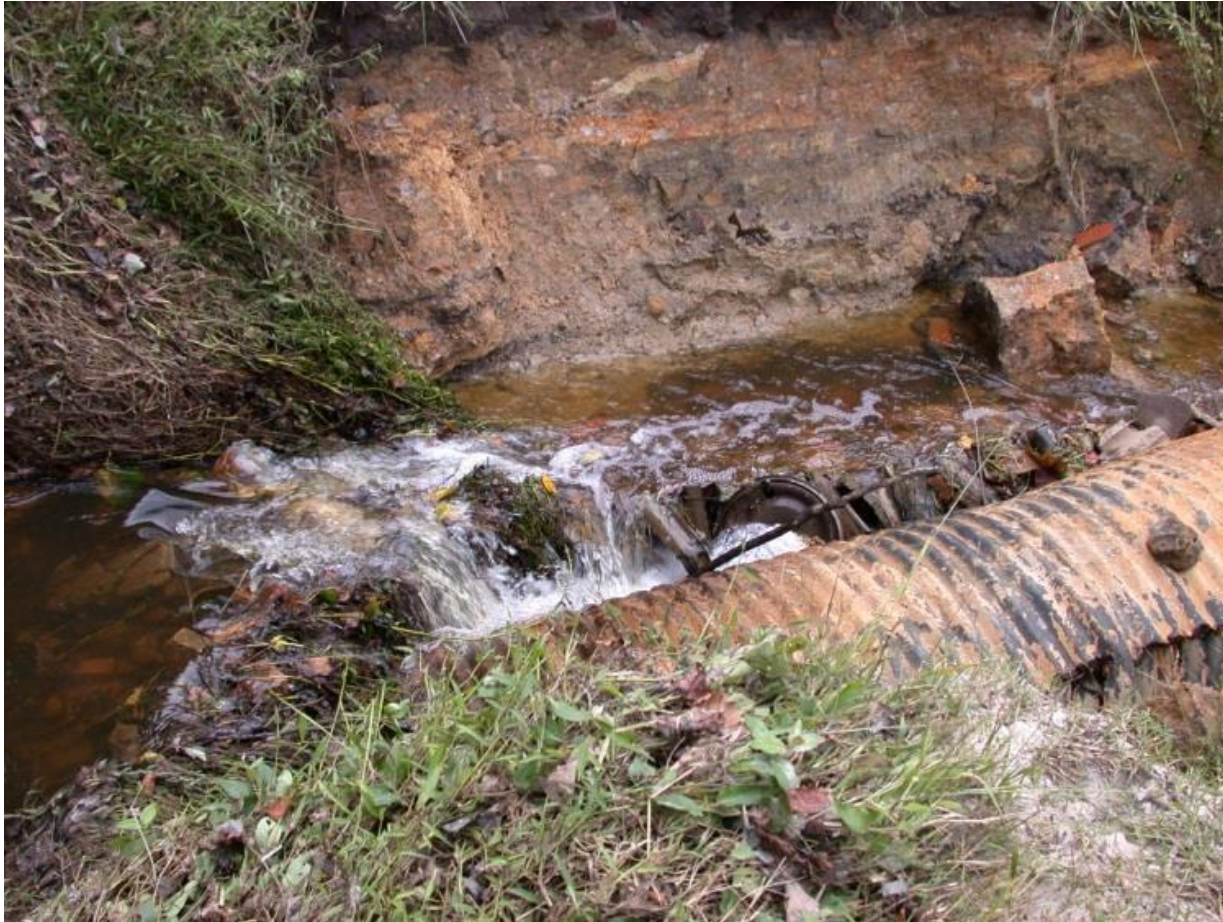
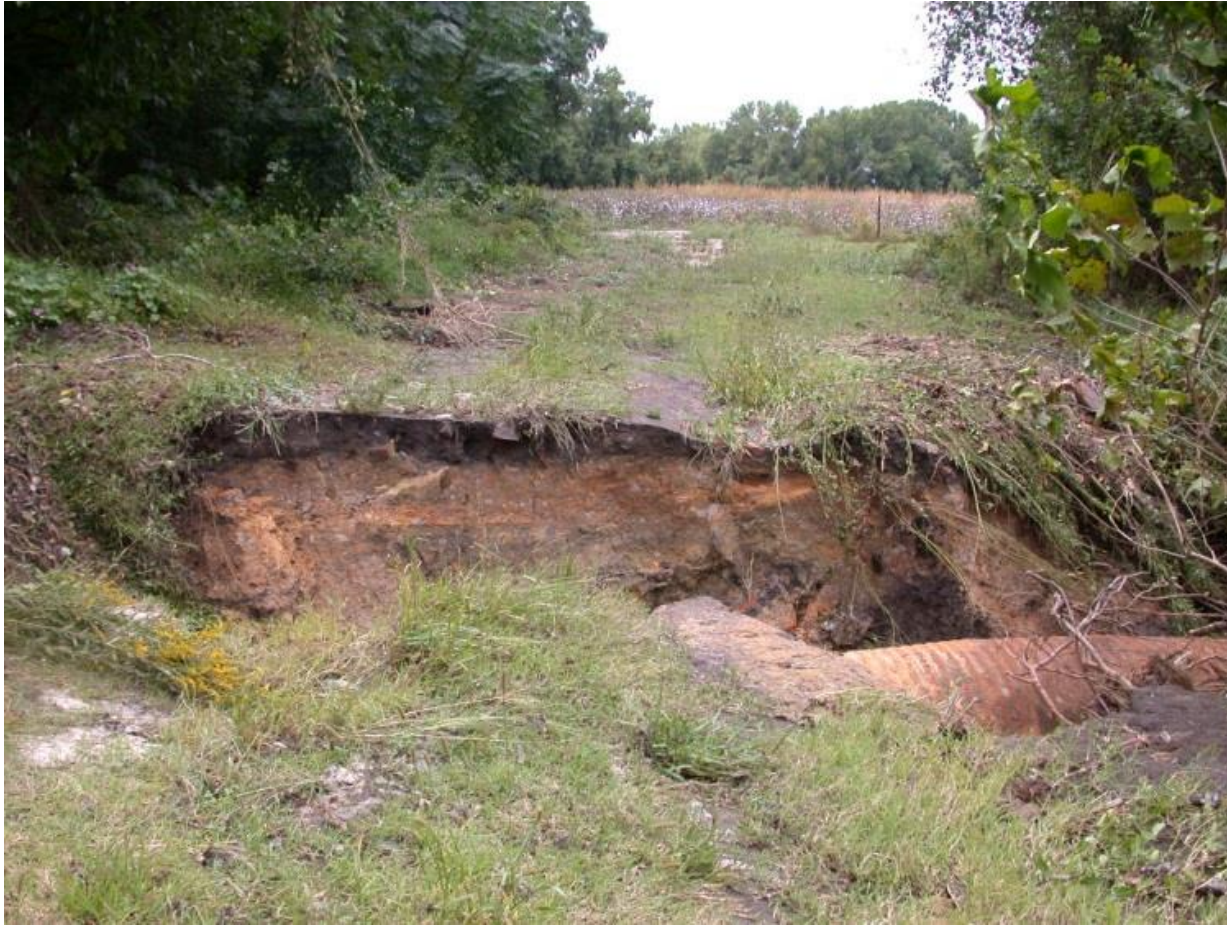
Pitt County, NC

- Restoration of 1 km of former agricultural drain
- Culvert under a farm road at the upstream end of project
- Recommended replacement but owner declined
- 270-year storm event

- Owner wanted Stantec to pay for repairs claiming there was an error in the design
- Indicated that they would take us to court
- We were able to cite the discussion about the culvert replacement
- Owner paid for repairs

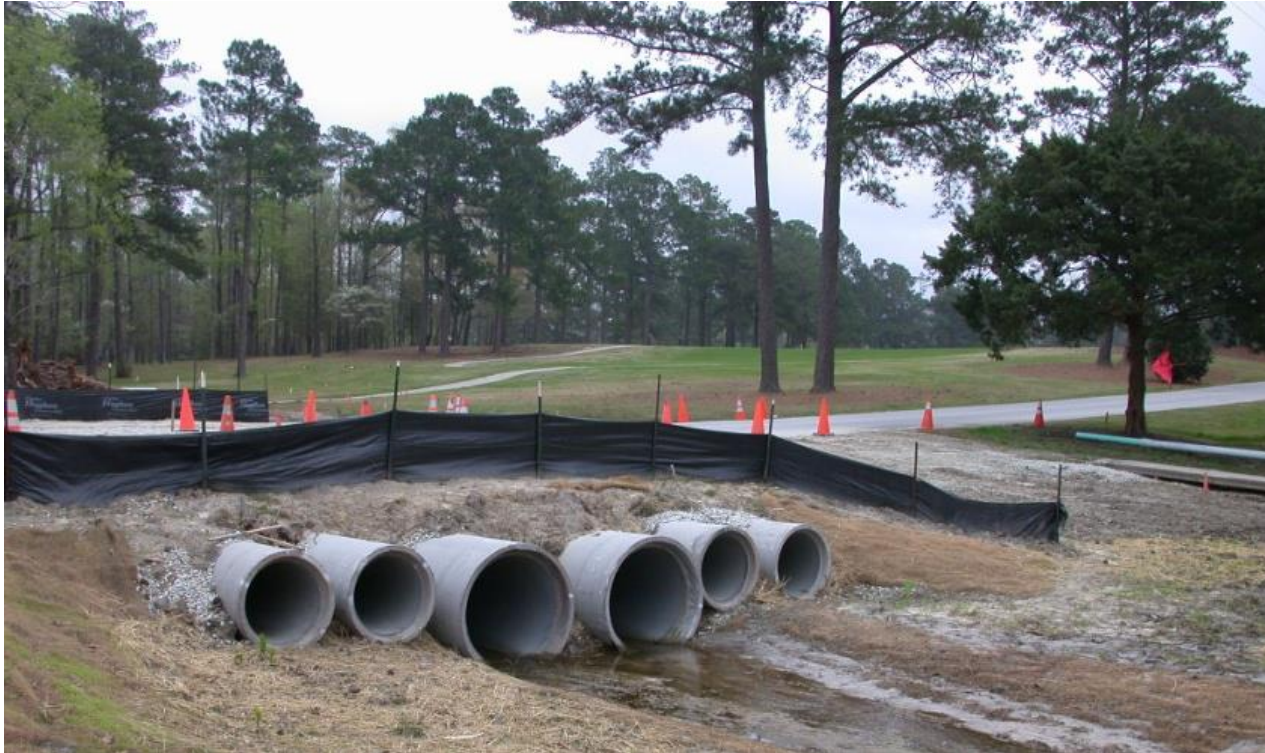
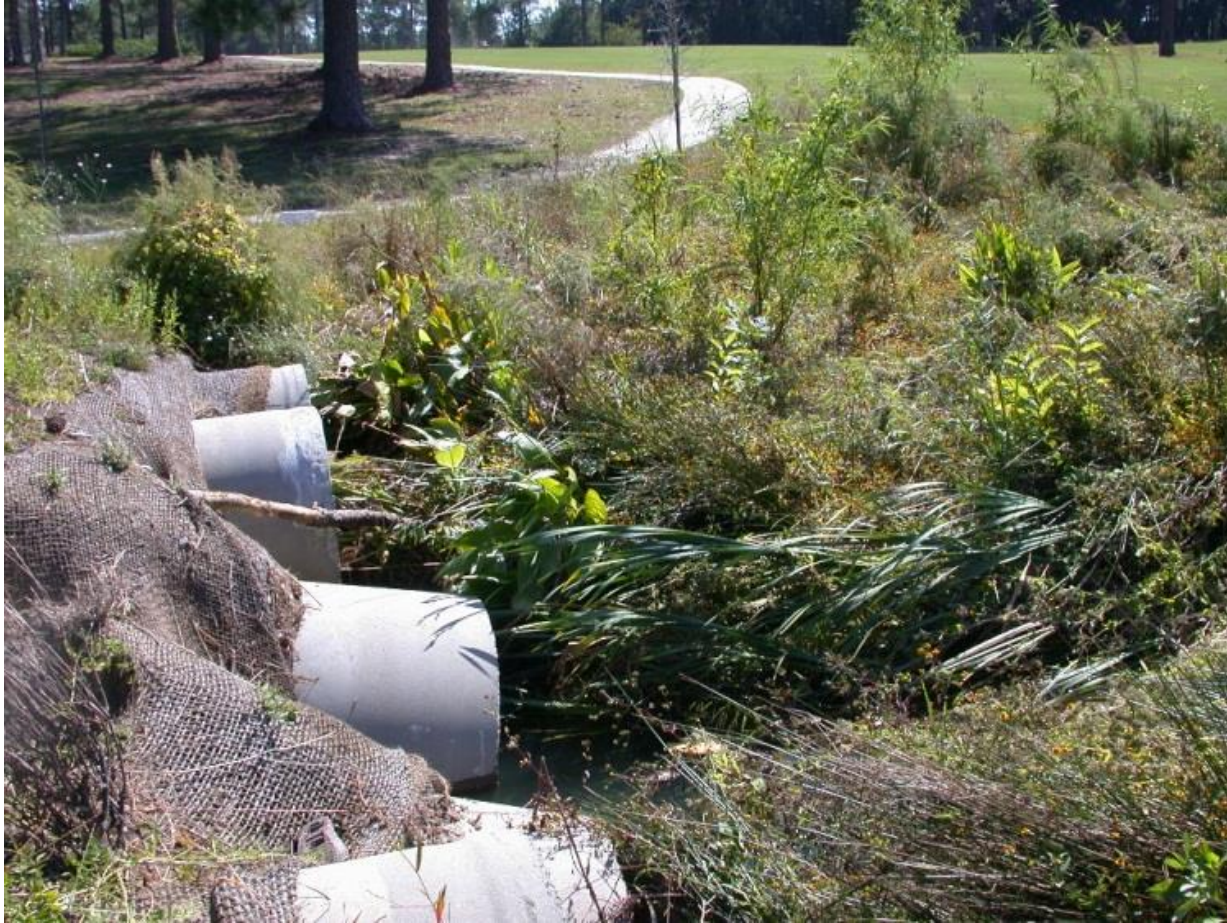
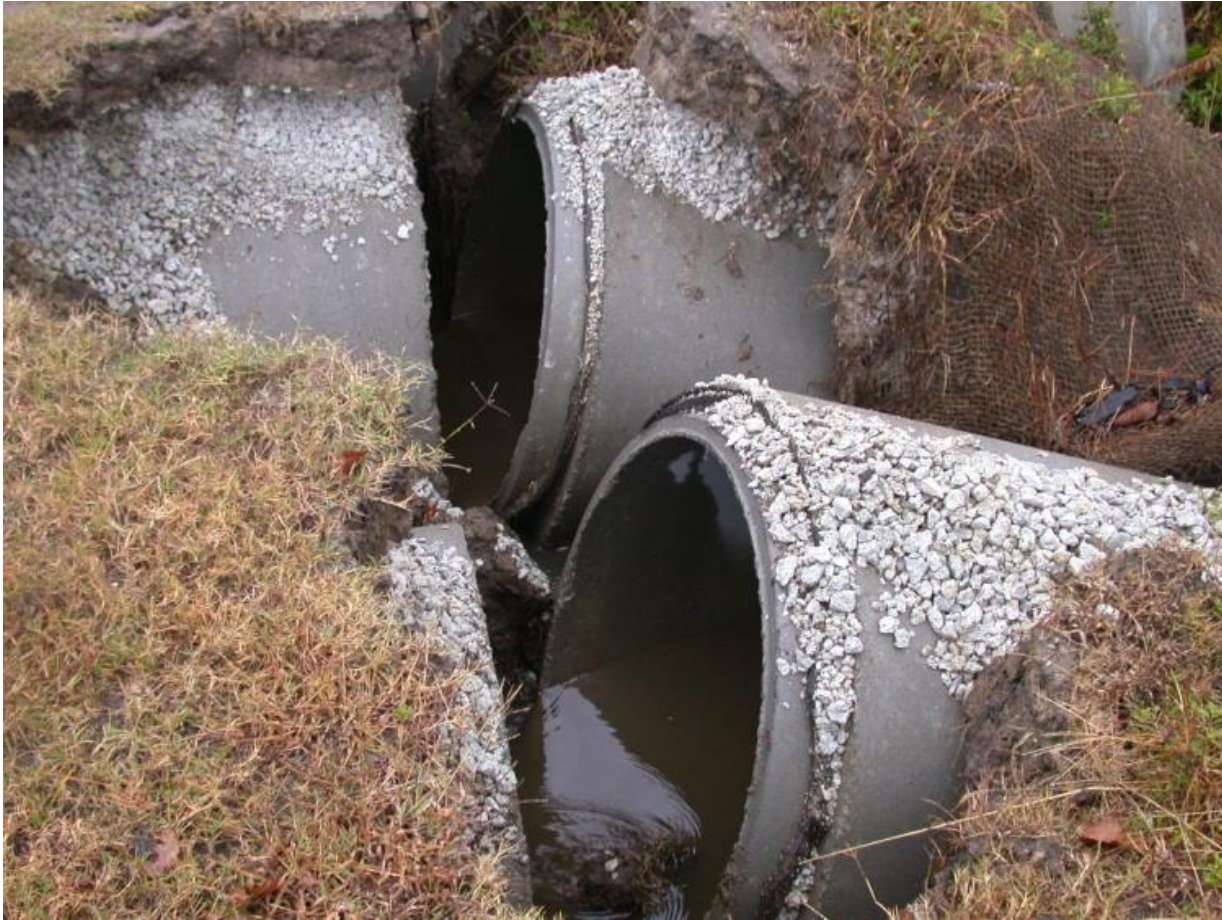
Jacksonville, NC

- Road crossing in the middle of a 1.5 km stream restoration project which flooded during storm events
- Stantec did the hydrology – increased the size and number of pipes under the road
- No headwalls in the original design – no headwalls in the new design
- 270-year storm event

- Owner claimed the design was deficient and wanted Stantec to pay for repairs
- Stantec admitted that we had not discussed headwalls
- Stantec cited the 270-year storm event
- Owner ultimately agreed to pay for the damages
