TRIECA | 2017 CONFERENCE

ESC Planning & Implementation

Case Study 1

Former gravel quarry

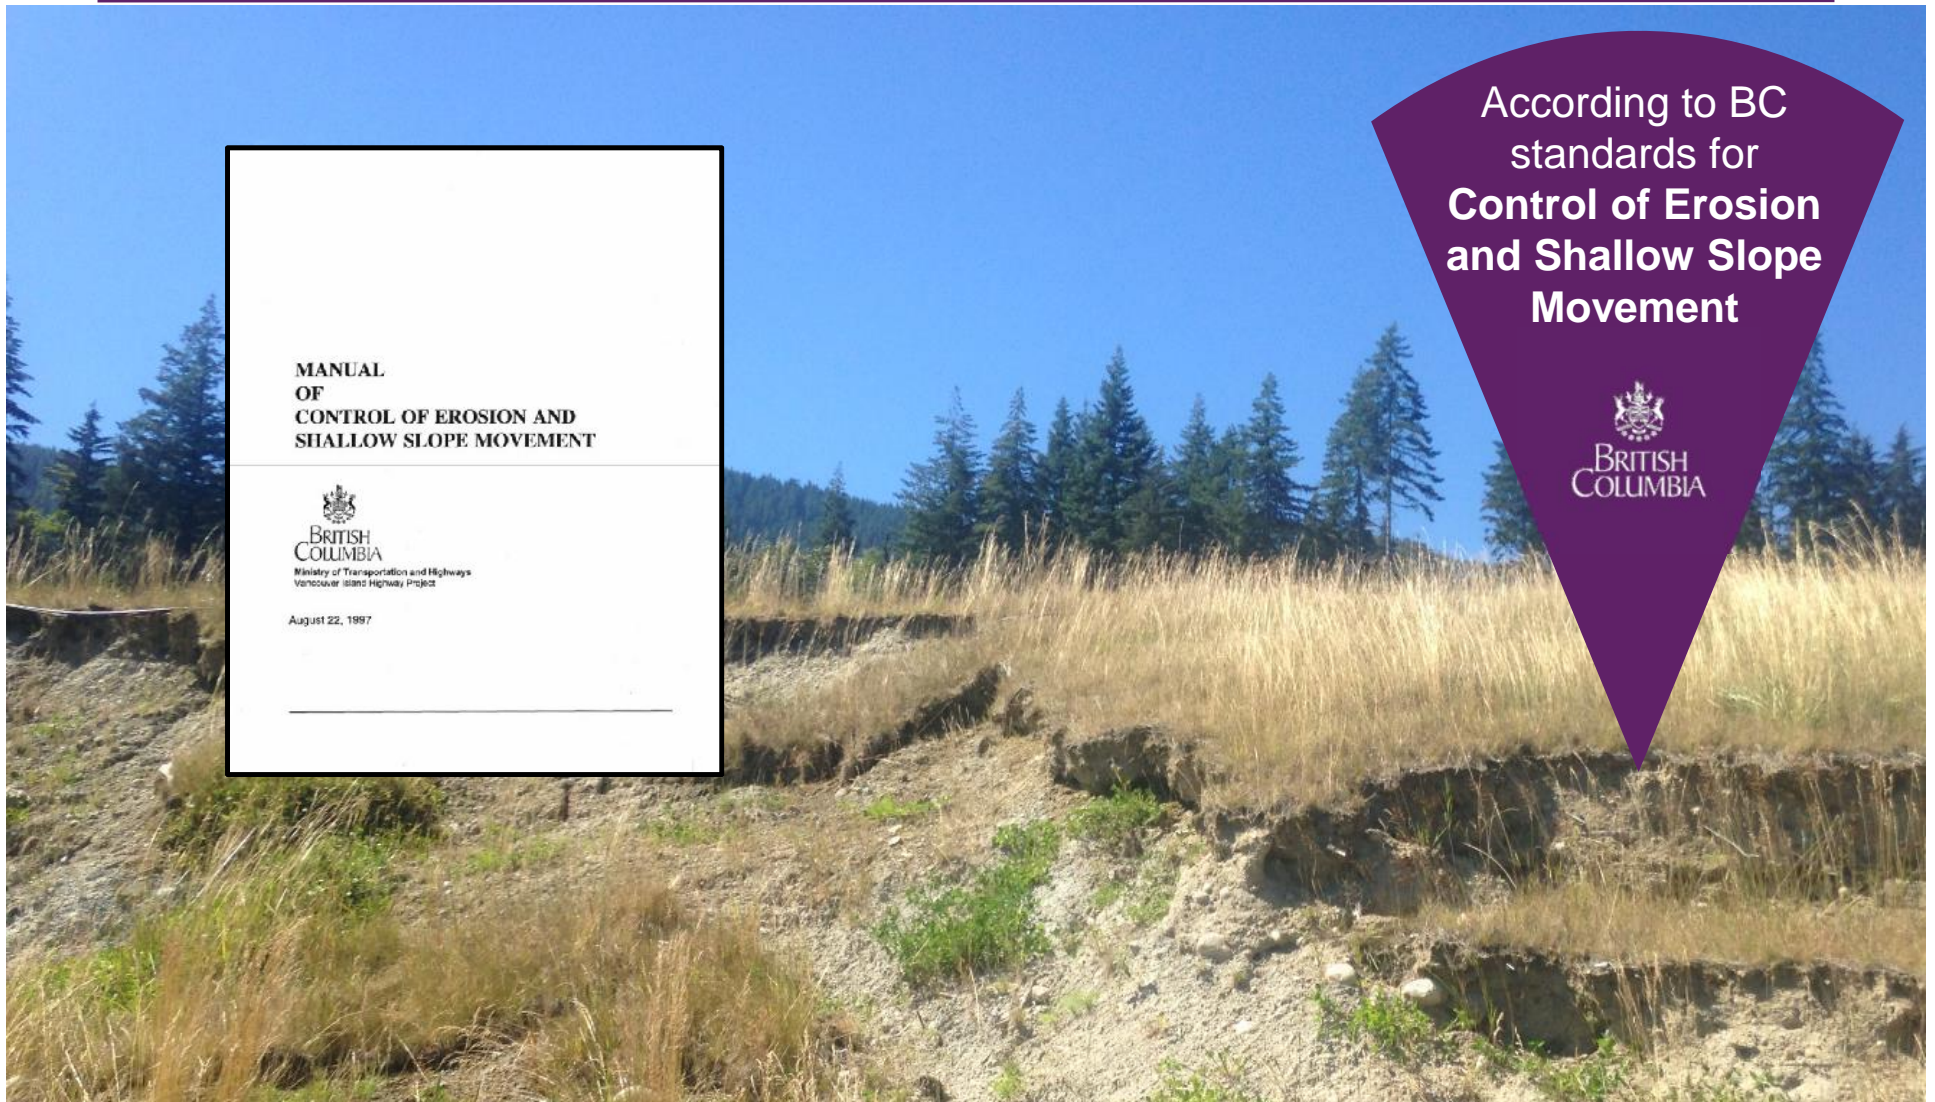
Former gravel quarry

- ▶ **Seepage loss:** utilize geosynthetic liners to reduce seepage loss from bottom of ditches to avoid oversaturation of top of slope.
- ▶ **Review hydroseed spec:** hydroseed application on nutrient poor soils is insufficient (on its own).
 - ▶ Combine bonded fiber matrix with a soil amendment such as biotic earth and hydroseed to reduce the risks of surficial erosion.
- ▶ **Disciplined communication:** develop protocols that facilitate 3-way communications.
 - ▶ Construction staff and Engineering staff do not communicate enough.

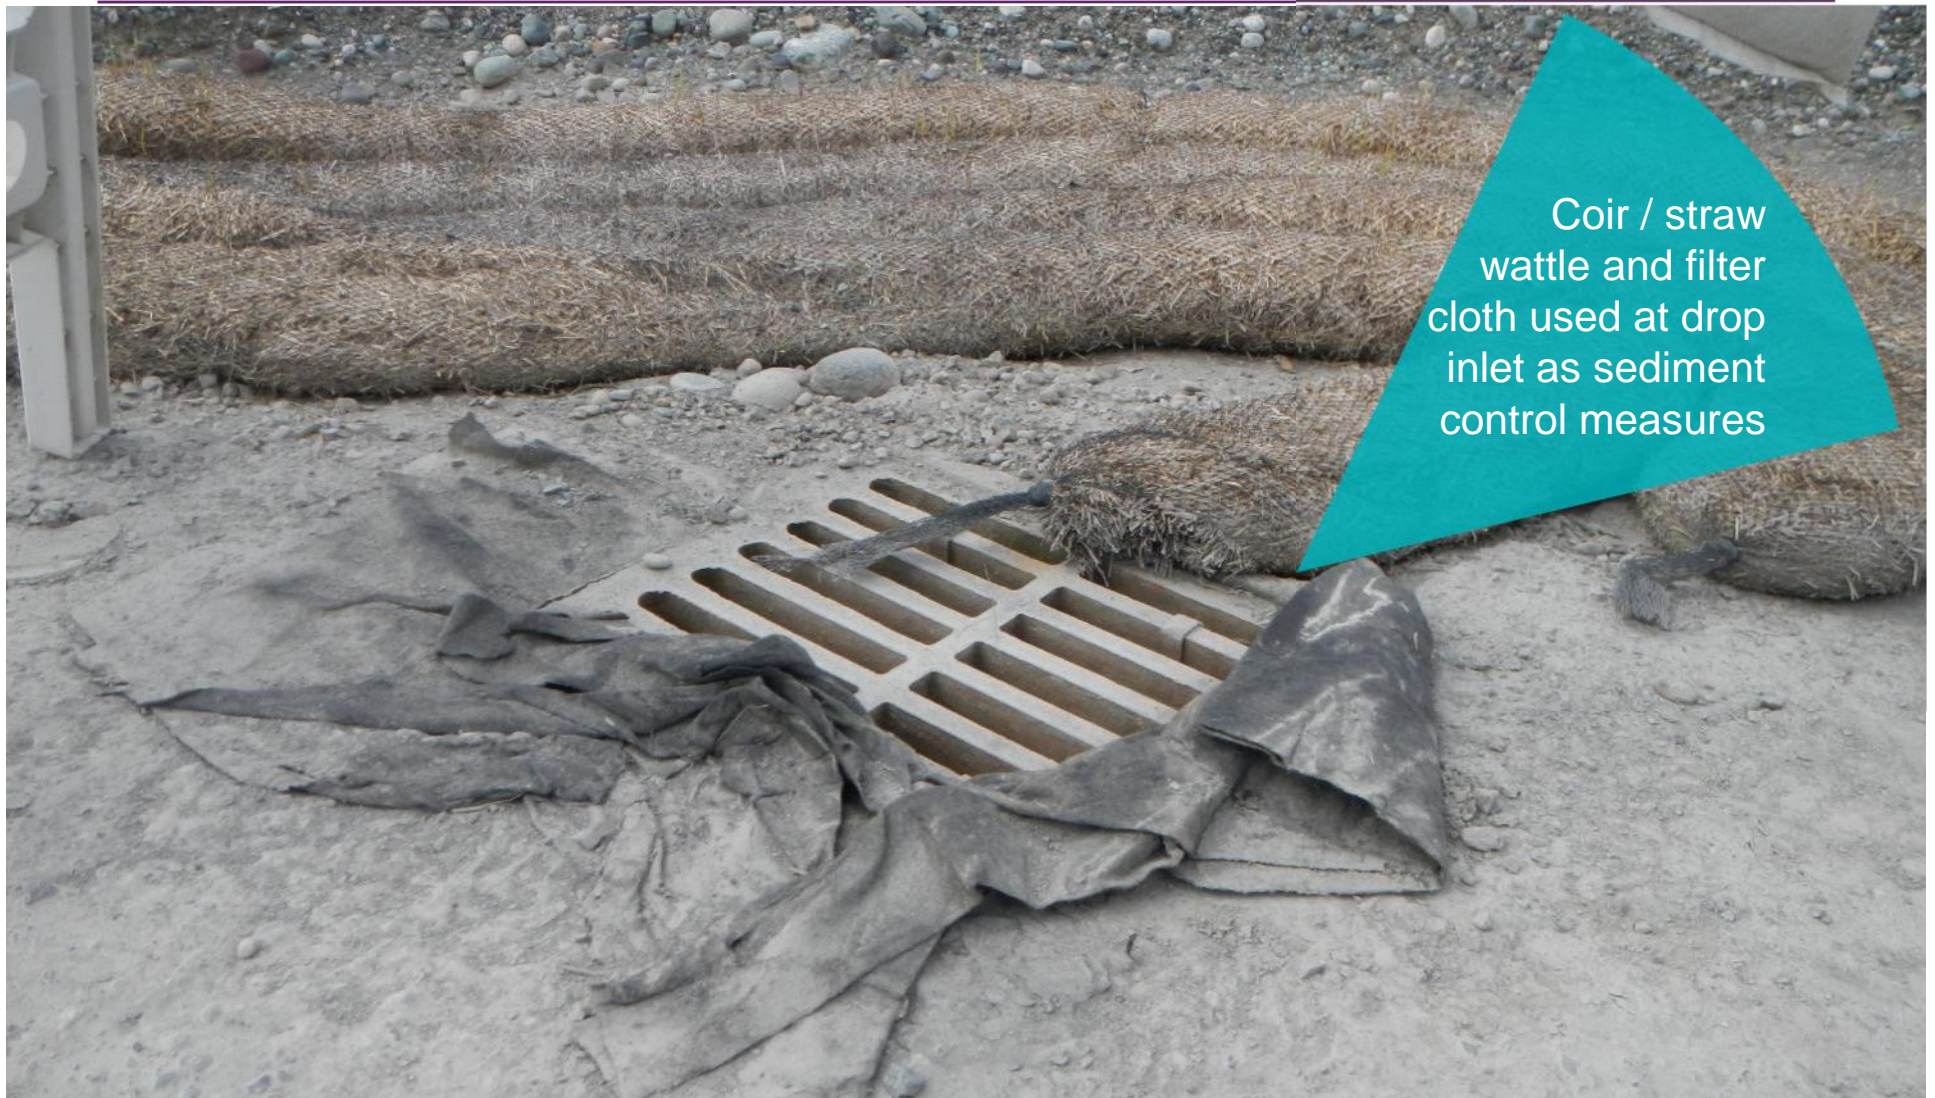
Large industrial site

- ▶ Too much emphasis on **sediment control** measures as opposed to **source control** measures.
- ▶ Gravel fill material for Contractor's lay down area was the source.
- ▶ Sediment control measures were not installed or maintained correctly.
- ▶ Multiple sieve tests of gravel revealed high quantity of fines.
- ▶ Broader use of alternative BMPs.
- ▶ Build in redundancy and plan for failure.

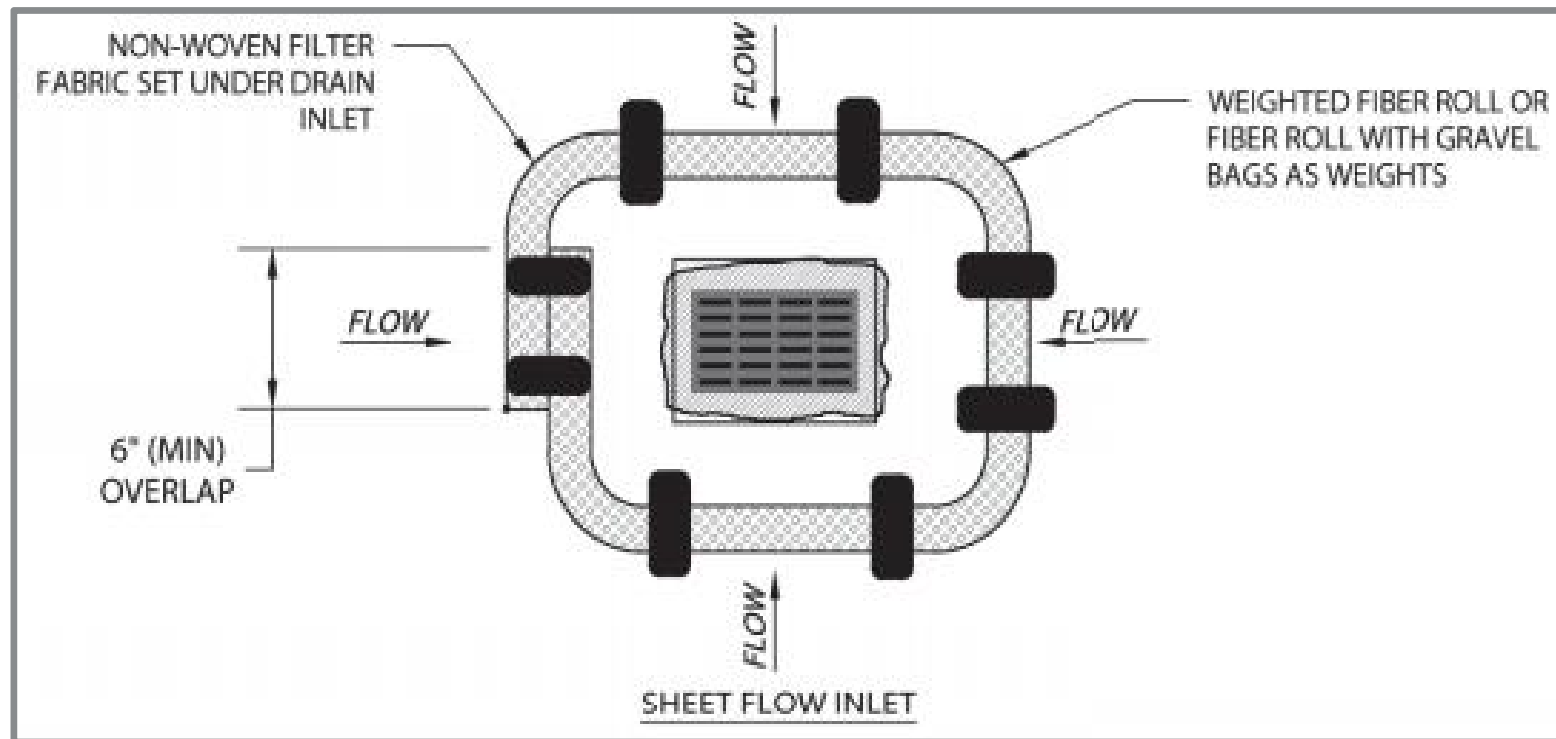
- Weighted fiber roll with overlap and use gravel bags as weights.

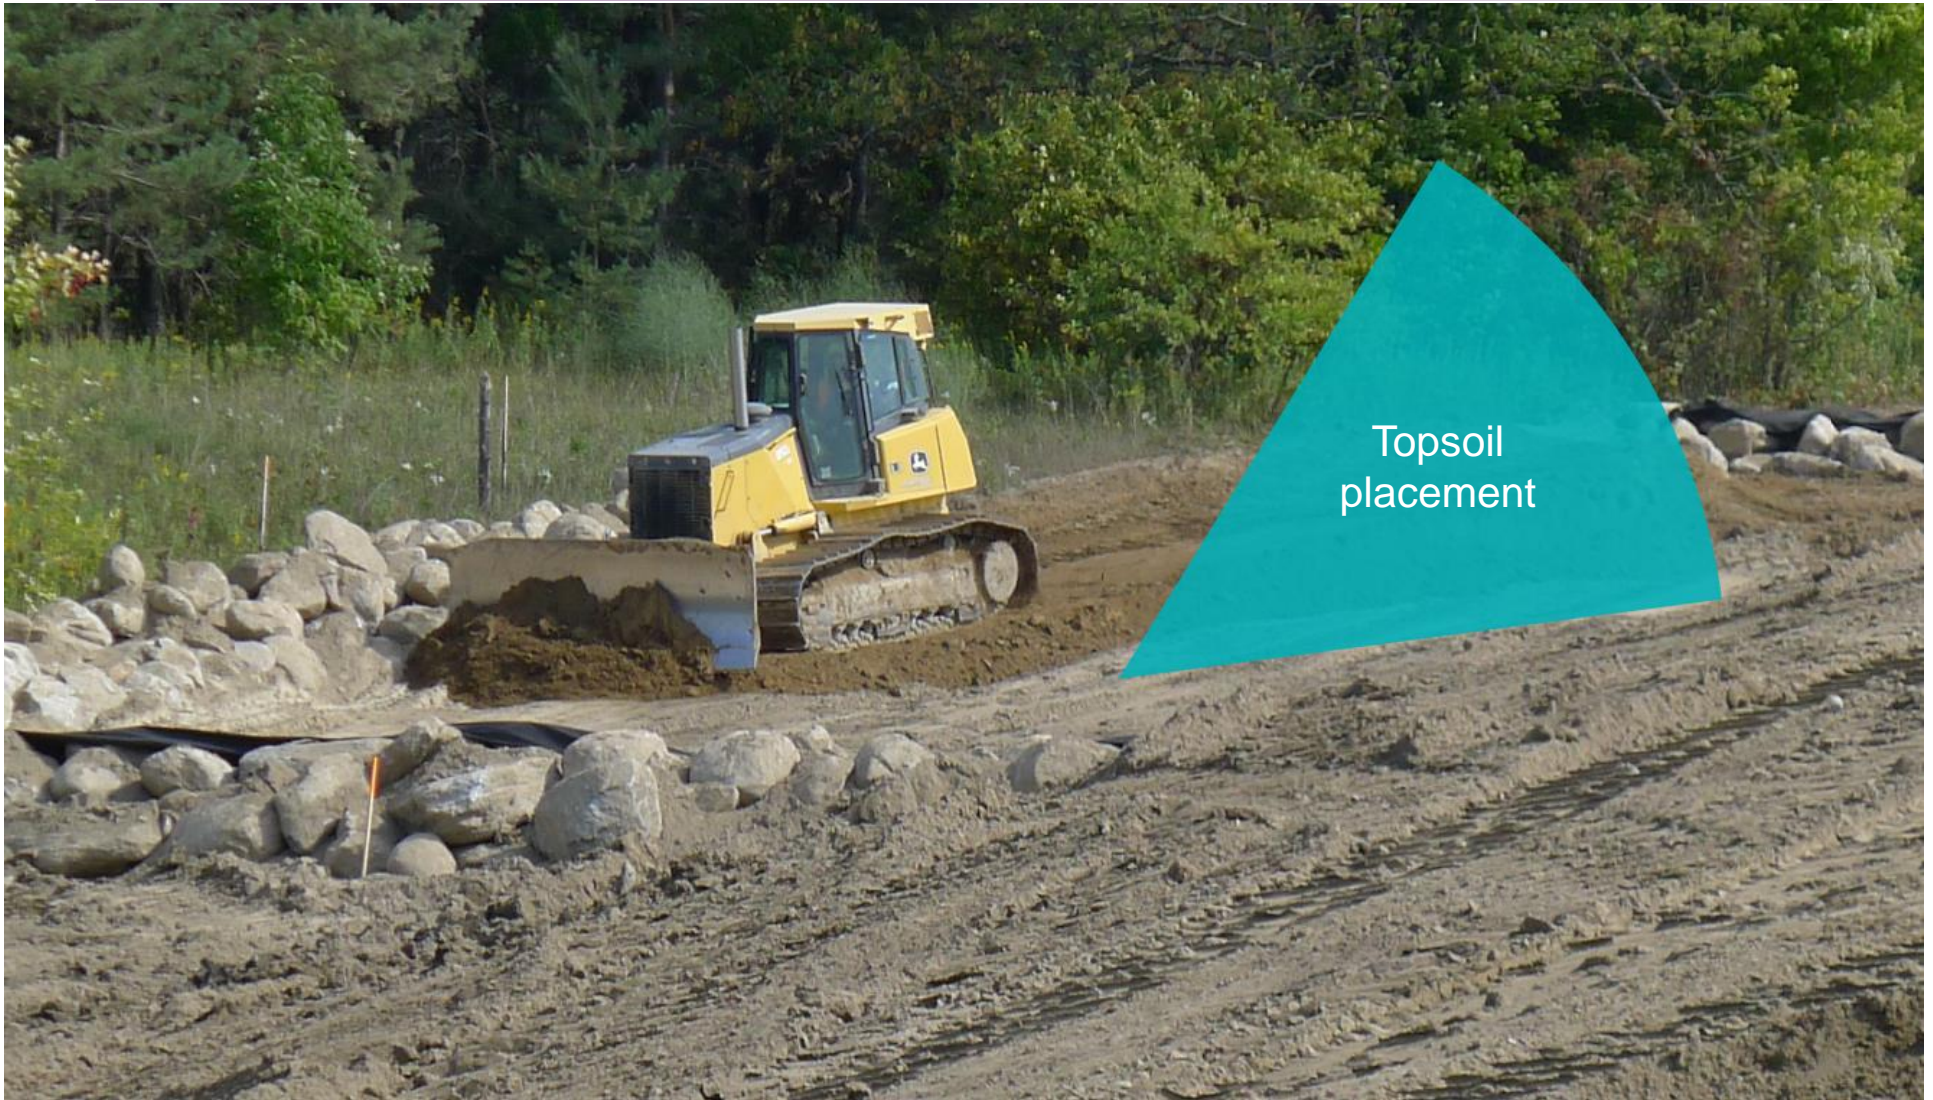
Brownfield redevelopment

- ▶ As site development progressed, need to revisit ESC Plan.
- ▶ We've moved on from the steam shovel and a wider adoption of current BMPs needed (too much emphasis on straw bales).
- ▶ Build and strengthen awareness to ESC measures in Contractor and Owner community.

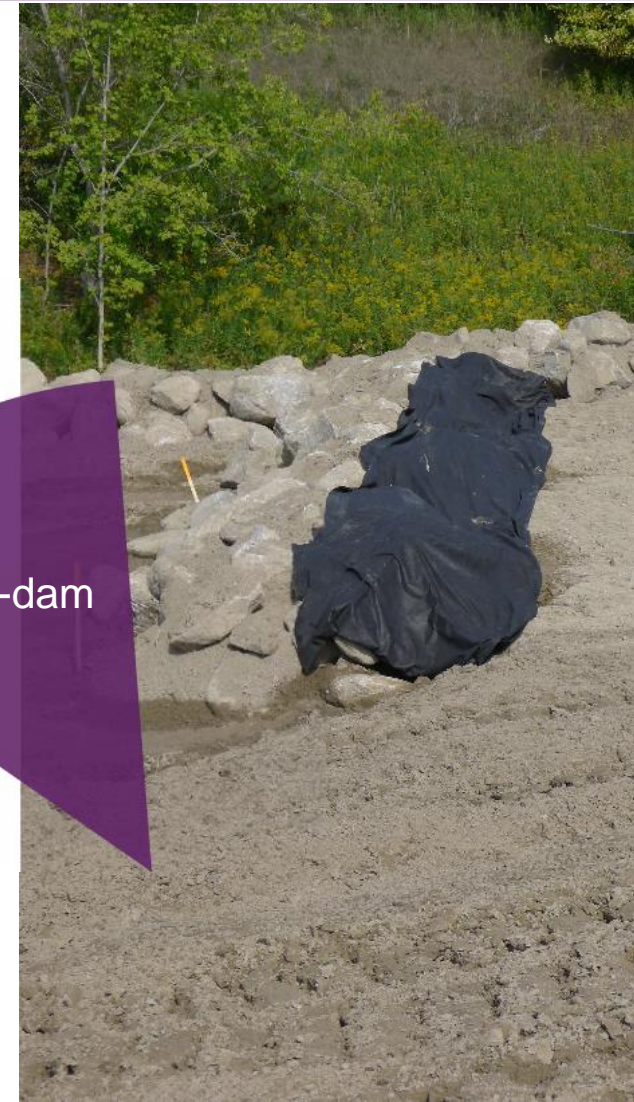
Rock
check-dam

- ▶ Practical and proven solutions to reduce surface runoff.
- ▶ ESC Design and Planning QP needs feedback loop with Contractor to identify what's working and what's not.
- ▶ Attenuation rock check dams with upslope non-woven filter cloth.

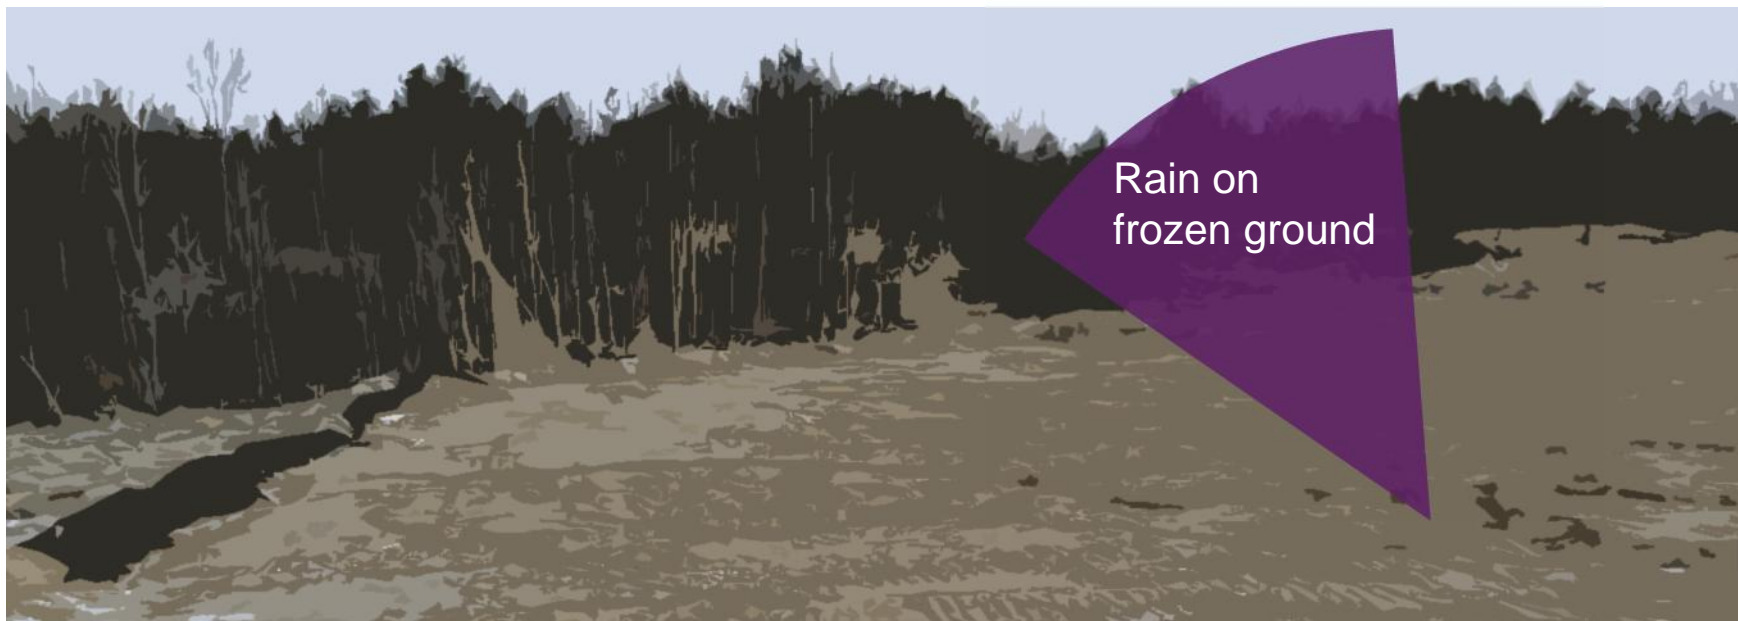
- ▶ Rain on frozen ground in Feb
- ▶ Rock check dams working, but some minor soil loss occurring
- ▶ Some source control measures implemented but not hydroseeding

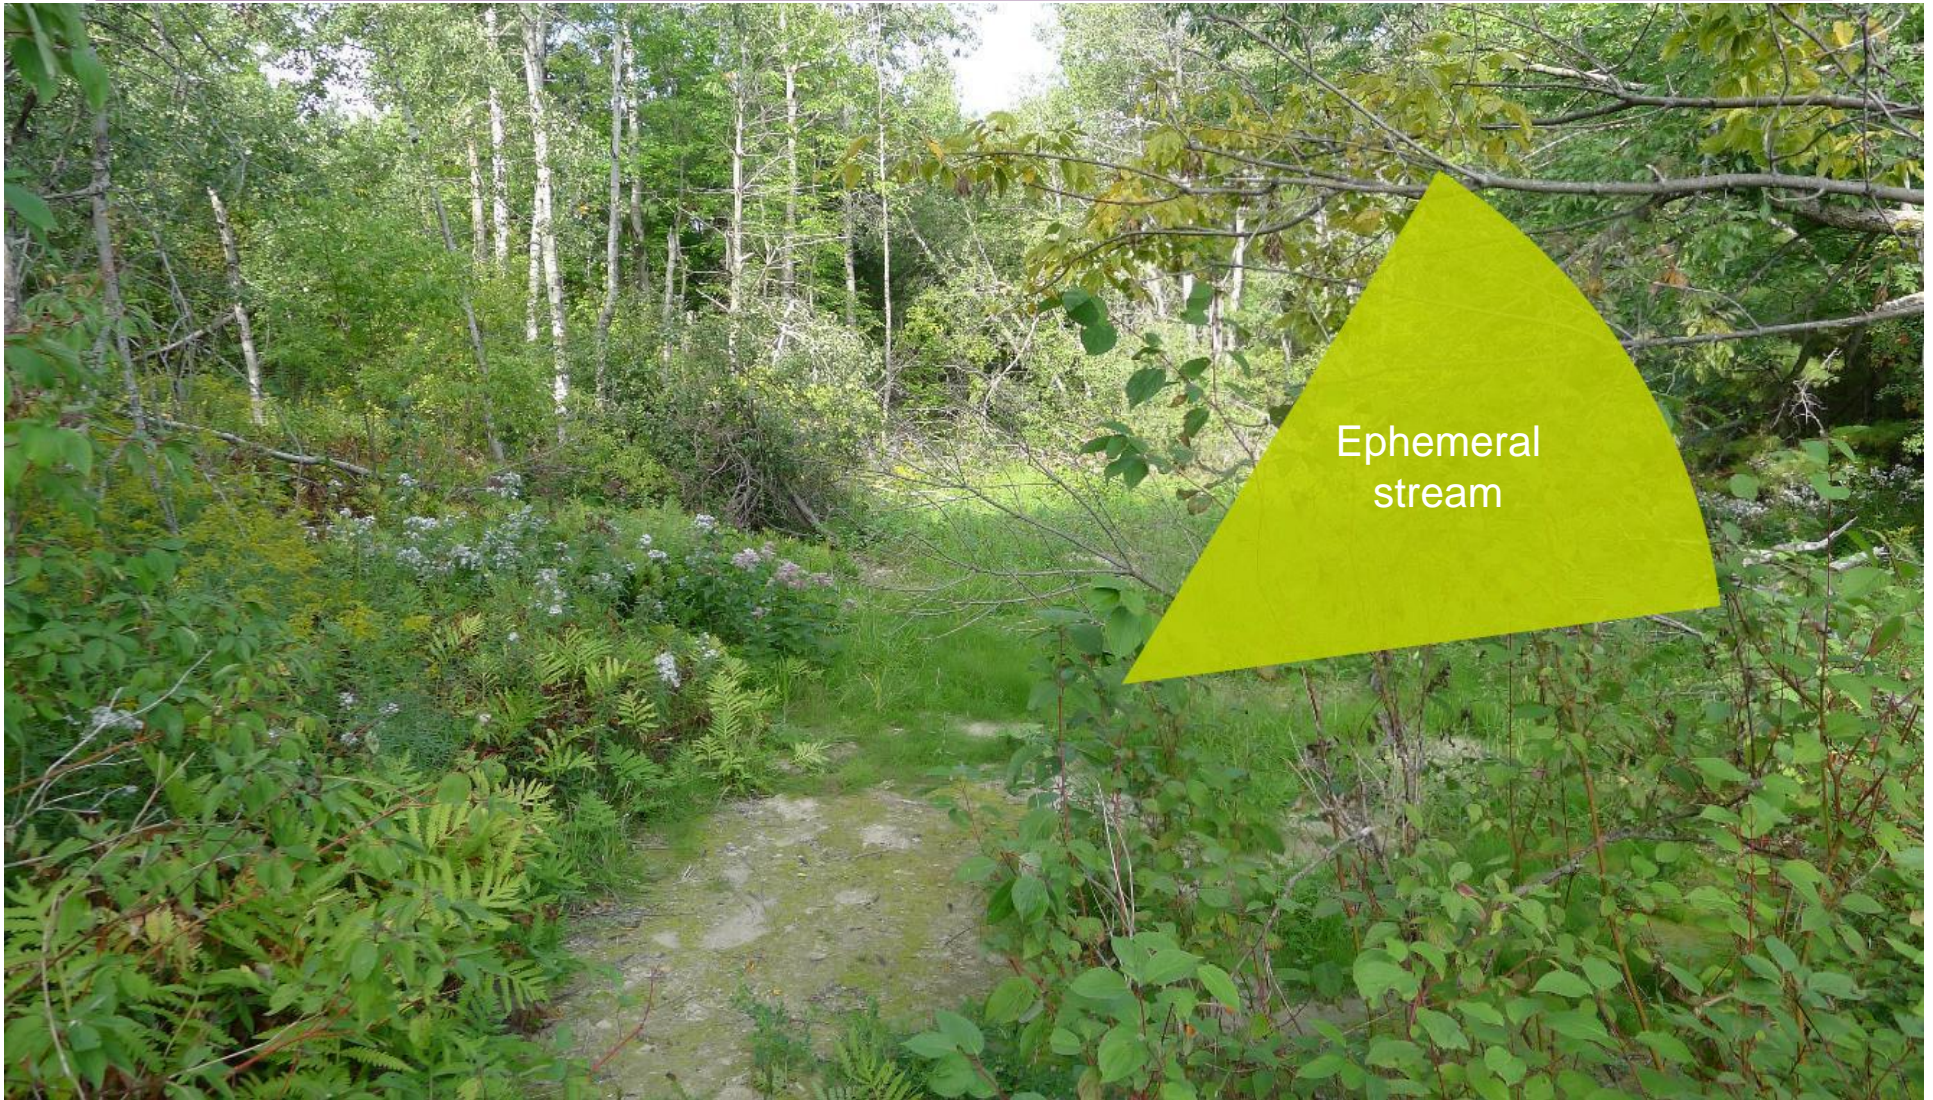
Brownfield redevelopment
