TRIECA | 2016 CONFERENCE

Erosion Risk Evaluation Tool for Prioritizing Infrastructure Encroachment Sites for Protection along Meandering Streams

Bercy Park – Sanitary Sewer Protection Project

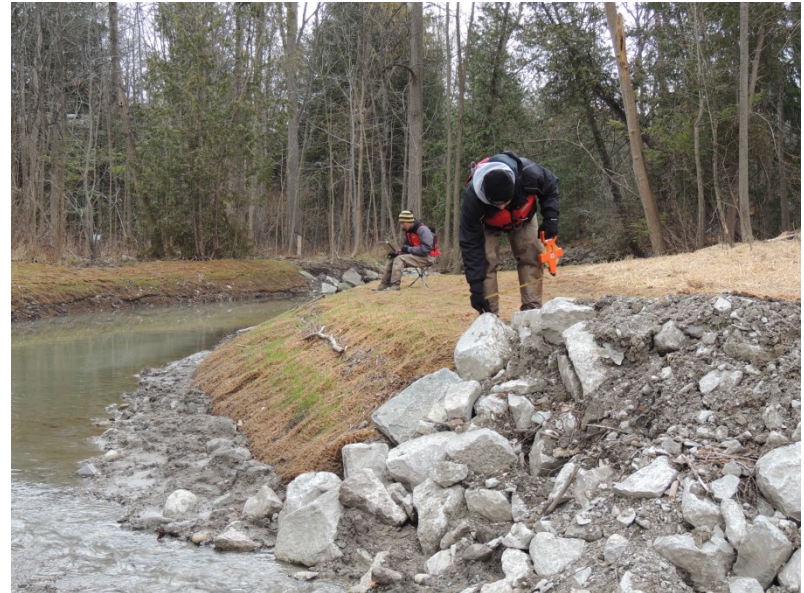
Infrastructure Hazard Monitoring Program (IHMP)

- Collaborative partnership since 2011
 - Long-term management of regional infrastructure assets subject to erosion hazards
- Monitoring 487+ sites
 - Priorities assigned based on risk to infrastructure

TRCA Priority Ranking	Number of Intersection (I) Sites	Number of Proximity (P) Sites	Total
Critical	1	0	1
High	22	12	34
Medium	26	29	55
Low	78	62	140
None	150	38	188
Not Assigned	69	0	69
Total	346	141	487

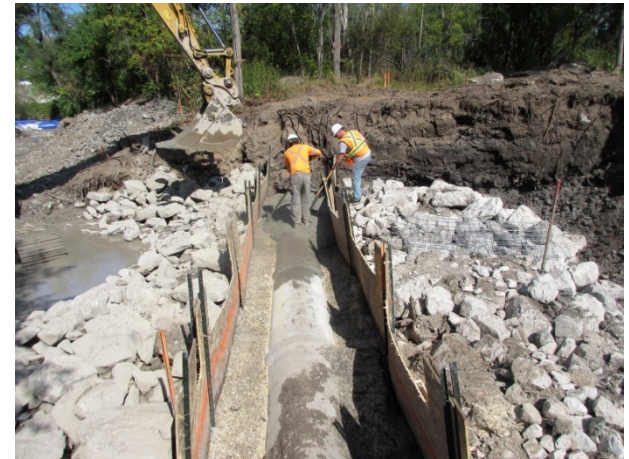
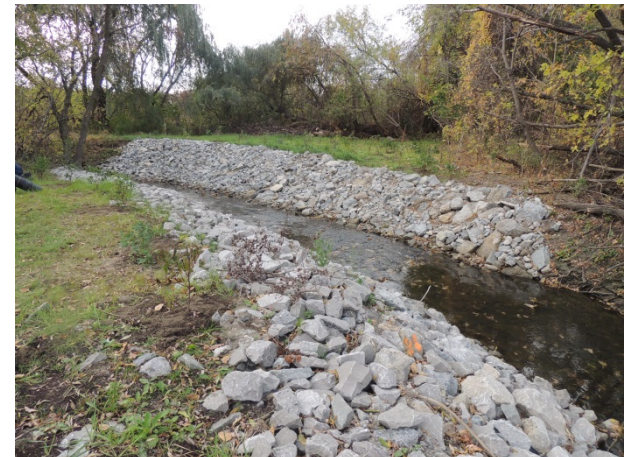
- 6 of the 10 highest priority sites within the IHMP located along German Mills Creek, in Markham
- TRCA and York Region agreed concentration of at-risk sites warranted reach-based assessment

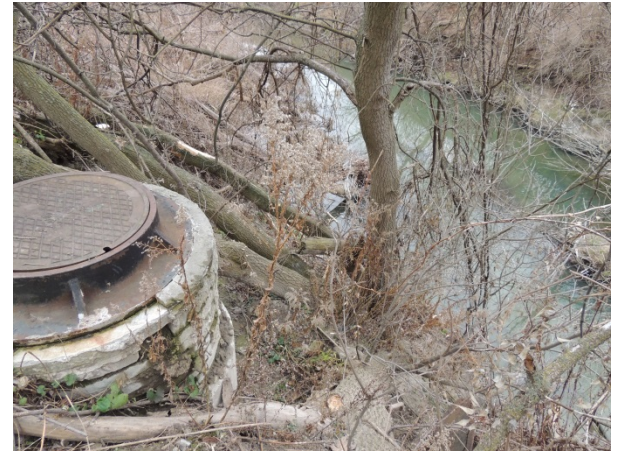
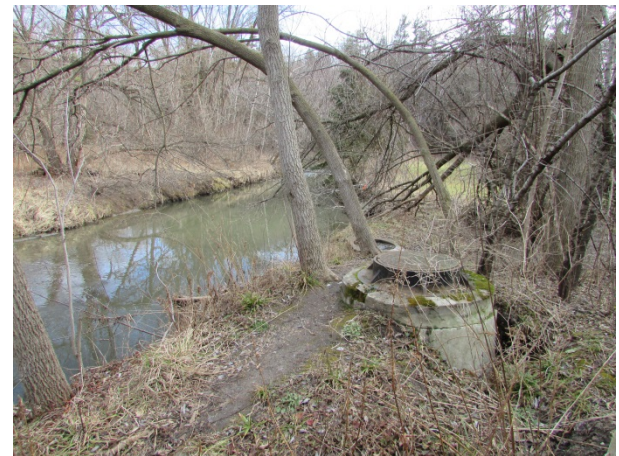
Study area

- Sanitary sewer infrastructure along German Mills Creek valley
 - Encroachments
 - Crossings
 - Manholes
- Recreational trail & pedestrian bridges

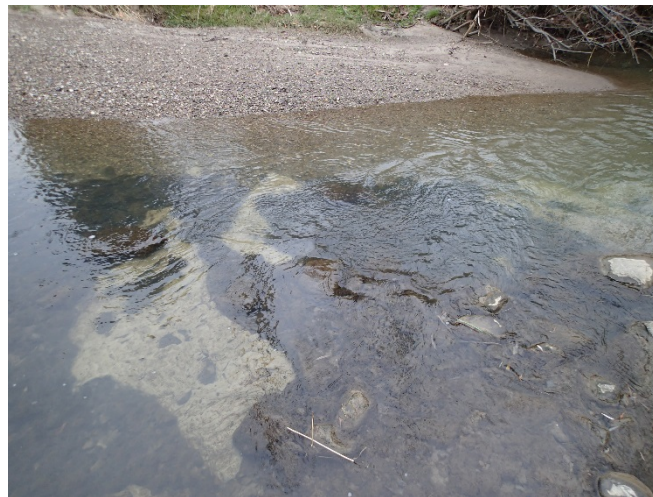
Site ID	Lateral Erosion Risk (LER) Index	Lateral Erosion Risk (LER) Rank	Vertical Erosion Risk (VER) Index	Vertical Erosion Risk (VER) Rank	Overall Erosion Risk (OER) Rank
P-531	2.9	1	N/A	N/A	1
P-060b	2.5	3	N/A	N/A	2
I-152	2.175	5	1.6	12	3
P-057	2.6	2	N/A	N/A	4
P-068	2	9	3	1	5
I-149	N/A	N/A	2.4	2	6
P-058	2.45	4	N/A	N/A	7
P-070	2.175	6	2.2	6	8
I-155	N/A	N/A	2.3	4	9
I-150	N/A	N/A	2.4	3	10
P-060a	N/A	N/A	1.6	10	11
P-069	1.95	10	N/A	N/A	12
I-154	N/A	N/A	2.3	5	13
P-065	2.15	8	1.8	8	14
P-516	2.15	7	N/A	N/A	15
I-151	N/A	N/A	2.0	7	16
P-062	N/A	N/A	1.6	11	17
P-508	N/A	N/A	1.5	13	18
I-153	N/A	N/A	1.8	9	19

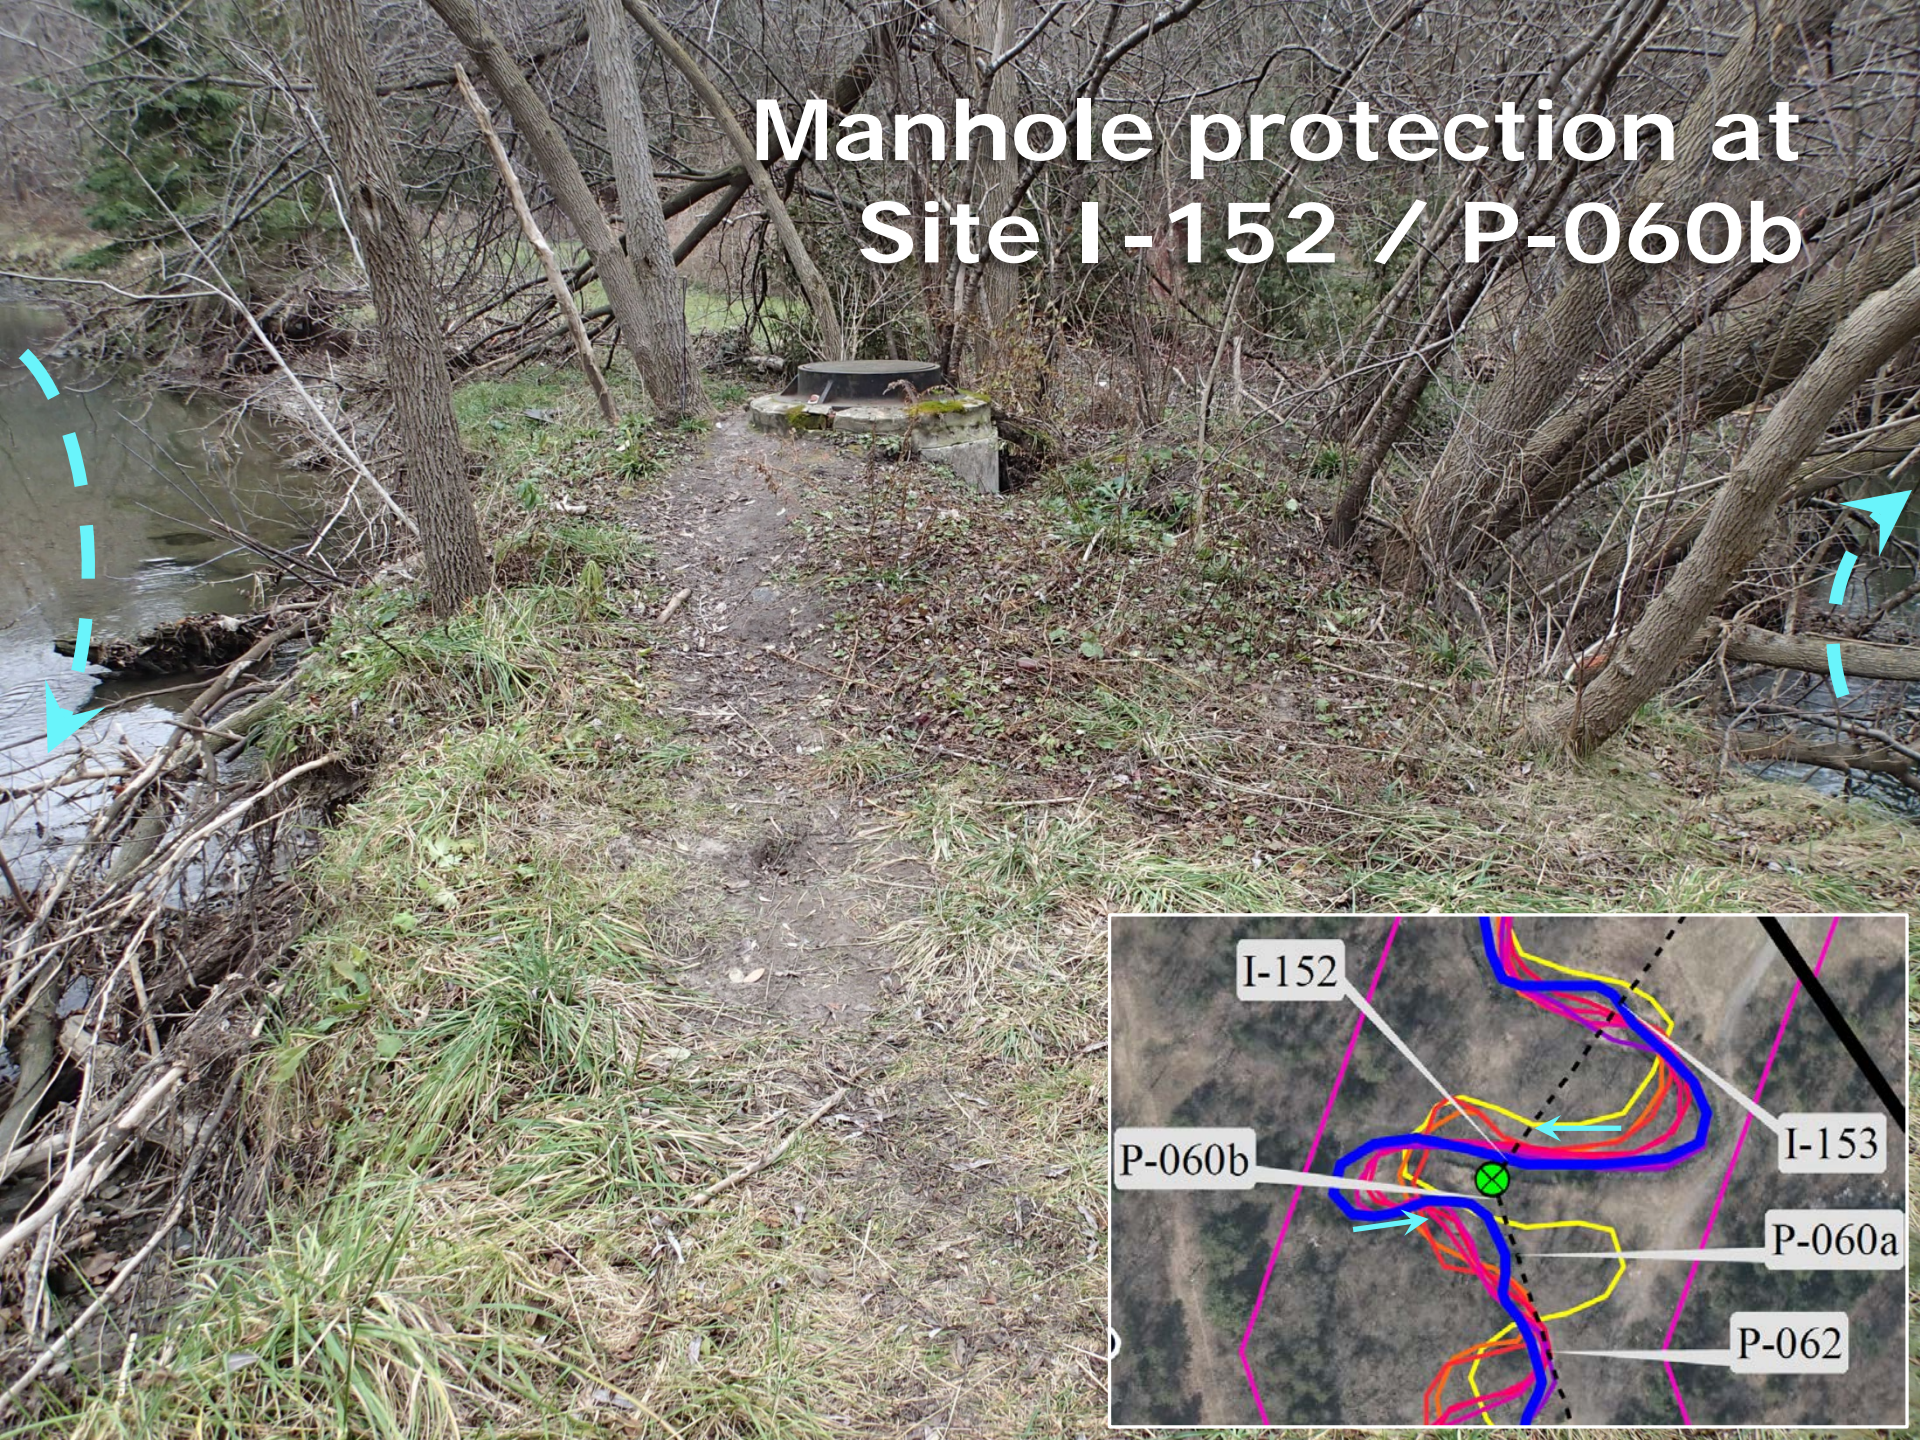
Manhole protection at Site I-152 / P-060b

Previous design

Imminent cut-off of
hairpin meander?

Extent and implications of
additional bank scour?

Manhole

Unnecessary downstream
extension of riprap?
