# WATER SENSITIVE URBAN DESIGN PERFORMANCE MONITORING

Crafting Water-Sensitive  
Communities in Cold Climate

TRIECA  
March 26, 2014

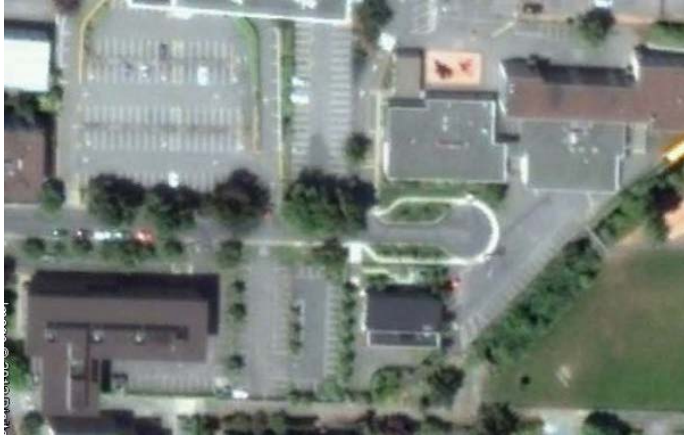
- Retrofit in 2009
- DA = 0.16 ha;
- Area = 180–196sqm
- Conventional storm sys
- Outlets to Bowker Creek
- Primarily ICI land-use
- Improved parking issue

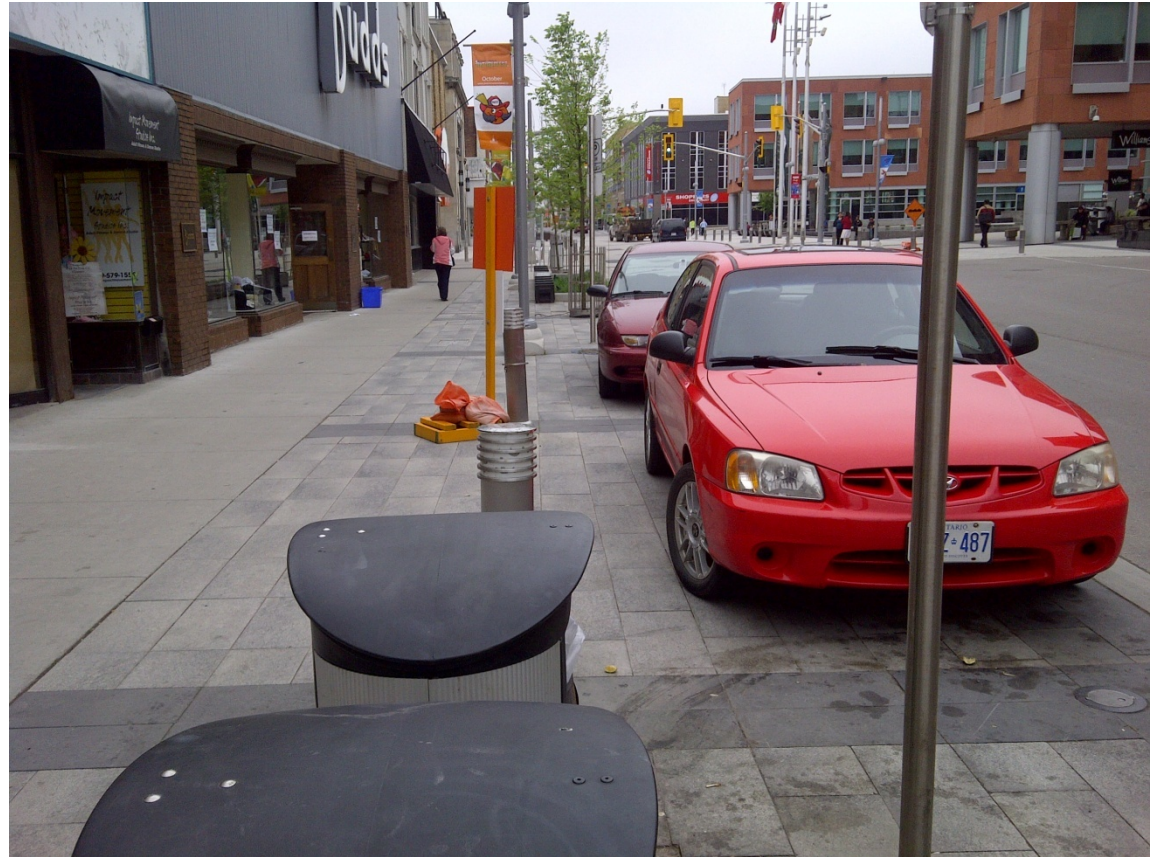
- ▶ Constructed in 2009 – City Centre
- ▶ Integrates on-street parking, stormwater and aesthetics
- ▶ Numerous cells distributed along King St.
- ▶ Has unique gate system – prevent chloride introduction

SOIL TRENCH ALONG ROAD SOIL TRENCH/TREE PIT OPENING ALONG ROAD, TYP.  
NTS

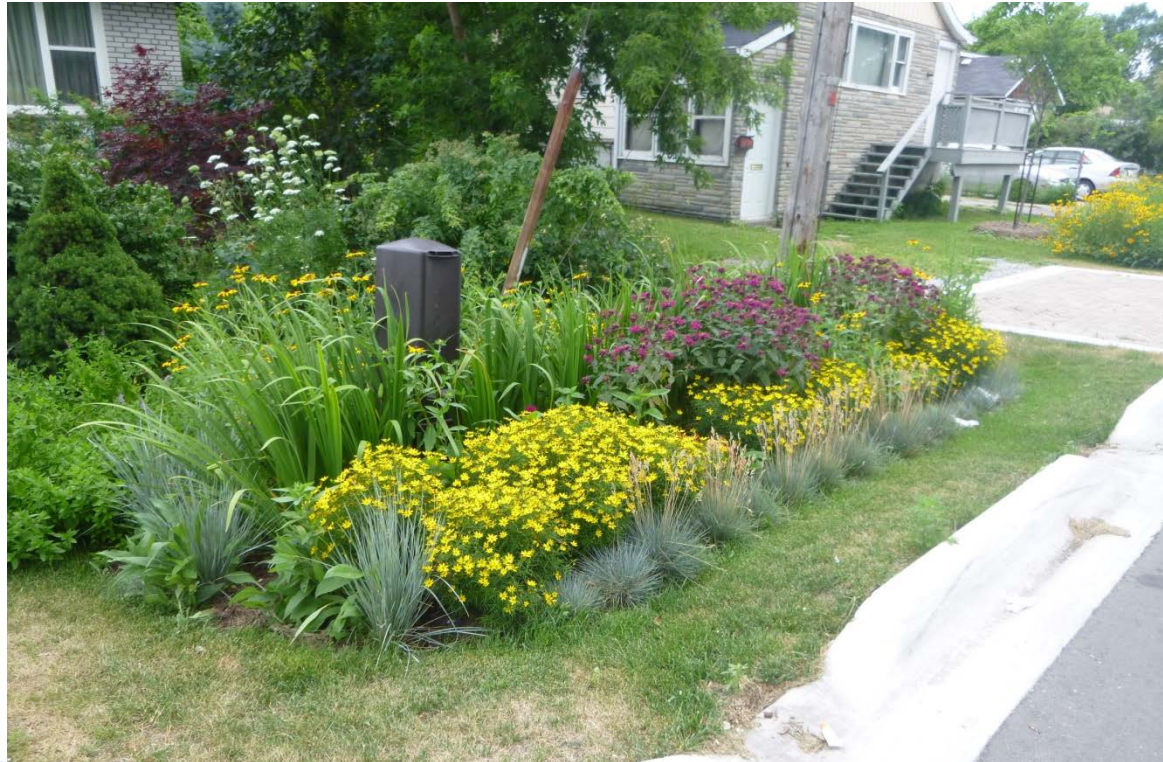
- ▶ Lakeview District (Mississauga)
  - Residential ROW utilizing bioswales and permeable pavement

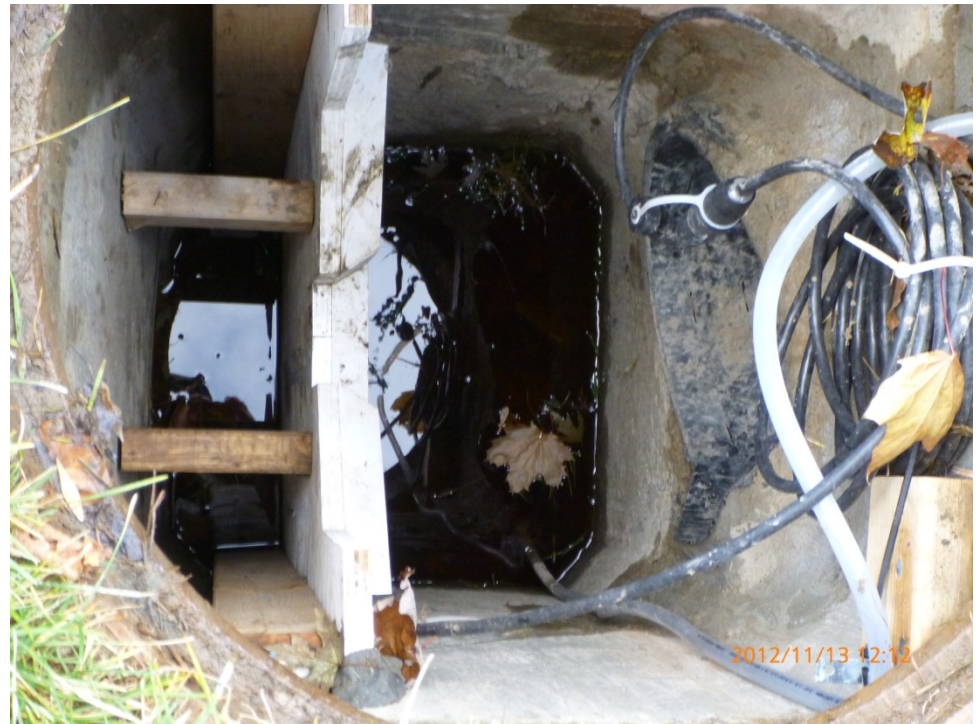
- ▶ Monitoring both pre and post construction by CVC;
- ▶ Precipitation, flow and water quality;

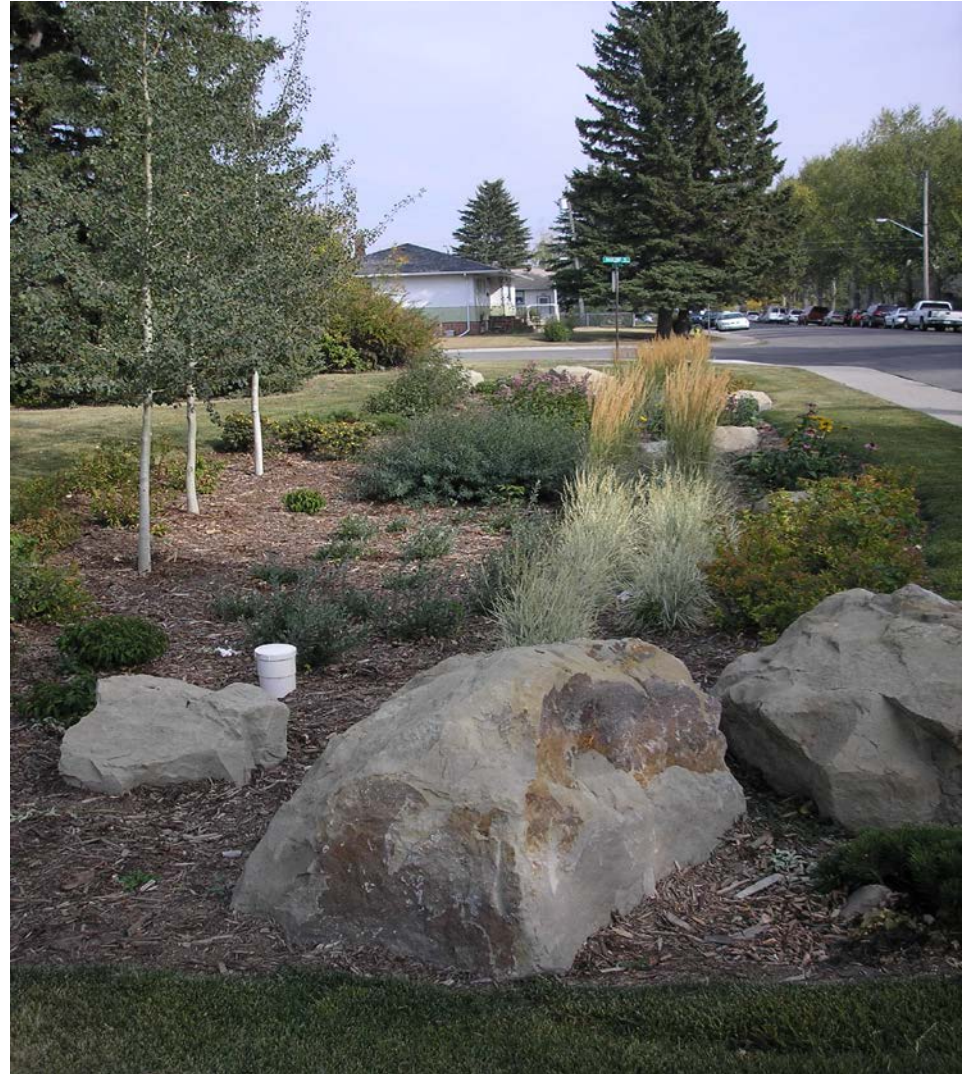
- ▶ Constructed in 2011
- ▶ City of Calgary initiative – part of the City's Broader SWM Strategy
- ▶ The majority of Winston heights flows to Nose Creek untreated
- ▶ Community Engagement – Winston Heights Community Association
- ▶ Maintained by the City of Calgary

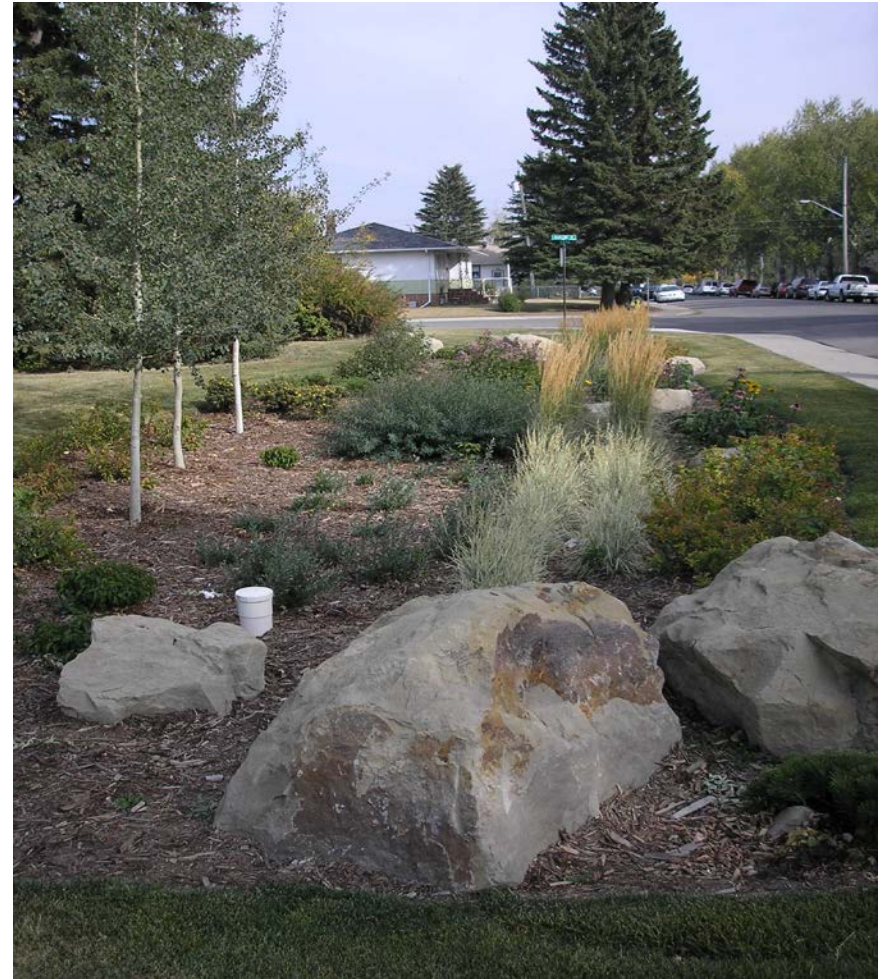
- ▶ **Monitoring is ongoing by the City of Calgary:**
  - ▶ 2 year program (May– Sept)
  - ▶ Flow out of the systems;
  - ▶ Water quality (automated)
    - ▶ Goal – 10 samples/yr
    - ▶ TSS, TP, Ammonia–N, TKN, NO<sub>2</sub>/NO<sub>3</sub>, pH, Anions & cations, Conductivity and total metals
    - ▶ 1 /year – pesticides, E.coli, total coliforms and dissolved metals

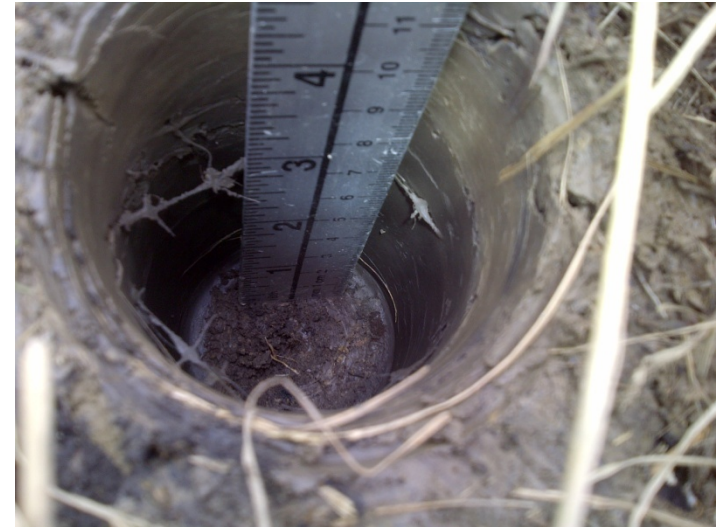
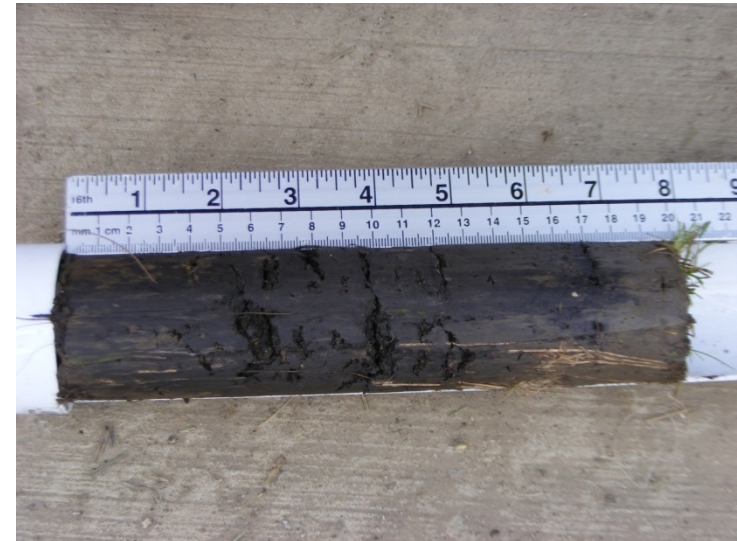
- ▶ **Coordinated Site Inspections;**
  - Infiltration testing (Guelph P);
  - Physical inspection of media profile (soil coring)
  - Media samples;
    - Grain size analysis (% weight sands (2 to 0.05mm  $\emptyset$ ))
    - % weight fines (<0.050mm  $\emptyset$ )
    - % weight organics
    - pH
    - Cation Exchange capacity (CEC)
