Ontario Case Studies of LID Design & Construction for Retrofits and New Developments:

“Real world” experience and lessons learned

Chris Denich, M.Sc., P.Eng
Aquafor Beech Ltd

TRIECA _ March 26–27th, 2013

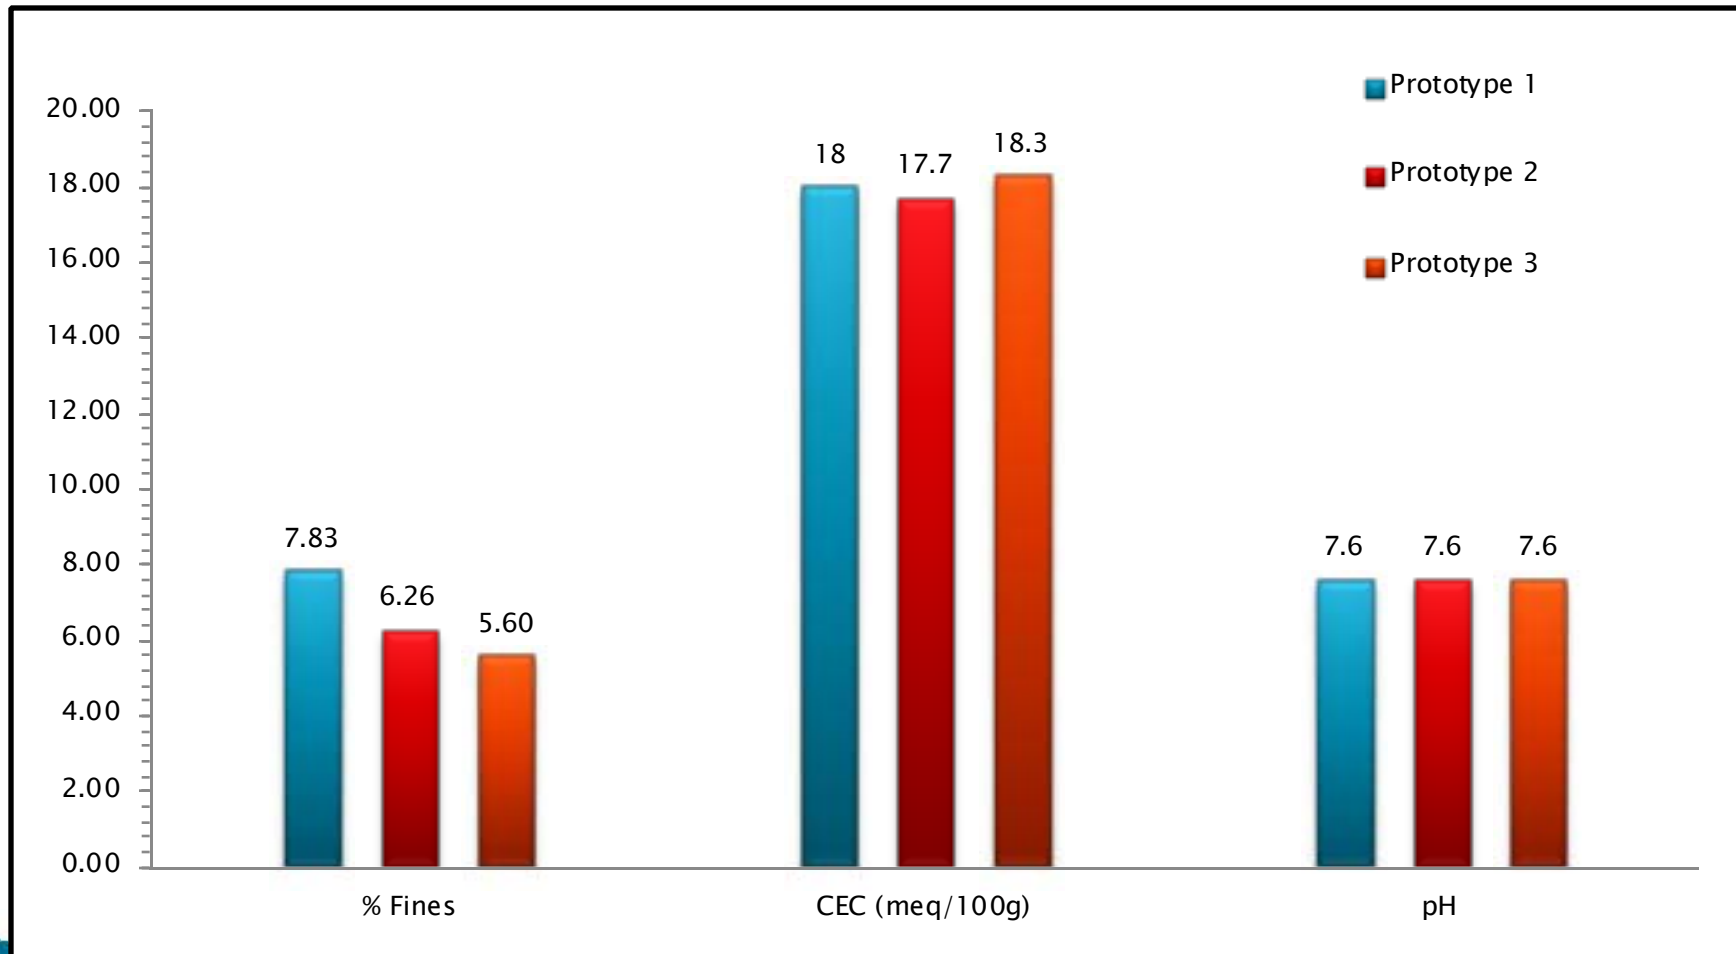
Hand Mixed Prototypes

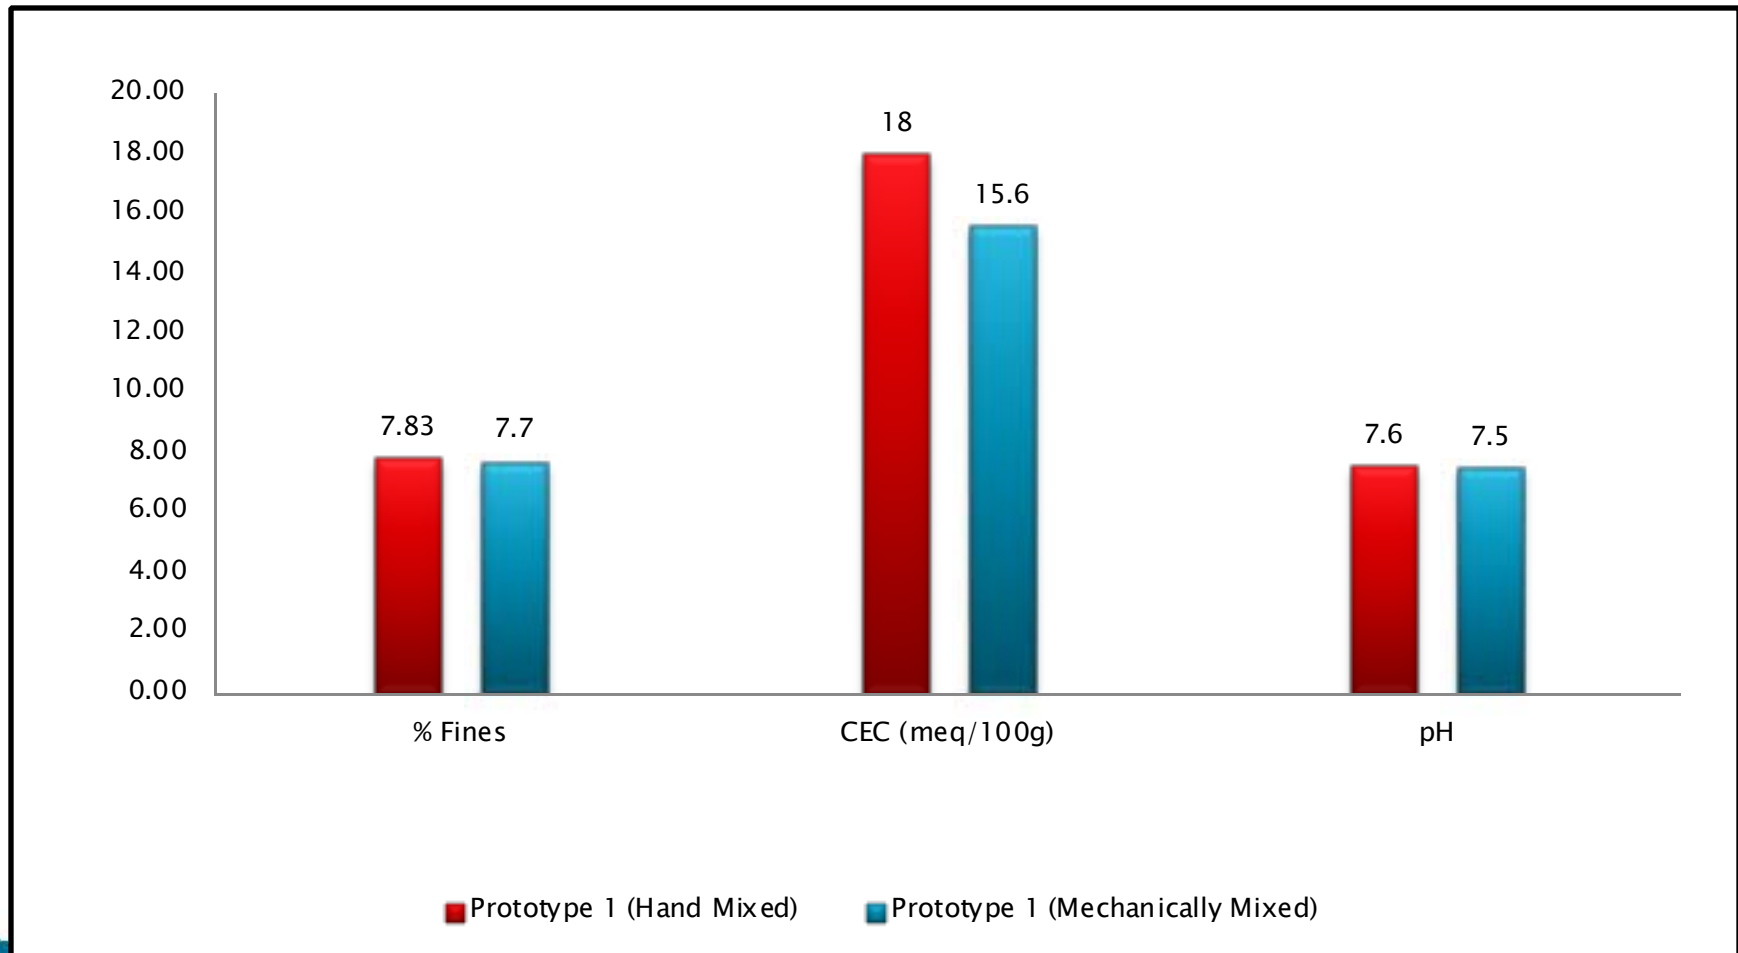
Mechanically Mixed Prototypes –
Mass Production

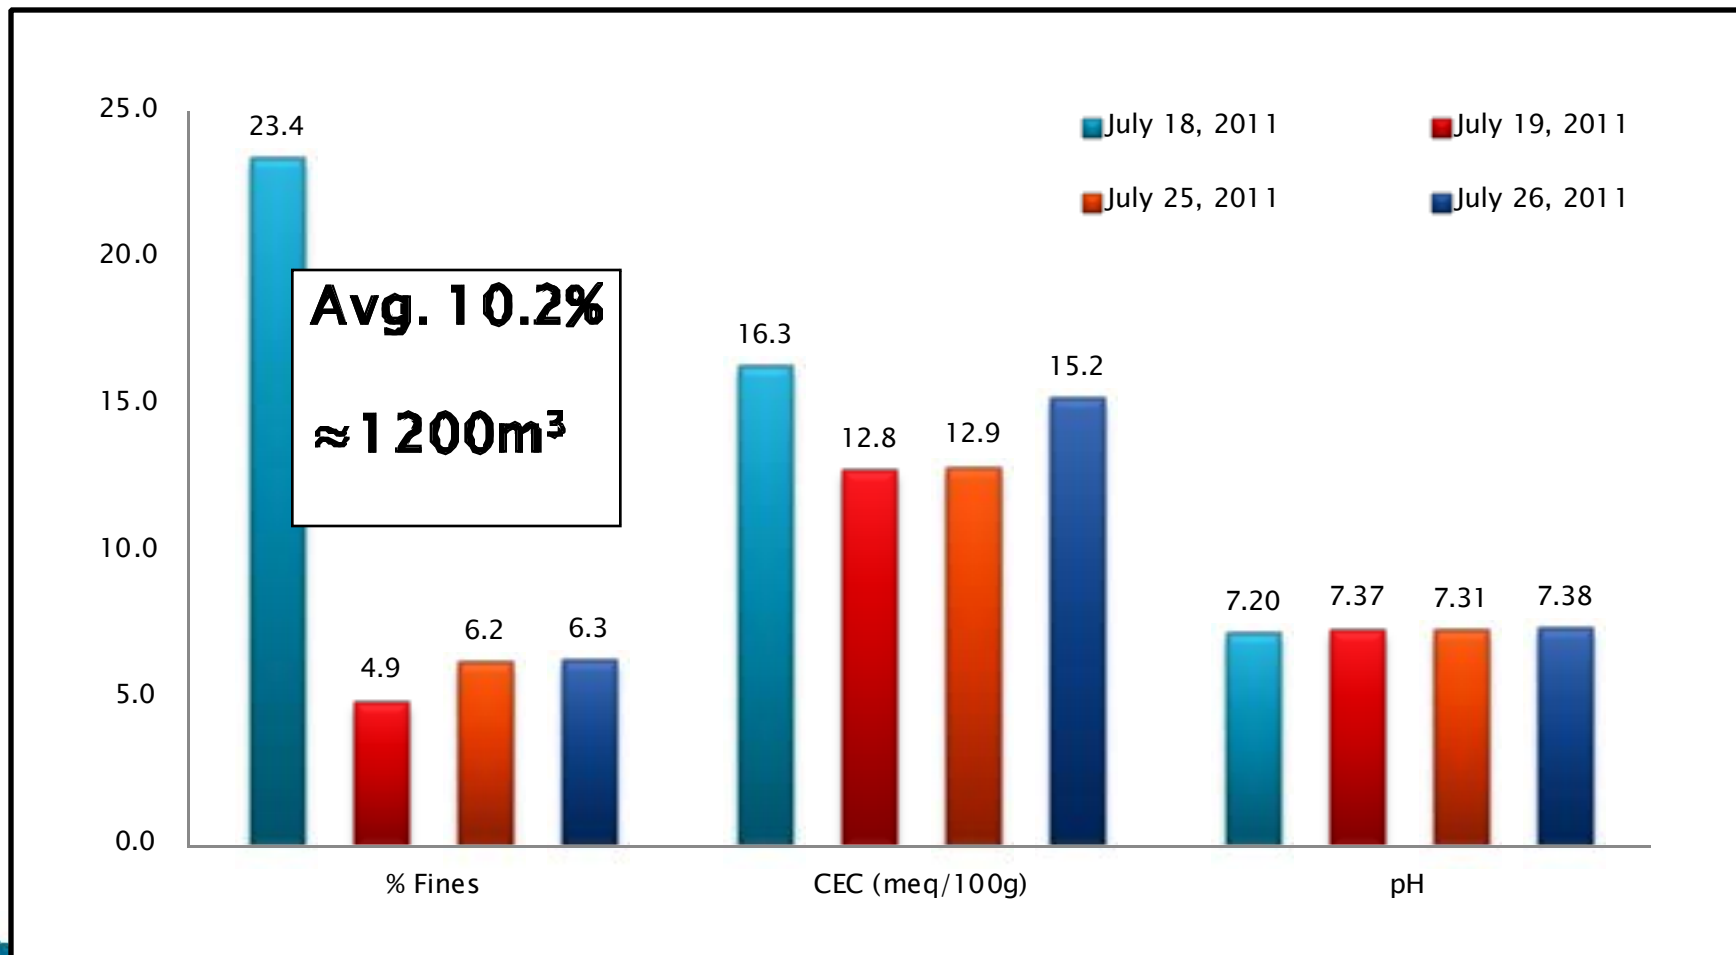
For Construction – Large Site

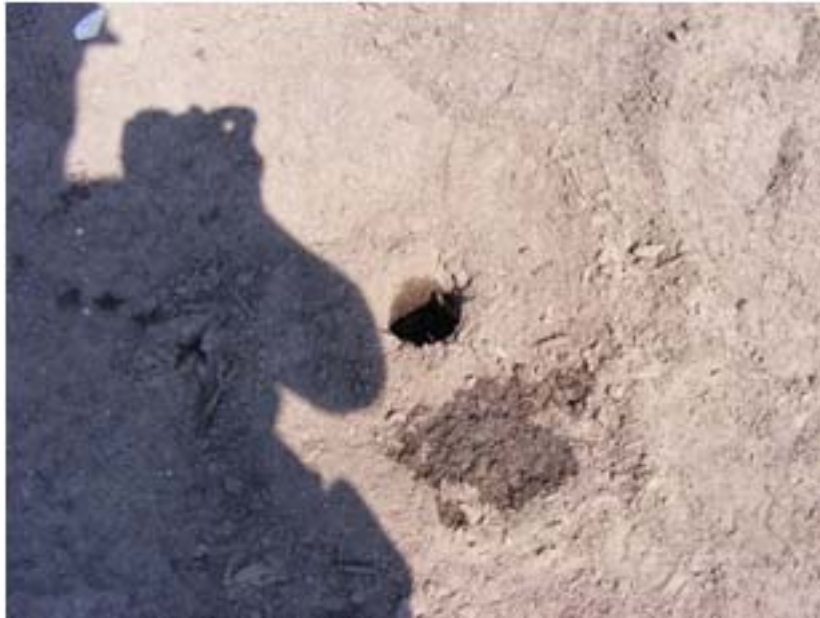
Infiltration Testing During
Construction: 50–75mm/hr

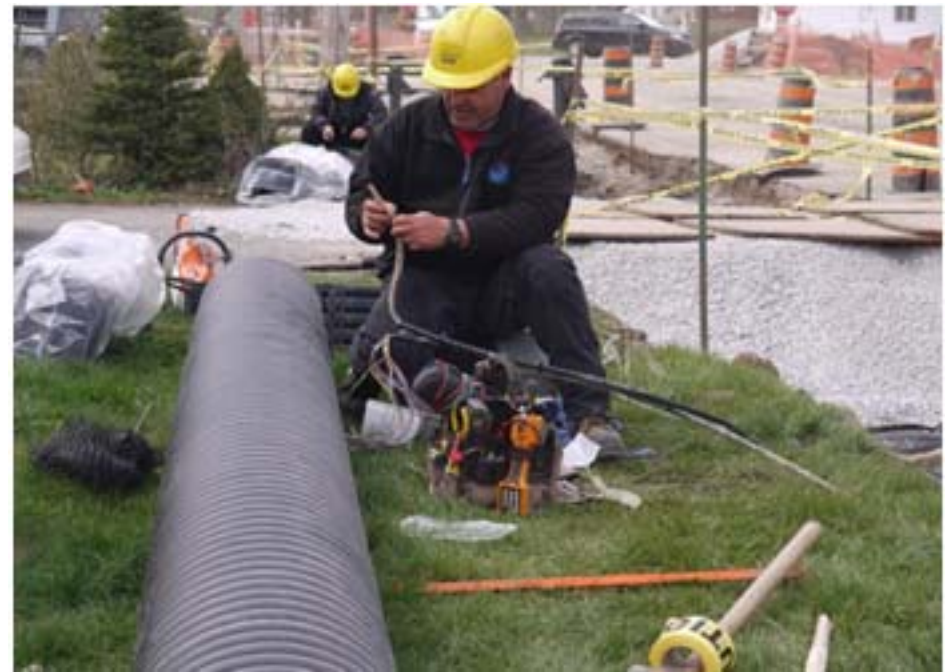
Water Service Line Punctured

Bell Line Damaged (Bell Service Onsite)

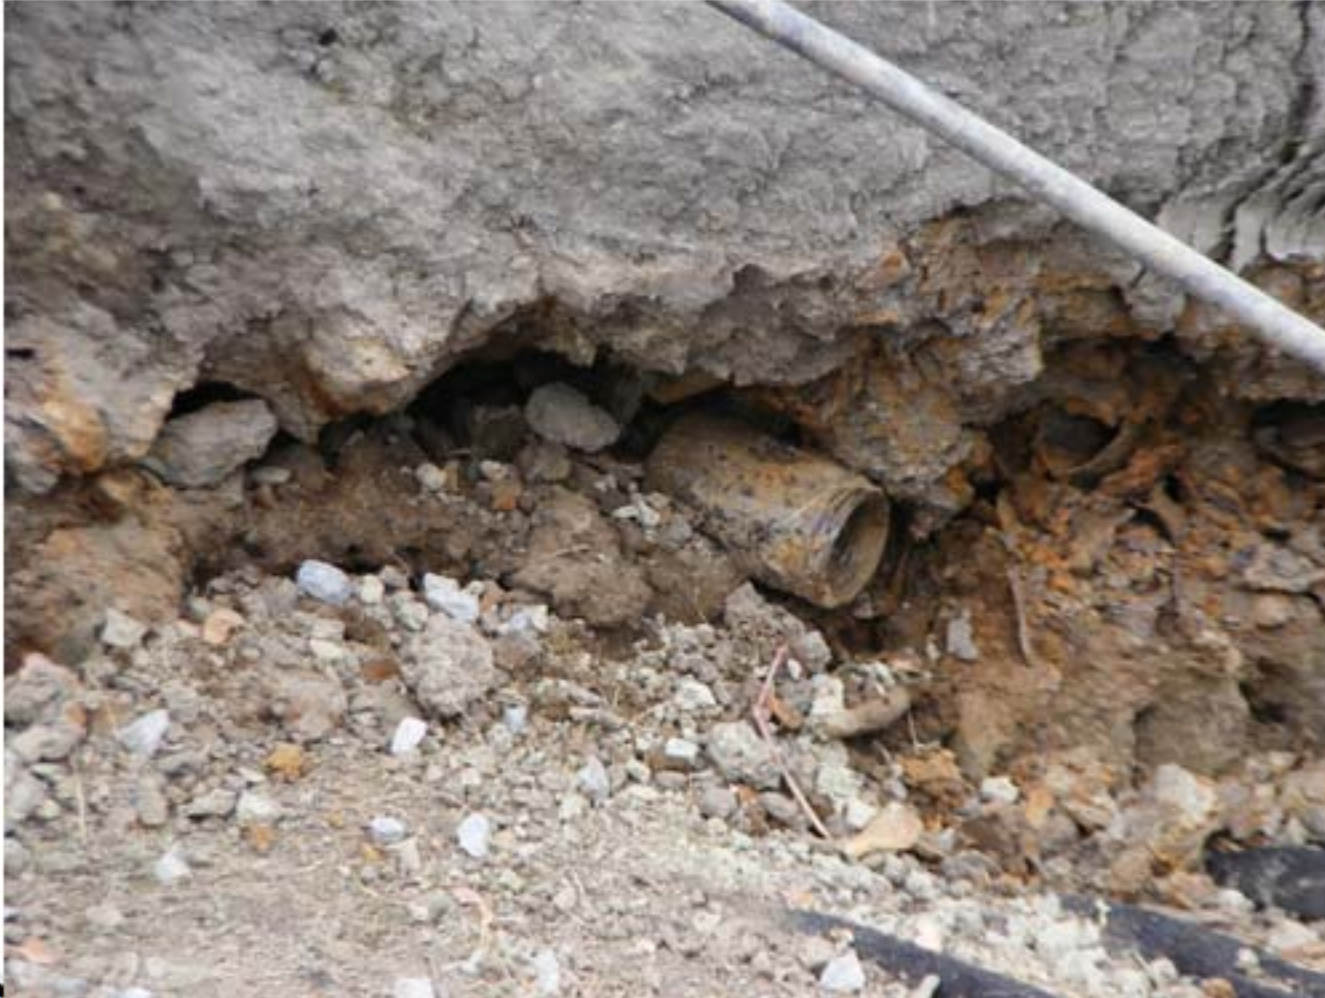
Materials not identified in the geotechnical reports!

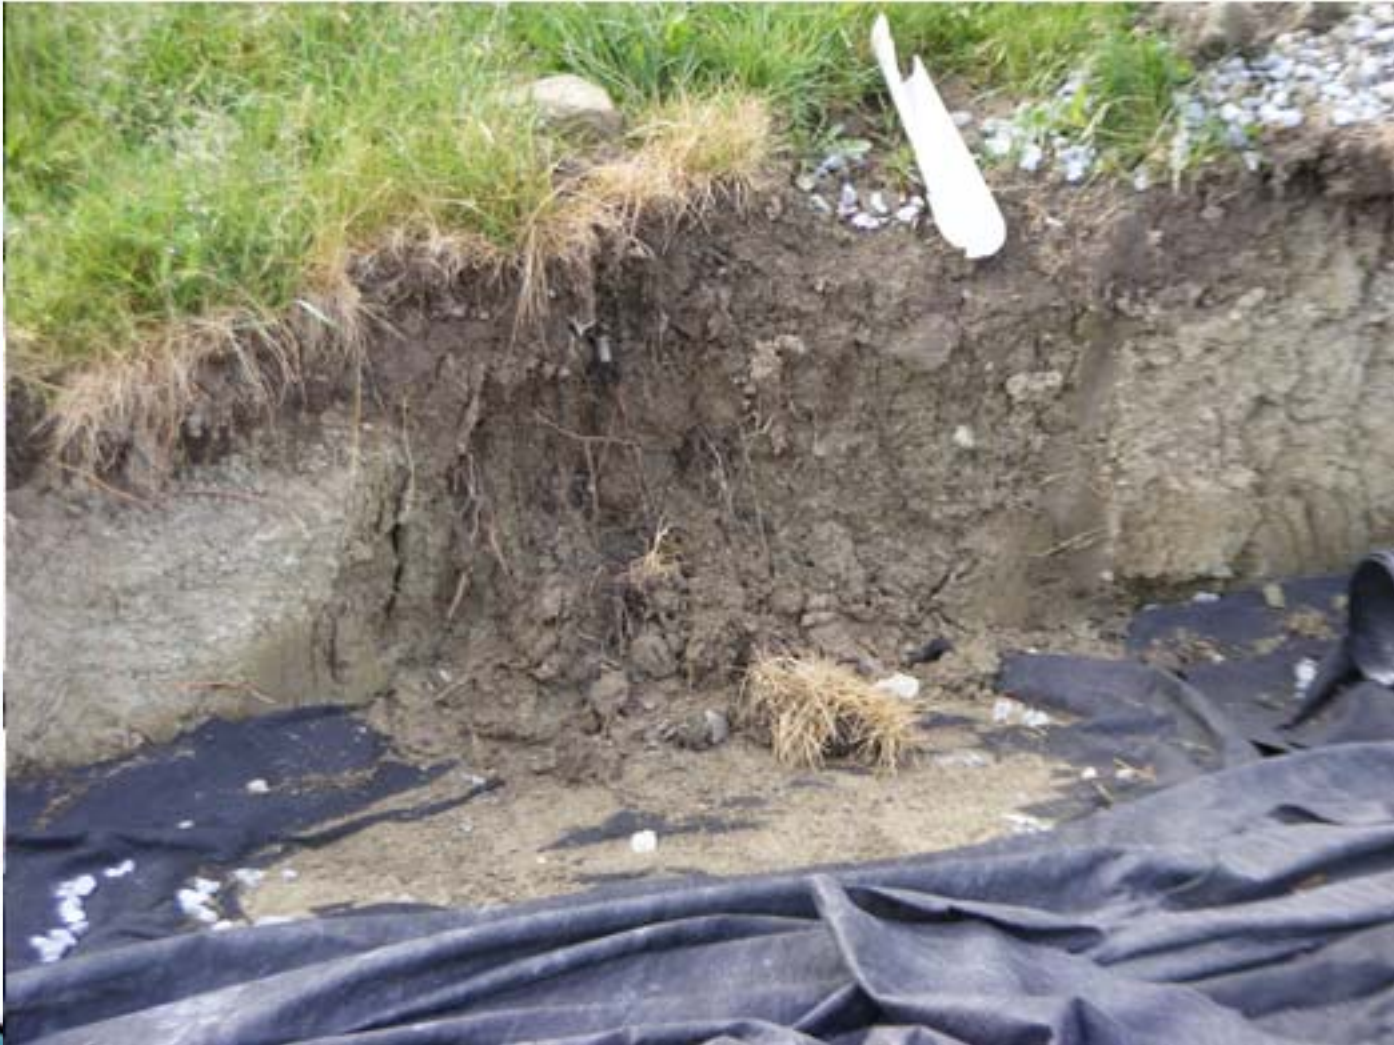
Sacrificial Geotextile

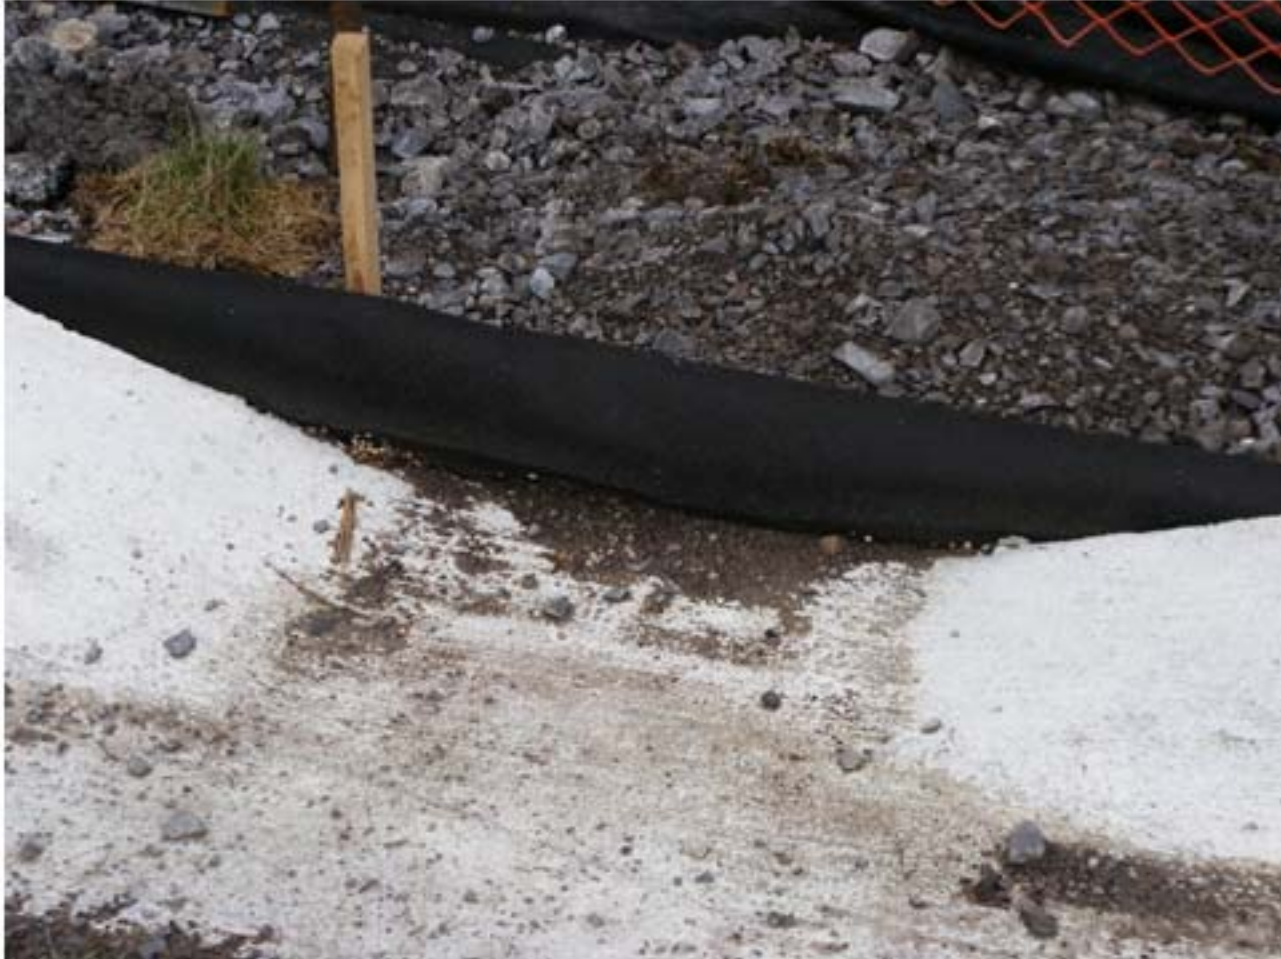
Inlet ESC Controls
