Quantifying the Benefits of Surface versus Underground Low Impact Development Practices

Tim Van Seters
TRIECA
March 26, 2014

Presentation Overview

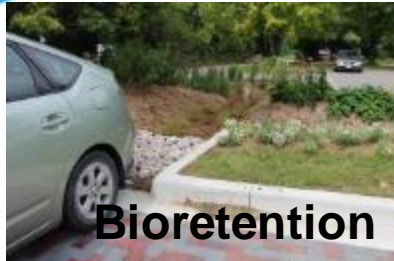
Study Areas

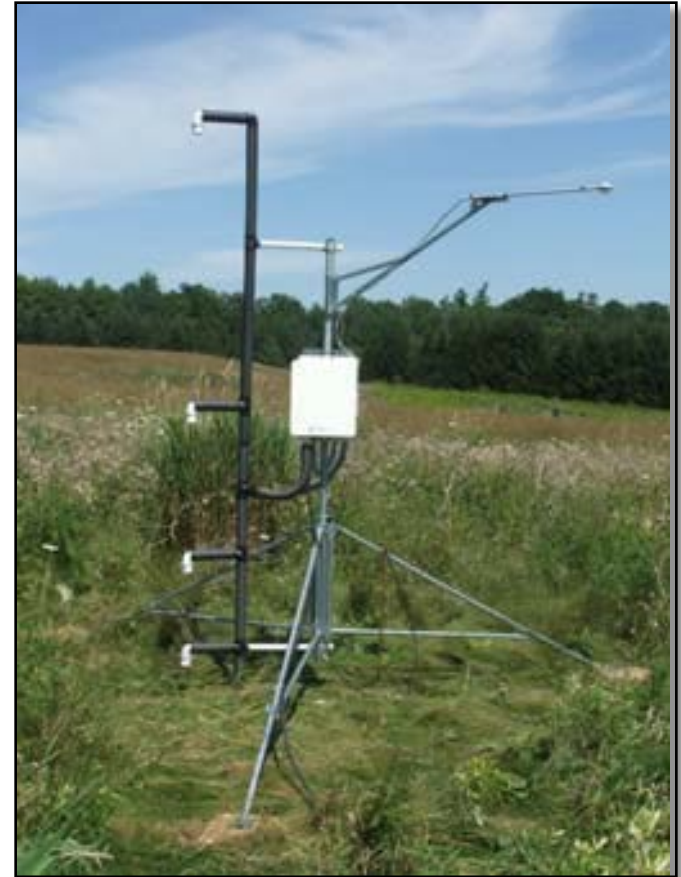
Evapotranspiration

- Based on actual measurements in a field at Kortright and a gravel roof at Downsview
- Bioretention $E_t = 4194$ L
- Stone inlet evaporation = 112 L

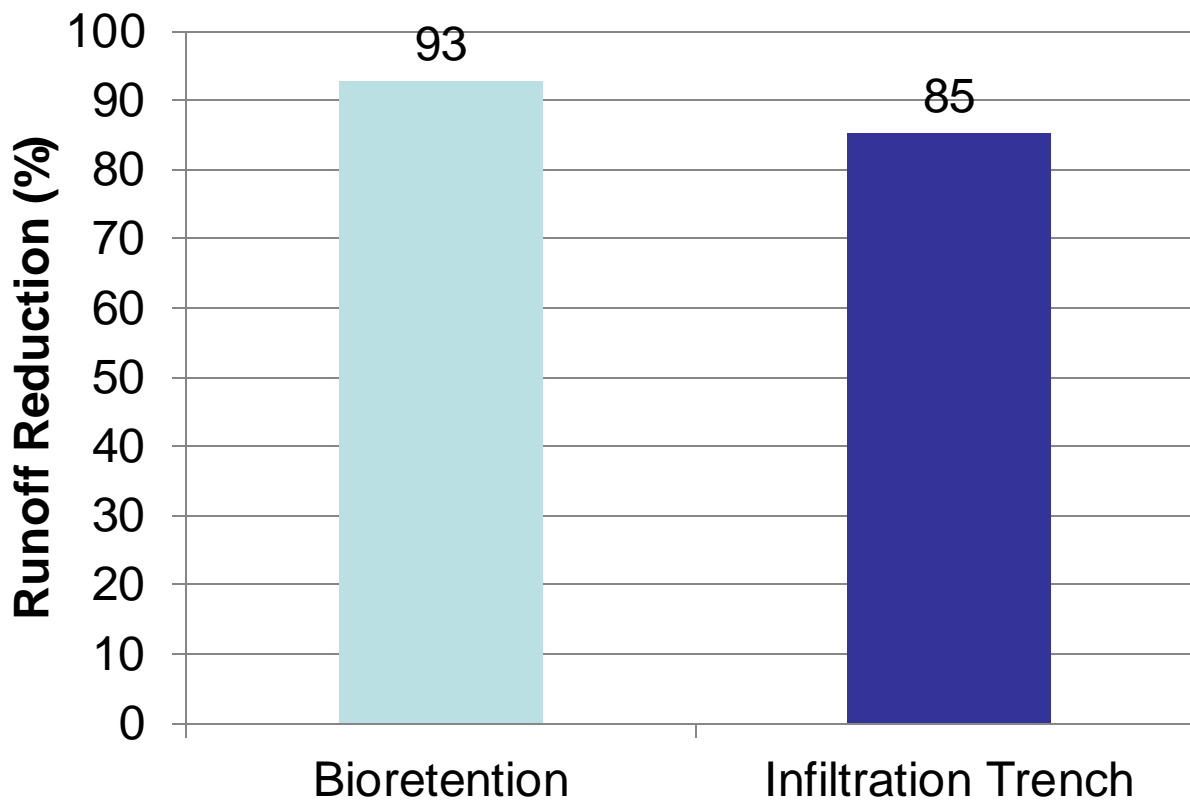
Runoff Reduction – warm season

May 28 – Oct 31, 2013

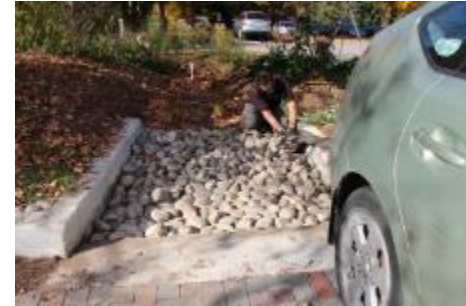
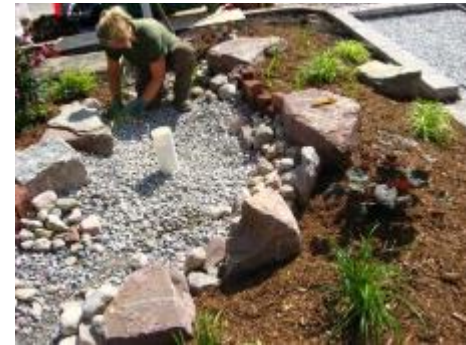
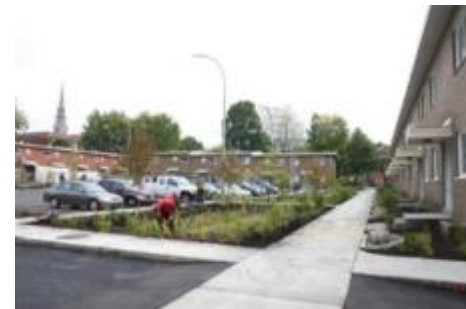
Bioretention Maintenance

- Irrigation until plants are established
- Plant maintenance
- Weeding
- Addition of mulch
- Full rehabilitation may only be required after 20 + years

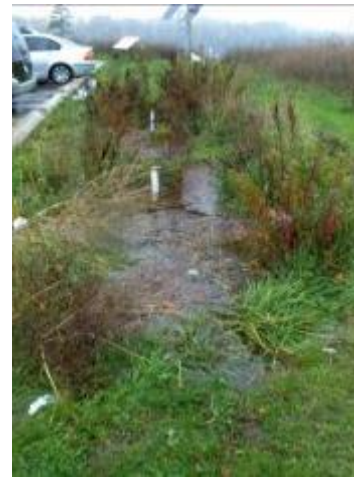
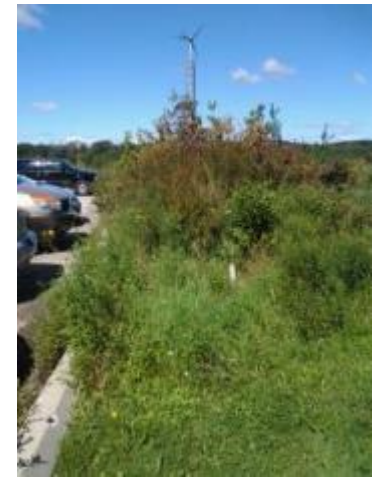
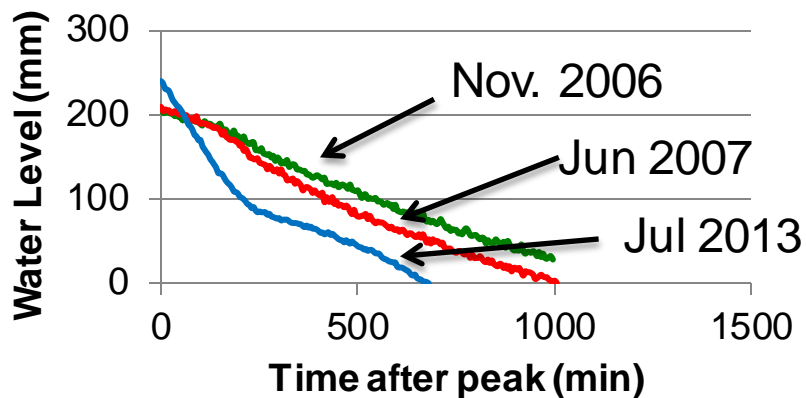
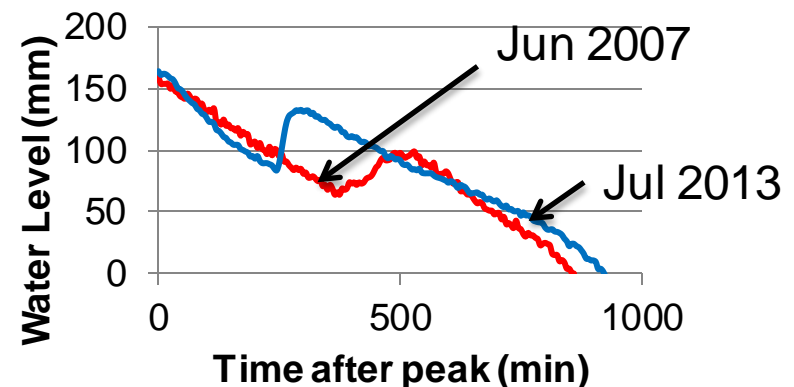
Bioretention Infiltration over Time

- Seneca College Bioretention
- No soil maintenance over seven years
- Drawdown of surface ponding levels after rain events in 2013 roughly the same as in 2006 and 2007

2007

2013

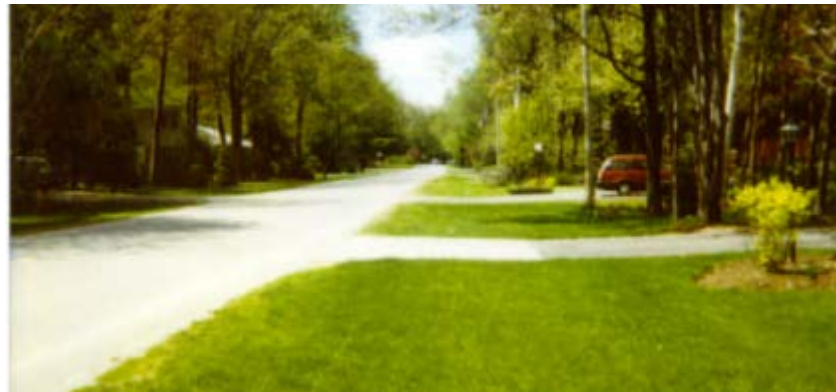
Exfiltration Systems, Ottawa

- Curbless system with pretreatment through a grass swale
- After 20 years, and limited maintenance, the system continues to function very well

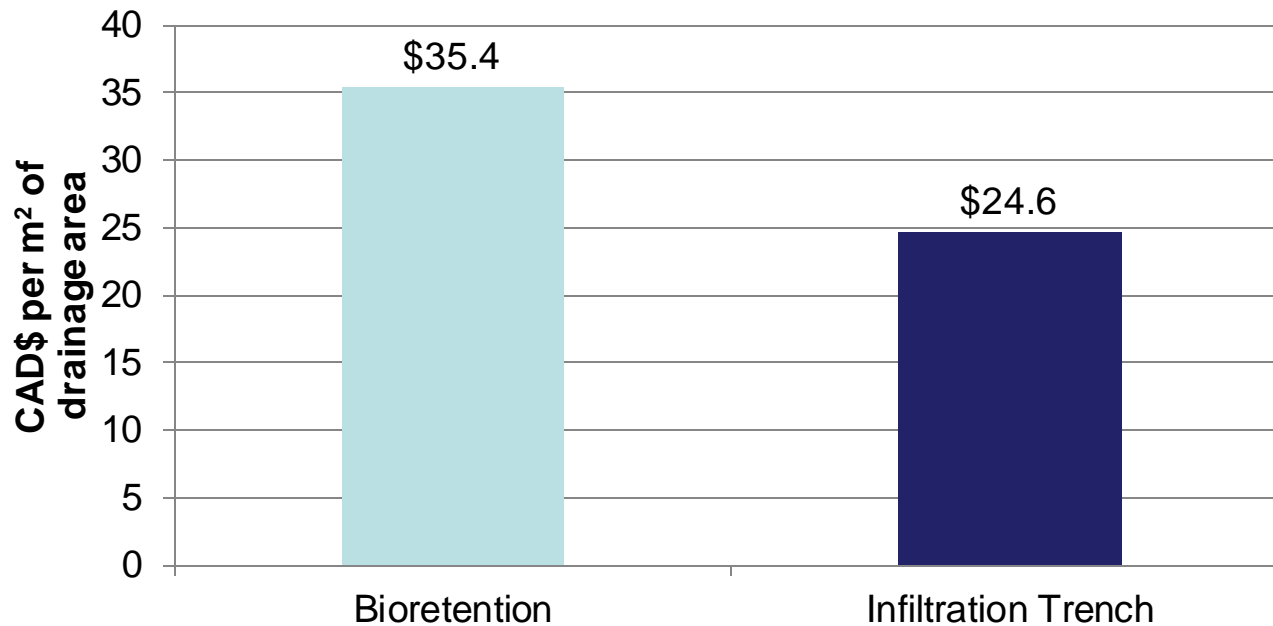
Initial capital costs

Hurdle rate = 5%

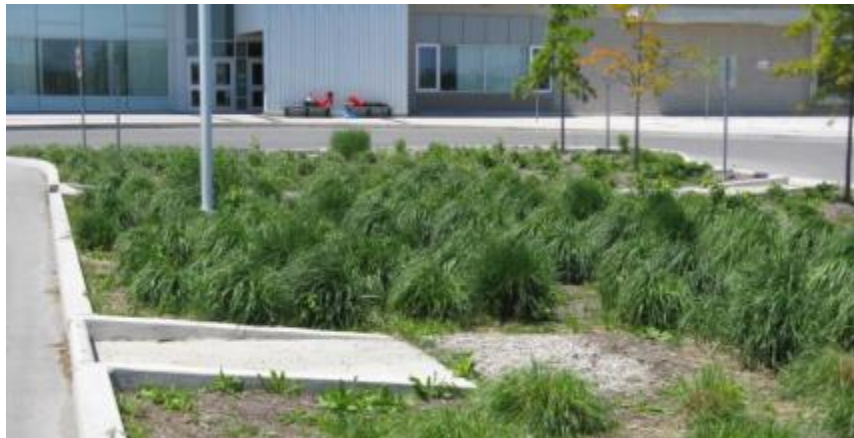
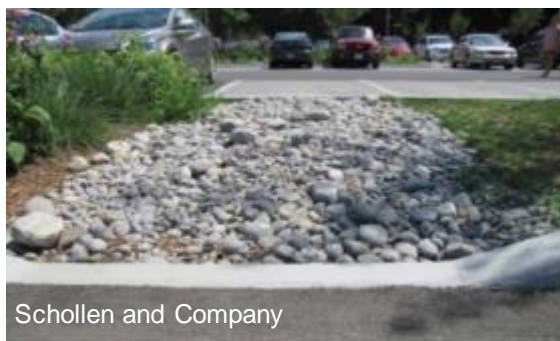
The Best of Both Worlds

- Bioretention and Infiltration Trench practices performed better than expected
- Treatment benefits of high permeability stone filters may be similar to those provided by traditional bioretention
- Concentrations of some water quality variables, such as TP, were lower in the trench outflows
- Granular filter inlets with overflows may provide inexpensive and effective pre-treatment to underground infiltration practices
- Combining the rapid infiltration properties of stone filters with the benefits of vegetation can preserve the aesthetic values of bioretention while reducing its surface footprint and long term maintenance burden
