The Poplar River Story: Changing the Fate of One of Minnesota's Outstanding Natural Resources

2019 TRIECA Conference
Jay Michels, CPESC
Partner/Project Manager
Emmons & Olivier Resources, Inc.

March 21, 2019

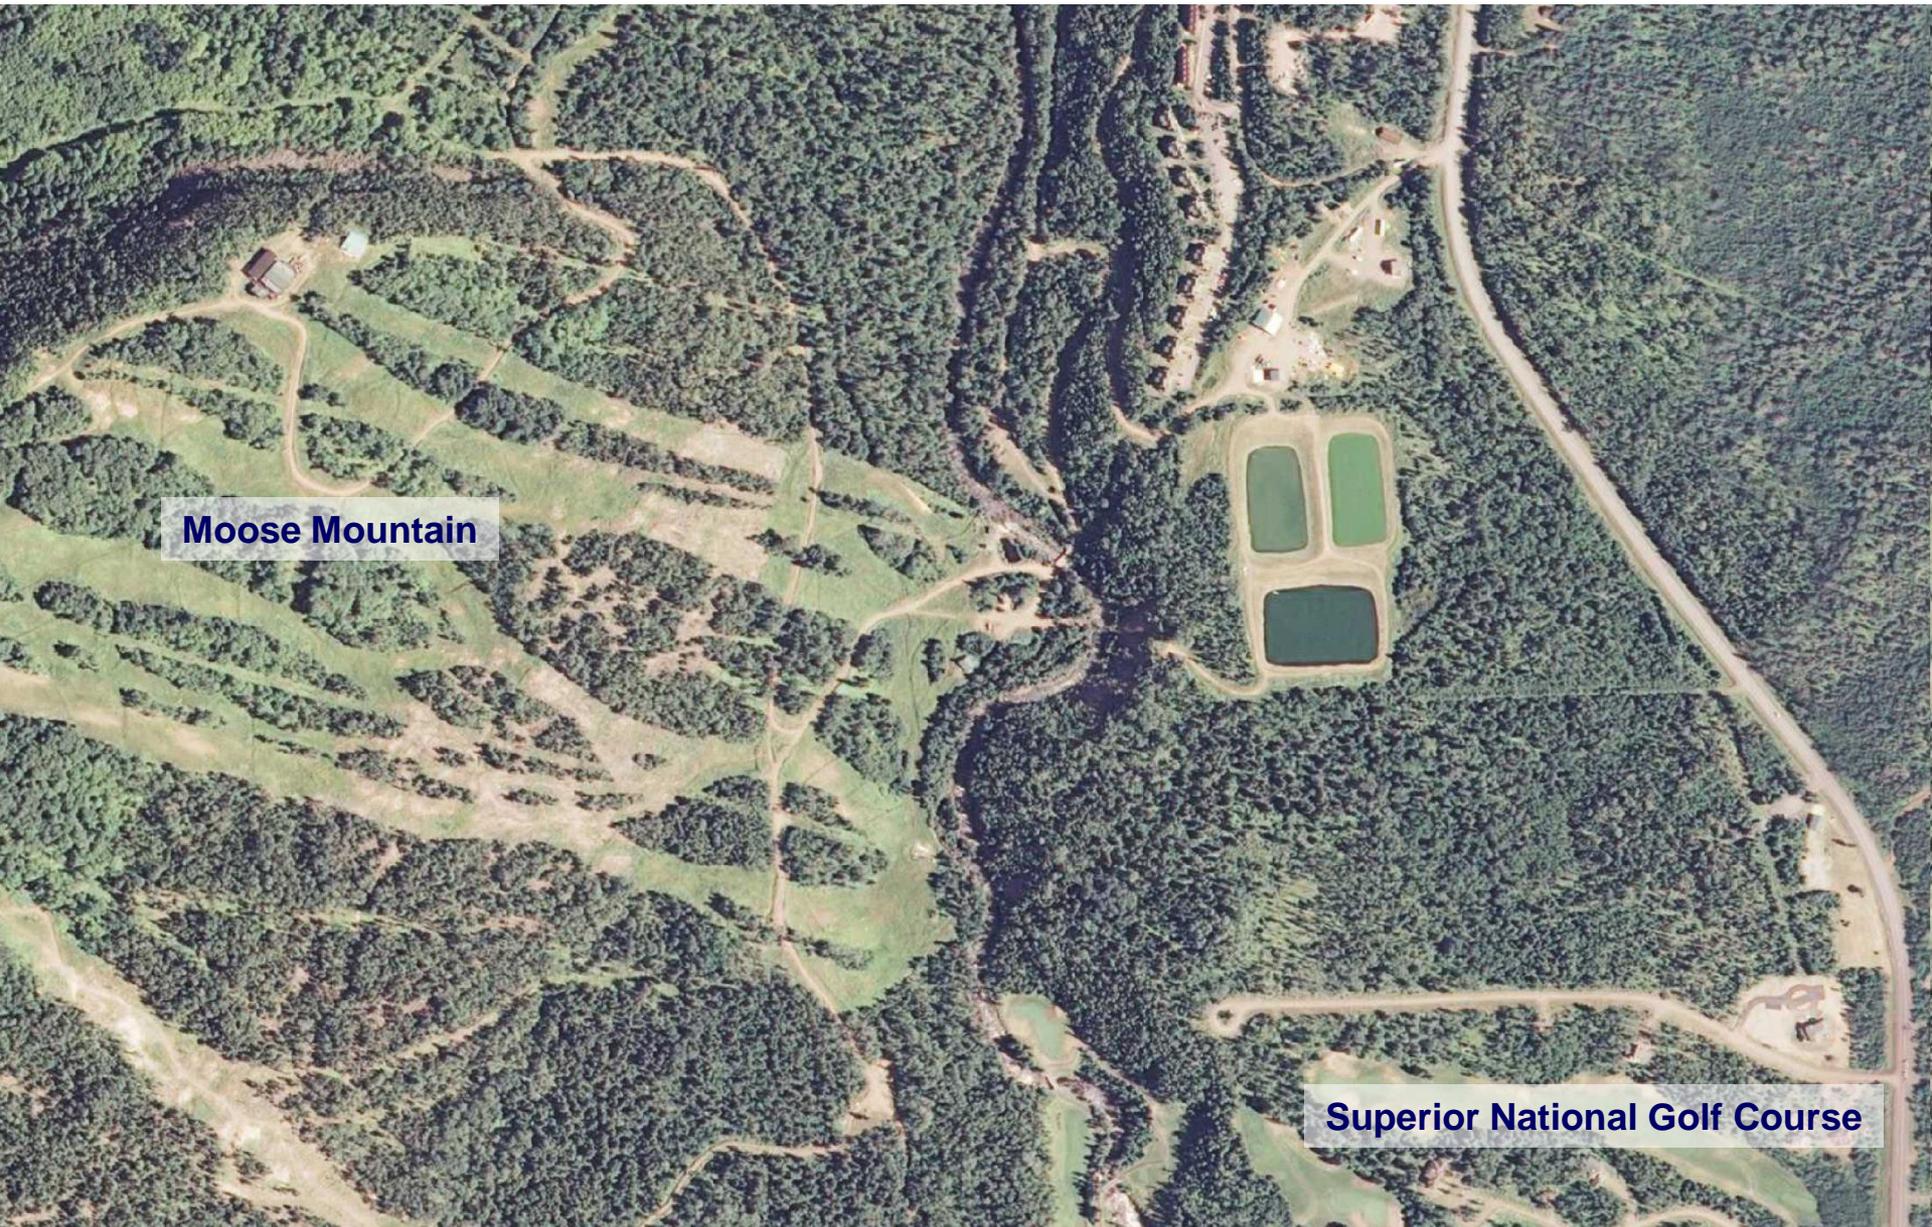
The Watershed

Moose Mountain

Superior National Golf Course

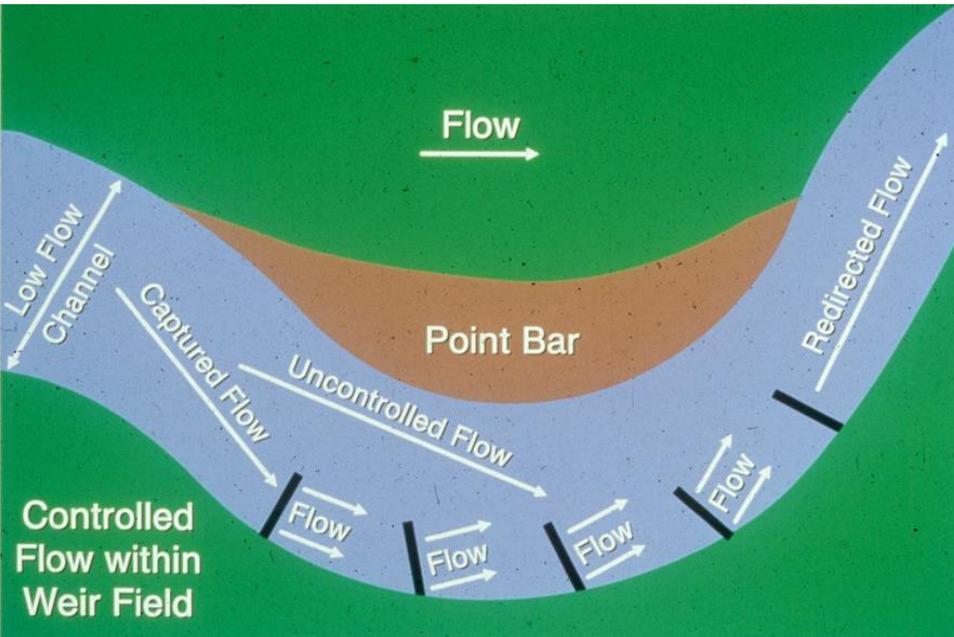
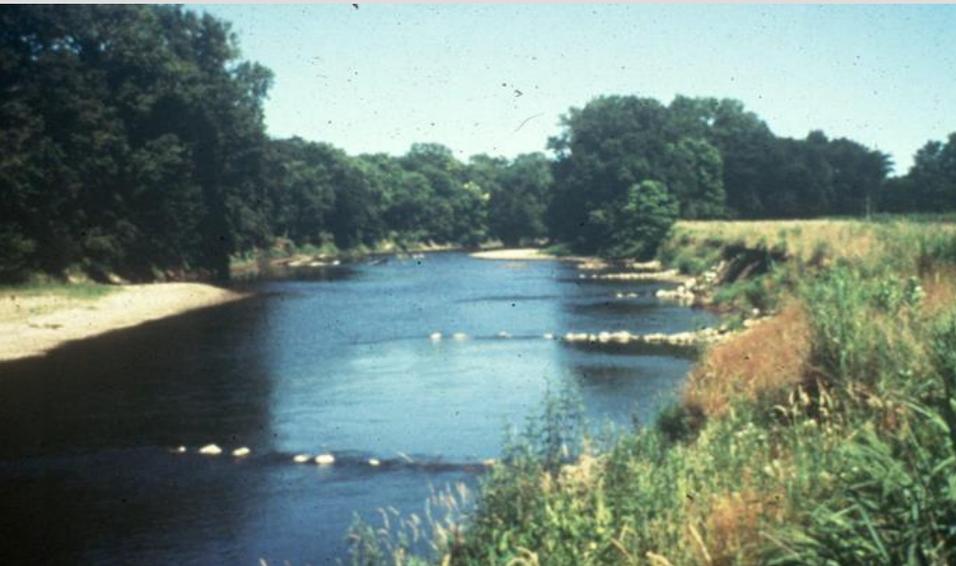
Water Training Device

ANGLED-upstream 20 degrees from perpendicular (70 degrees from the bank)

LENGTH-determined by how much river flow needs to be controlled & by future thalweg location

HEIGHT- lower than any flow that can erode the bank, usually +/- 1 ft of the bankfull water surface elevation

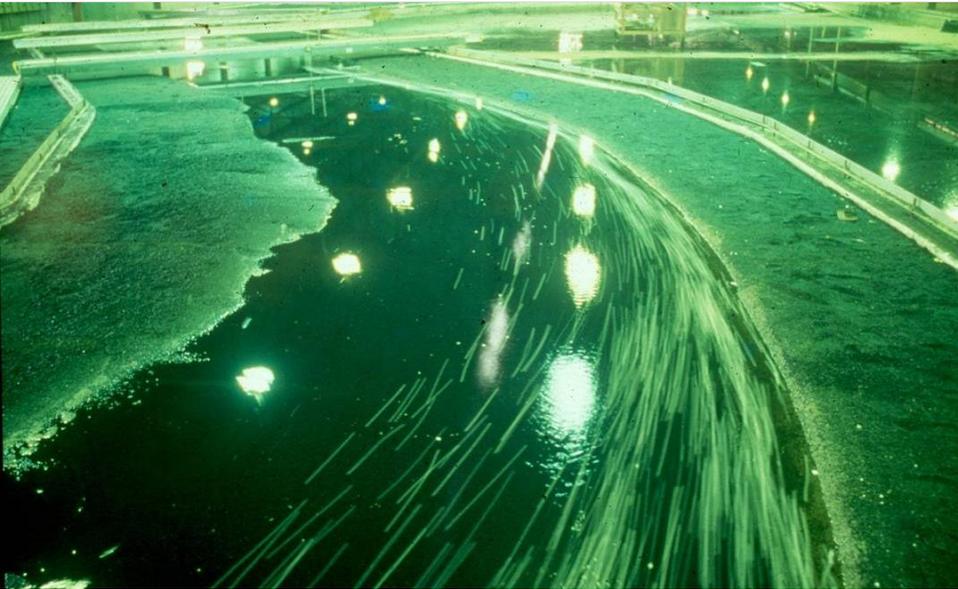
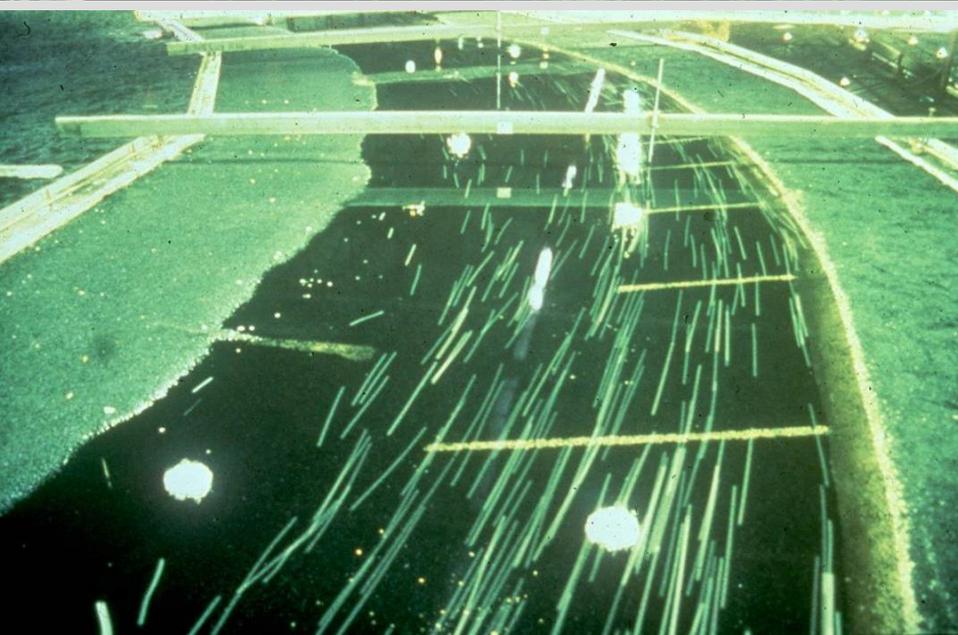
Moves scour & thalweg

Reduces velocities within the weir field & at toe of bank

Water flowing over the weir is redirected at an angle perpendicular to the longitudinal axis of the weir

With weirs angled upstream, the erosive flow is directed away from the outer bank & toward the inner part of the bend

Secondary currents (Helical Flow) in bend are broken up

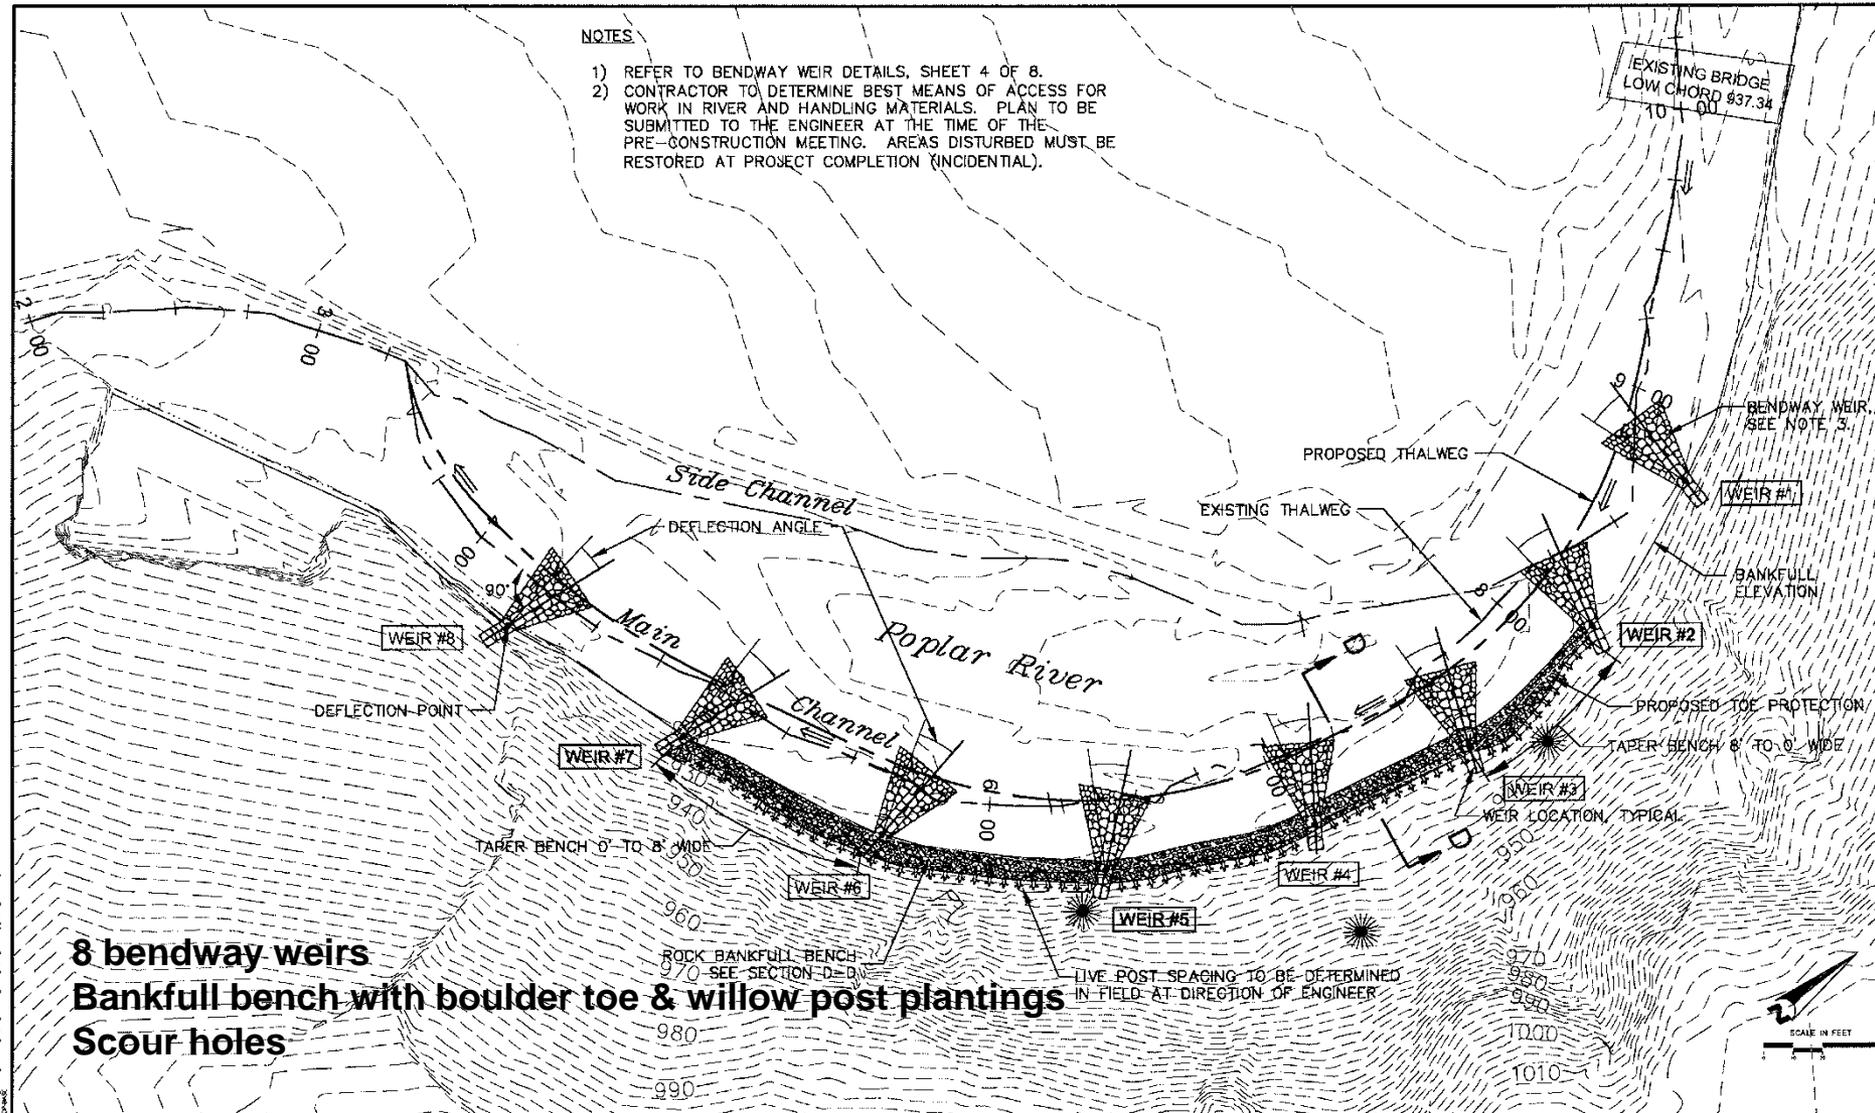
SHEET 3
 OF
 8 SHEETS

8 bendway weirs
Bankfull bench with boulder toe & willow post plantings
Scour holes

POPLAR RIVER MEGA SLUMP STABILIZATION PROJECT
 TOE STABILIZATION OVERVIEW
 LUTSEN, COOK COUNTY, MINNESOTA

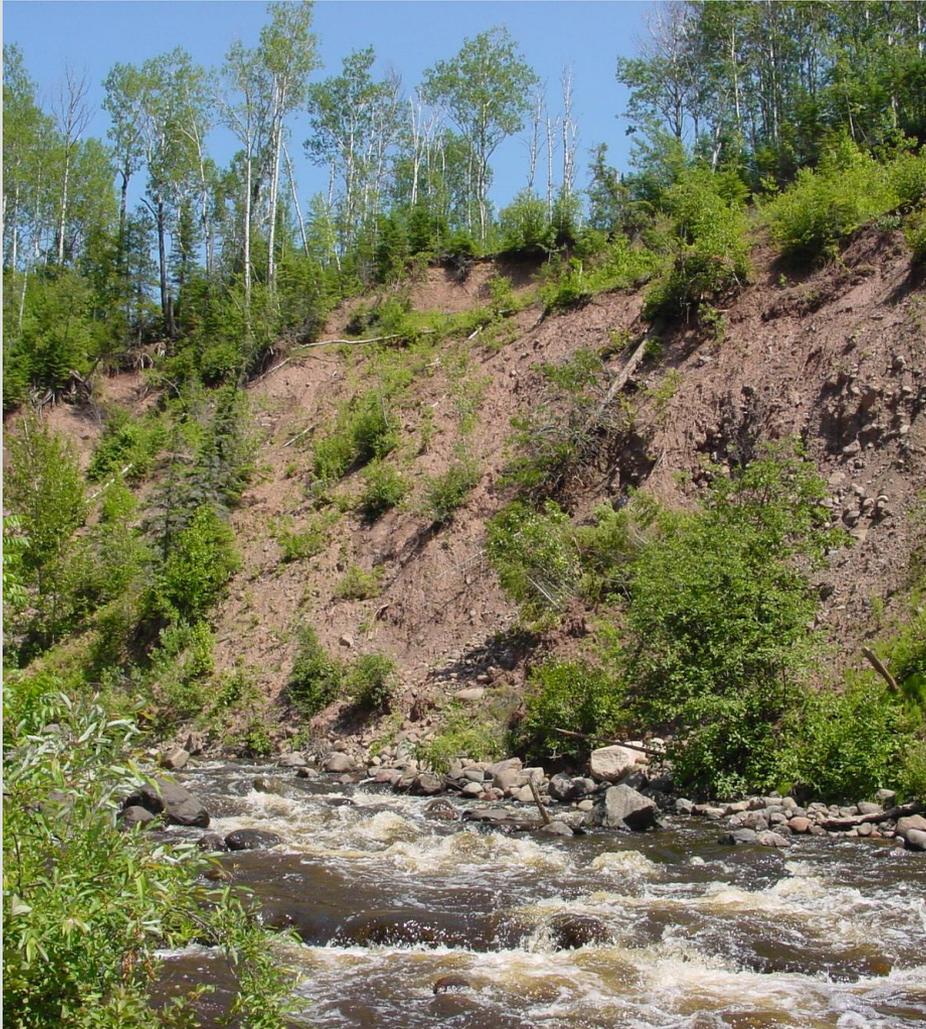
Lower half of slump had large shelf , indicating slide may have been caused by toe failure following a major rain event that caused the BWCA blowdown July 4th, 1999.

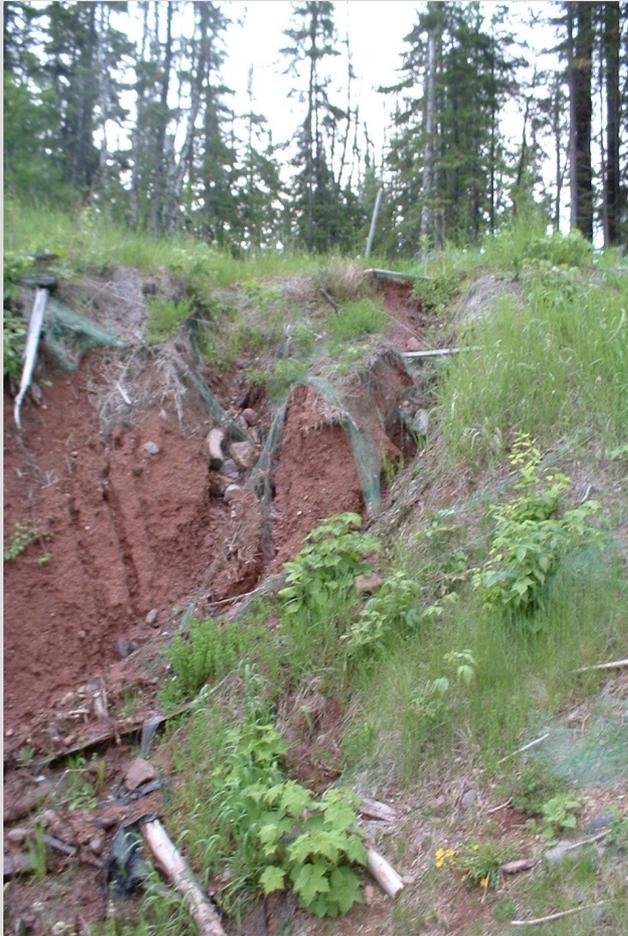
Defend toe of slope to eliminate streambank erosion

Eliminate surface run on through berm and grade adjustment

Look for opportunities to manage contributing watershed

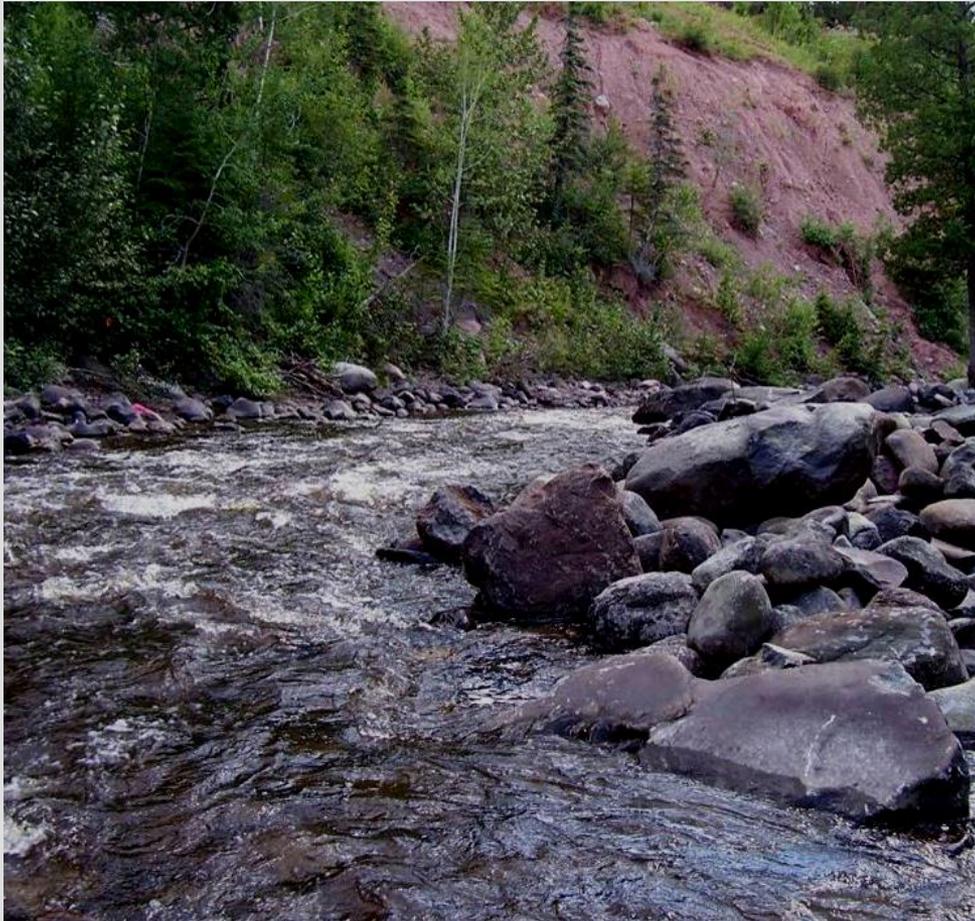
Step 1- Clear a path on the left side for the entire length of channel

Access in middle of the channel, work will be completed from both ends to the middle

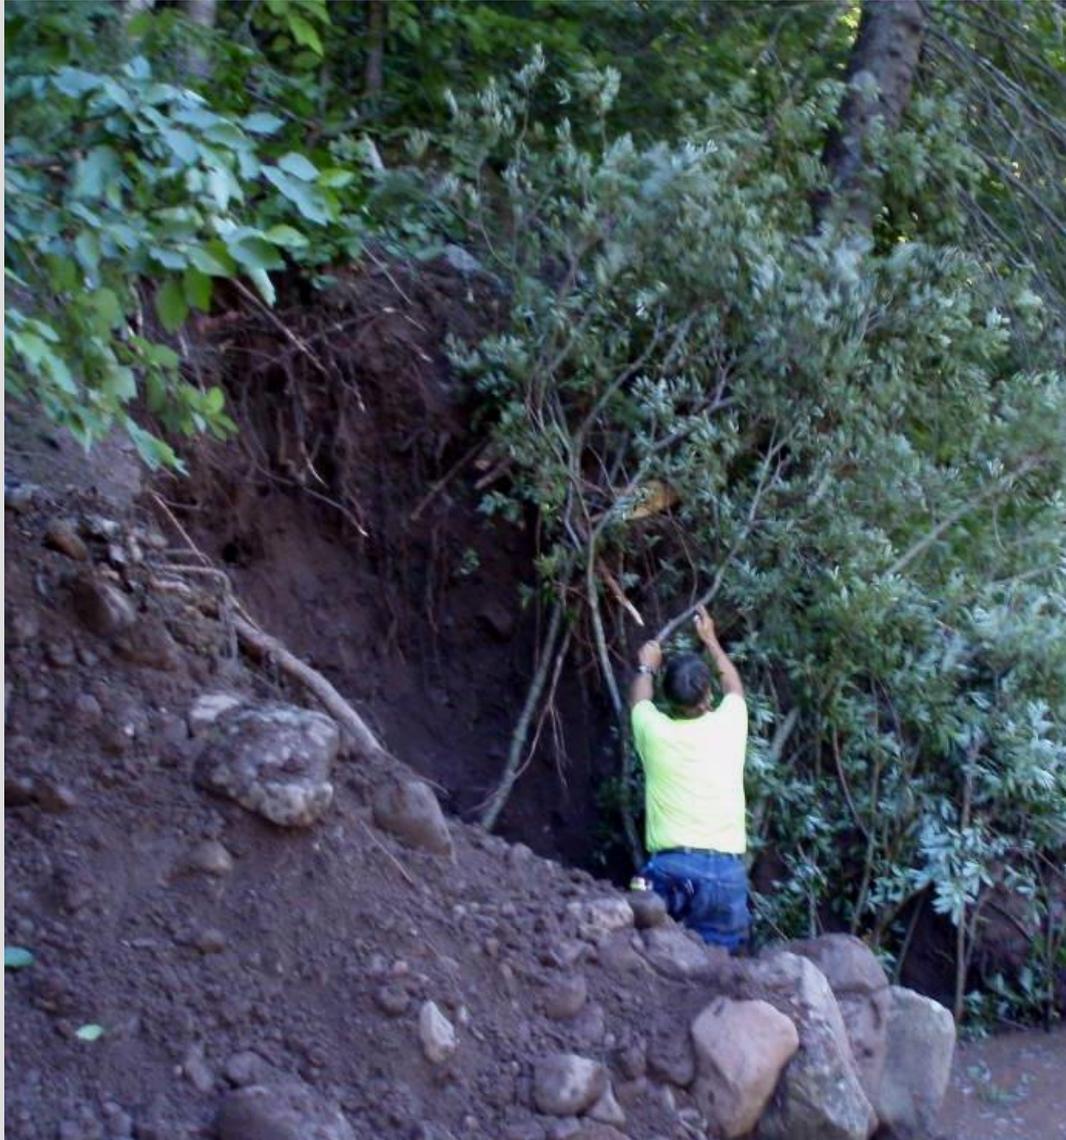
Deeply planted willows oriented perpendicular to flow will act as a “living dike”, slowing near-bank flow velocities

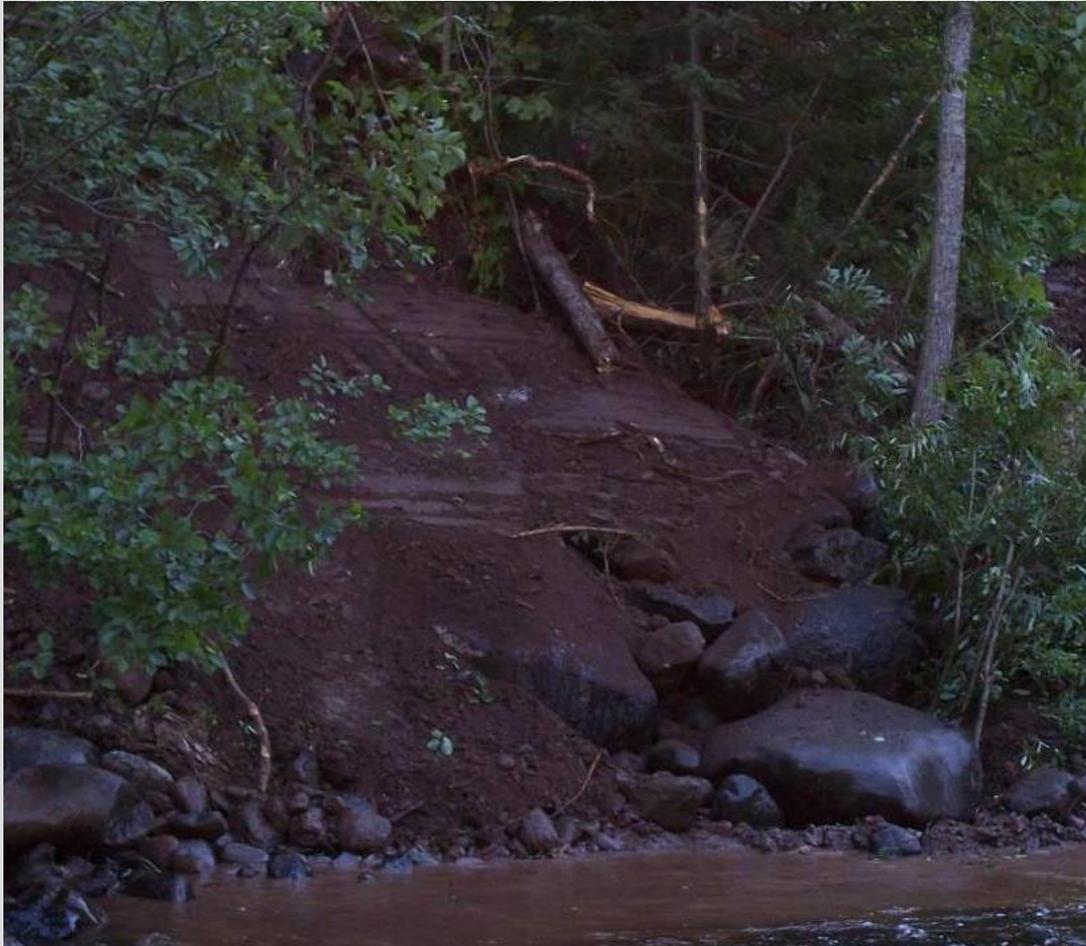
Once willows are in place, keyways are constructed using large quarry rock with “choke” stone from stream to fill voids

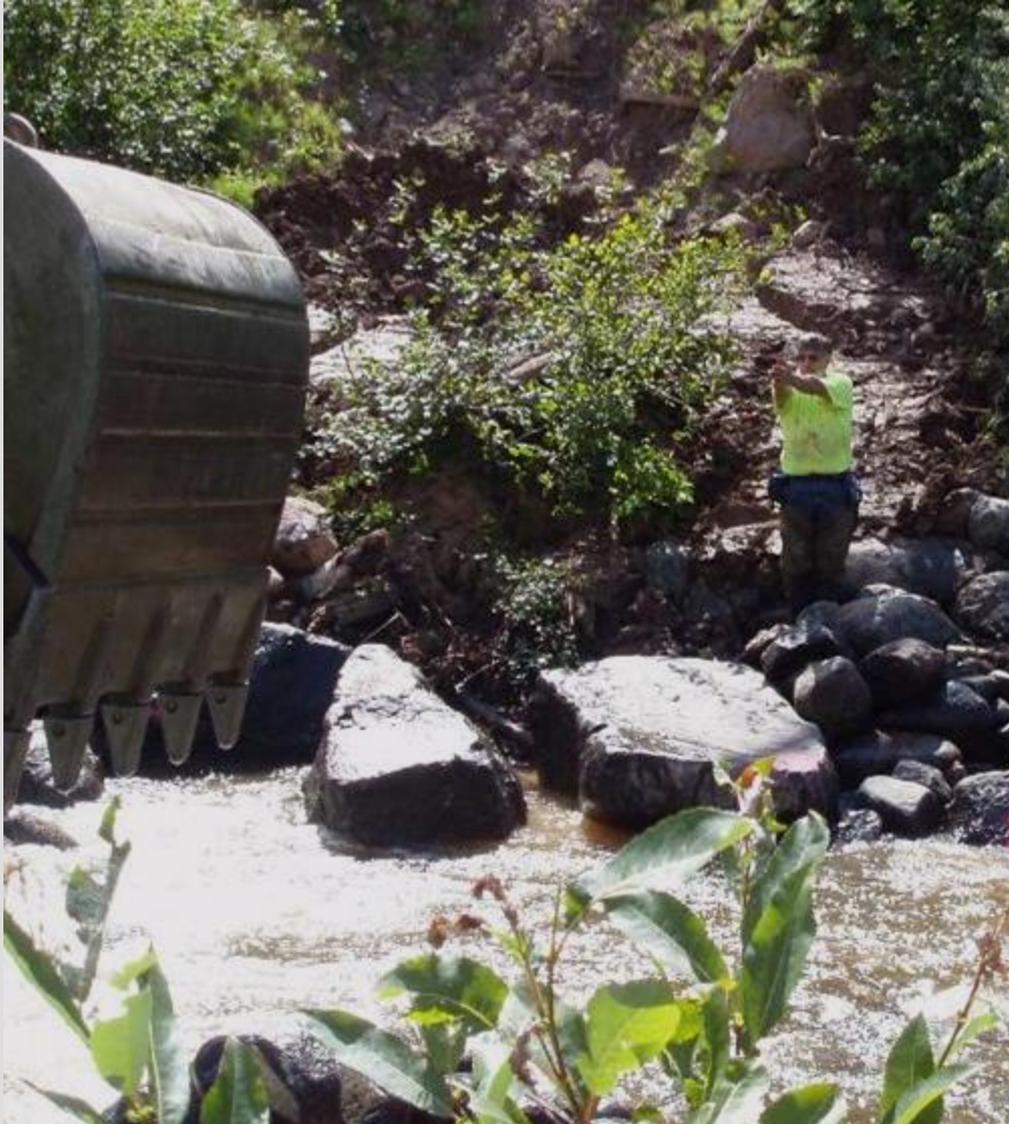
Upstream angle of bendway weir is set 20% upstream from perpendicular

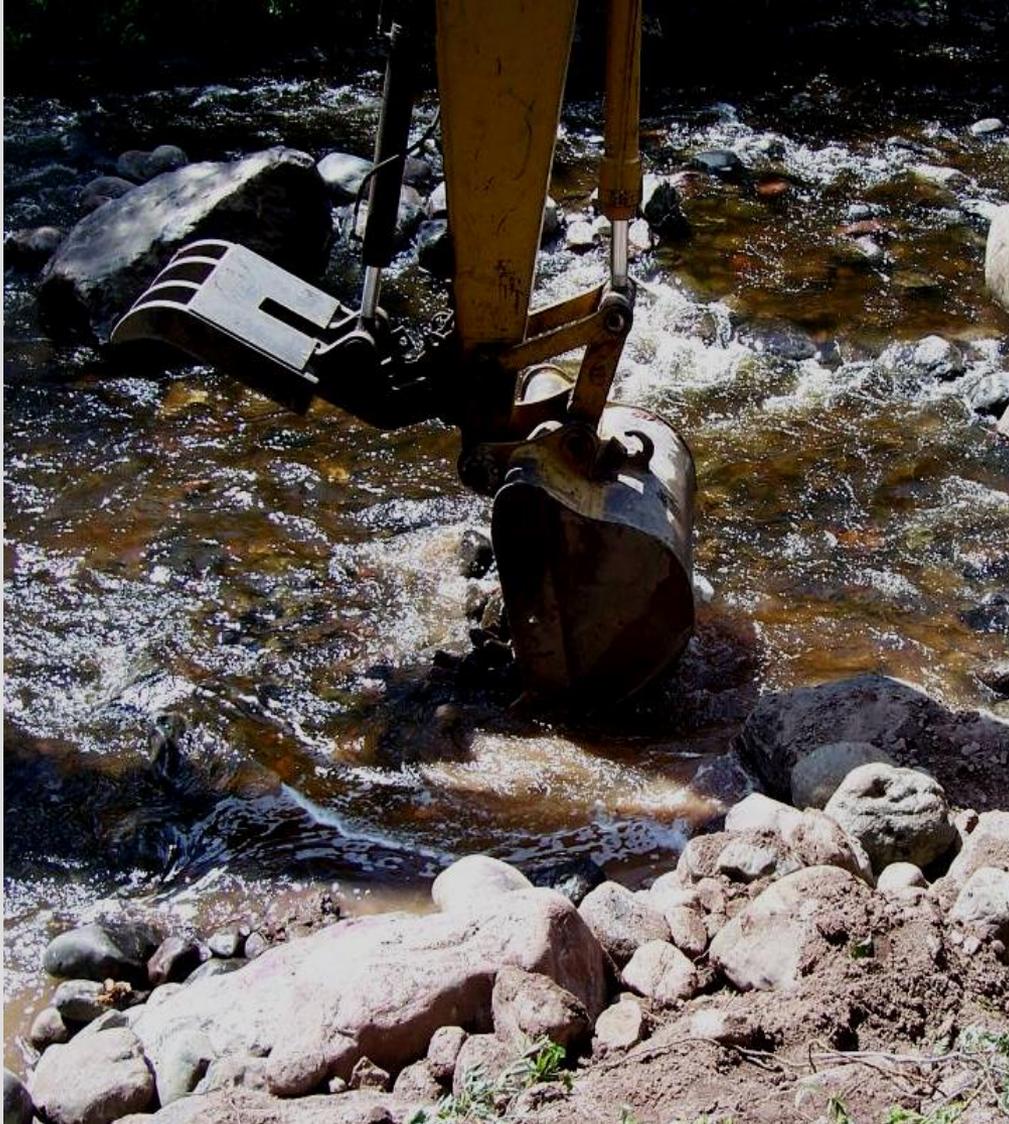
**Streambed excavated
to allow for installation
of bendway weir**

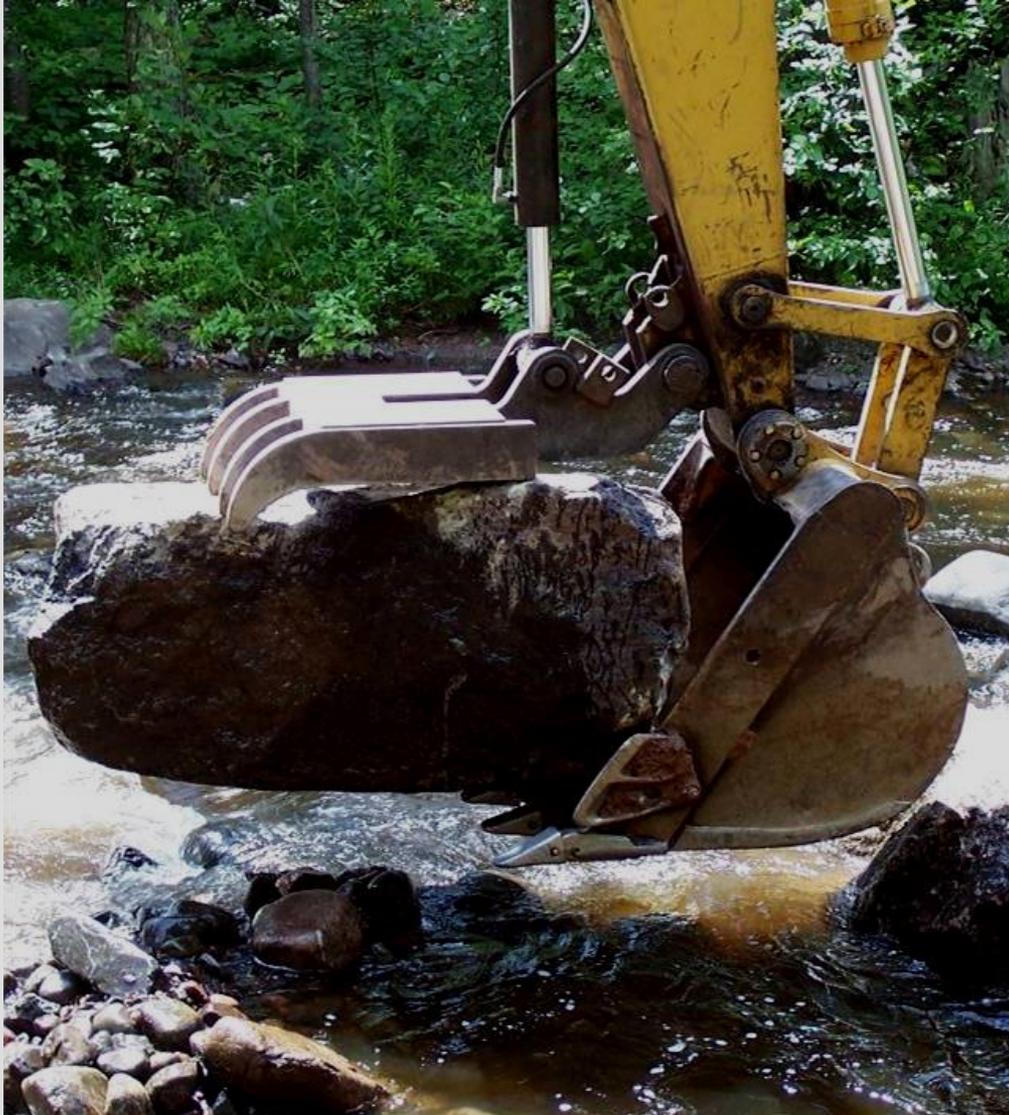
**1st bendway weir
stone abuts to keyway**

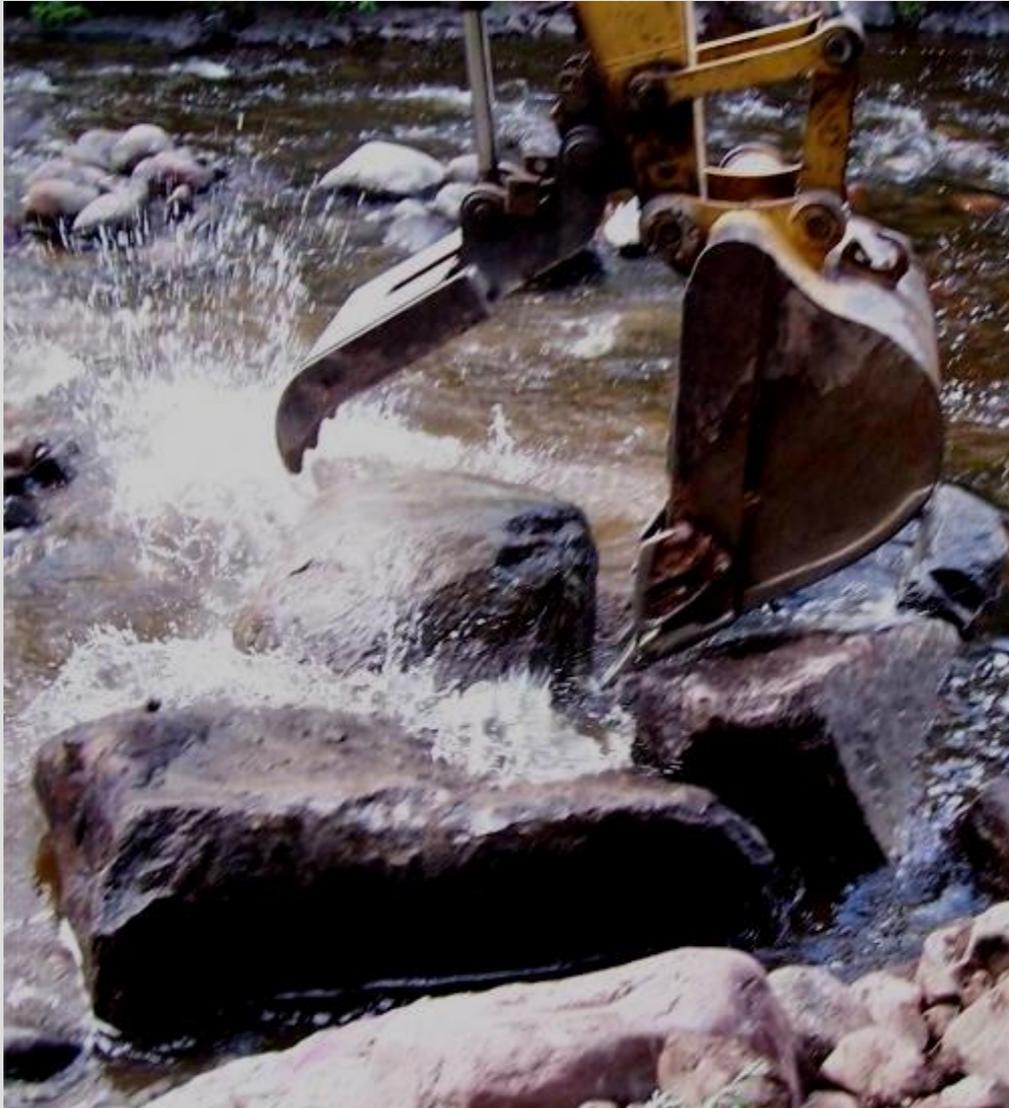
**Each weir built with
double row of stone**

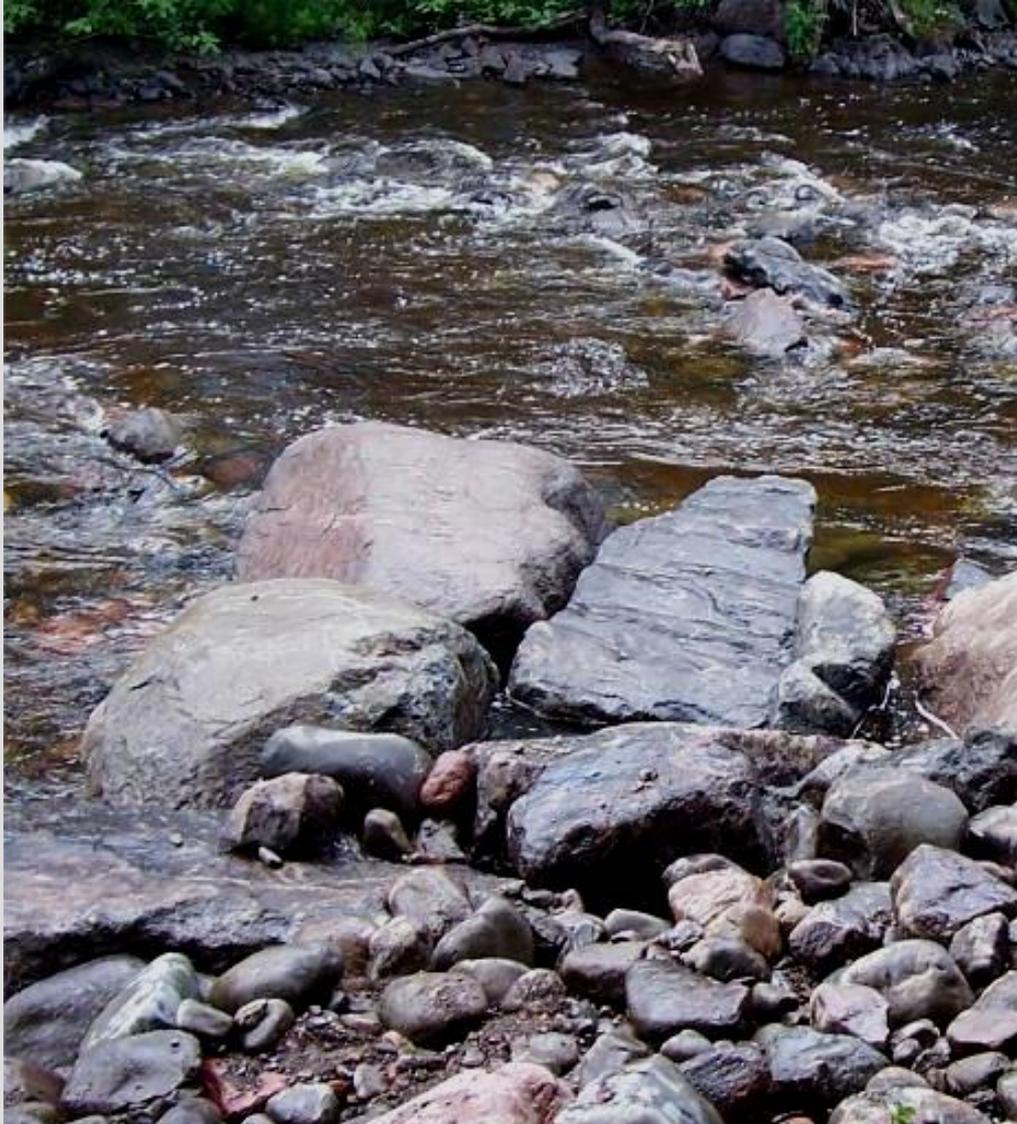
Completed weirs range from 15'-22' long with pool dug at stream end to align thalweg off the end of each weir

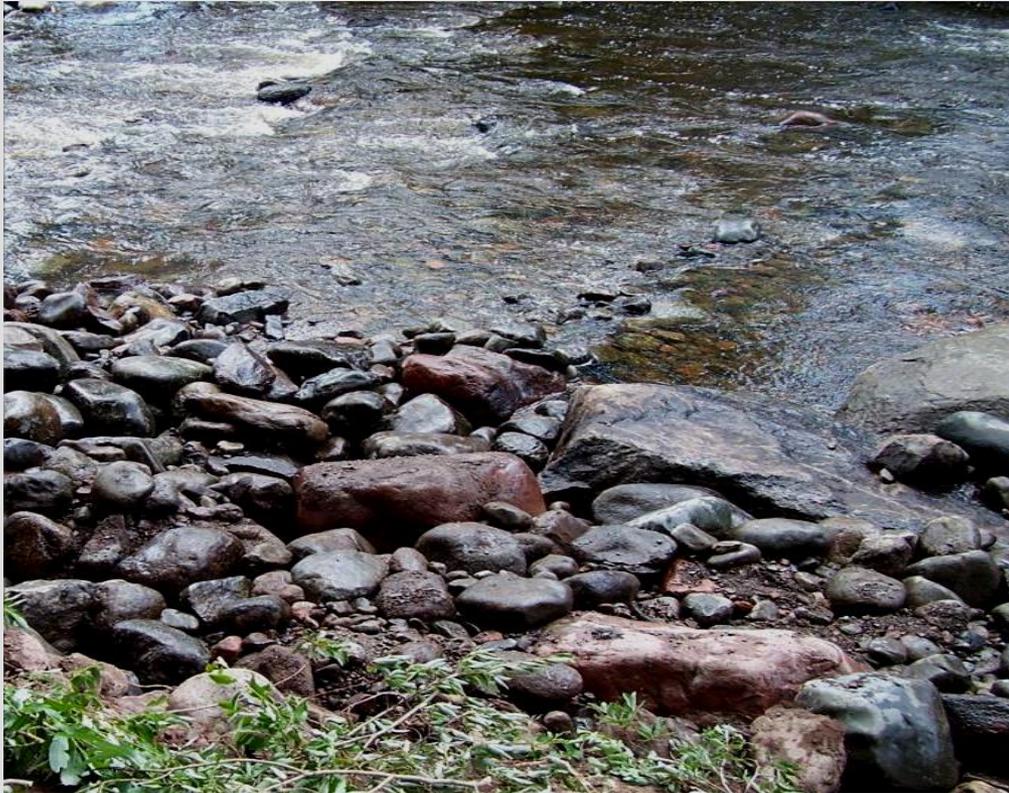
**Boulders placed on
upstream and
downstream side of
weir to smooth flow
transition over weir**

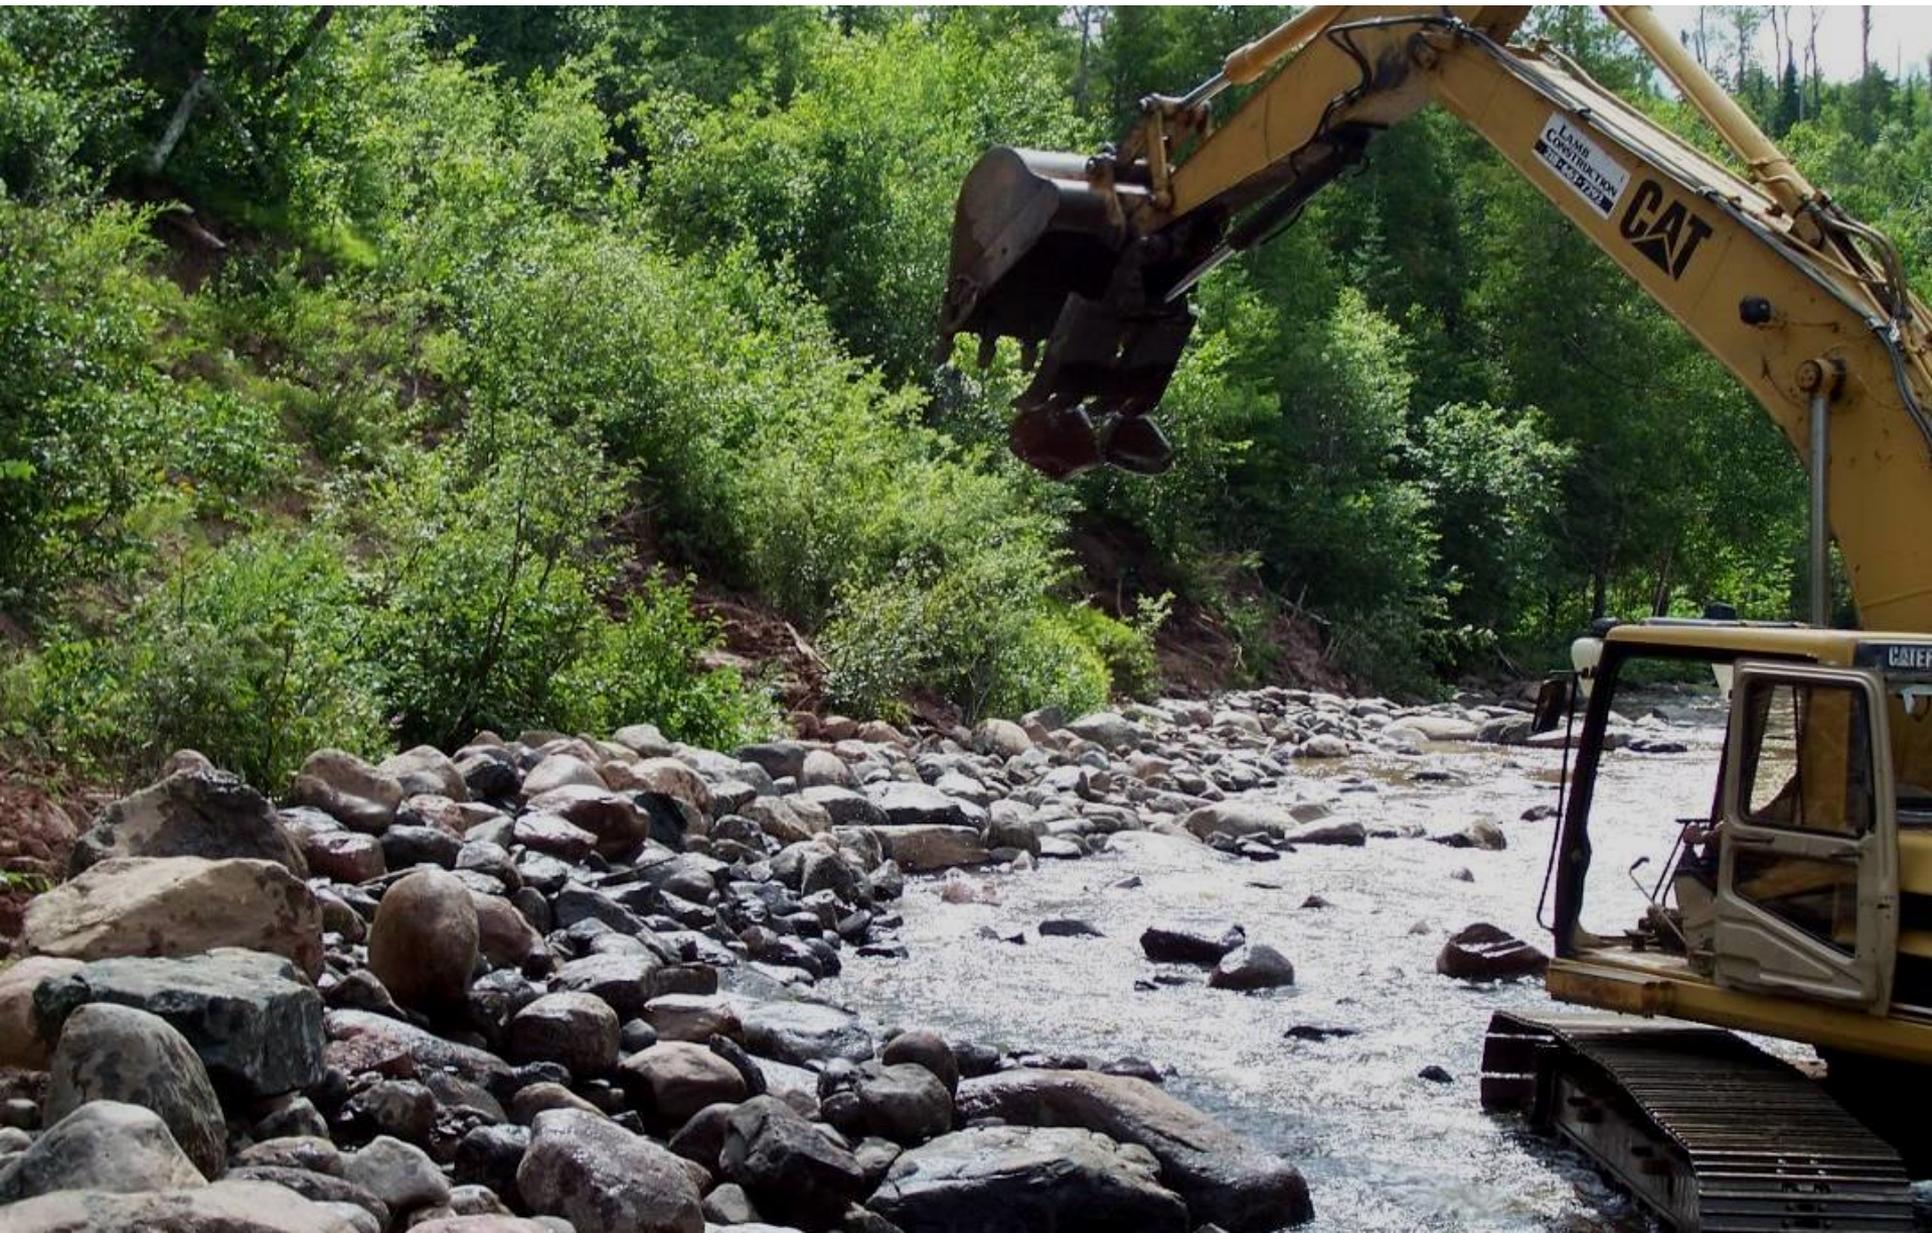
CONSTRUCTION – August 8, 2009

CONSTRUCTION – Random Boulder Field

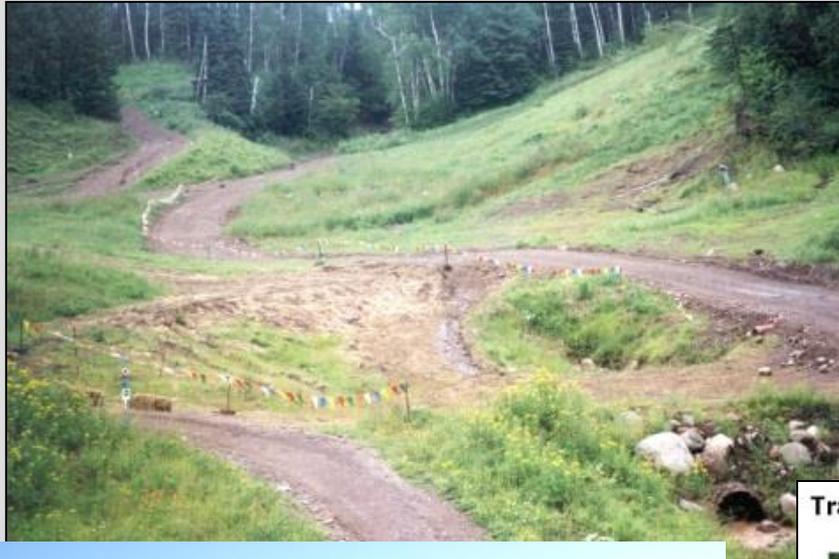
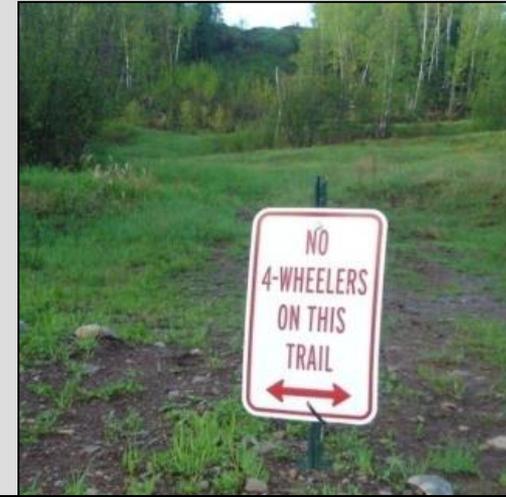
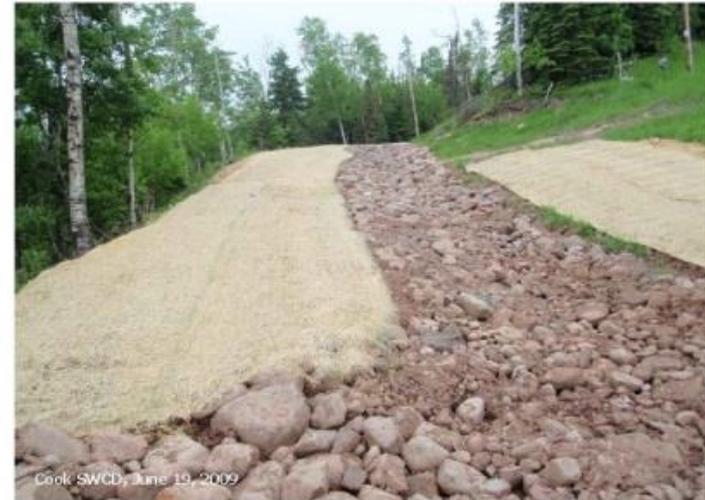
Cook SWCD, June 19, 2009

Trailside Ditch Stabilization, Riprap and Reseeding - After Ullr Mountain

A 500-foot section of the Ullr Mountain Trail was stabilized with riprap and reseeded.

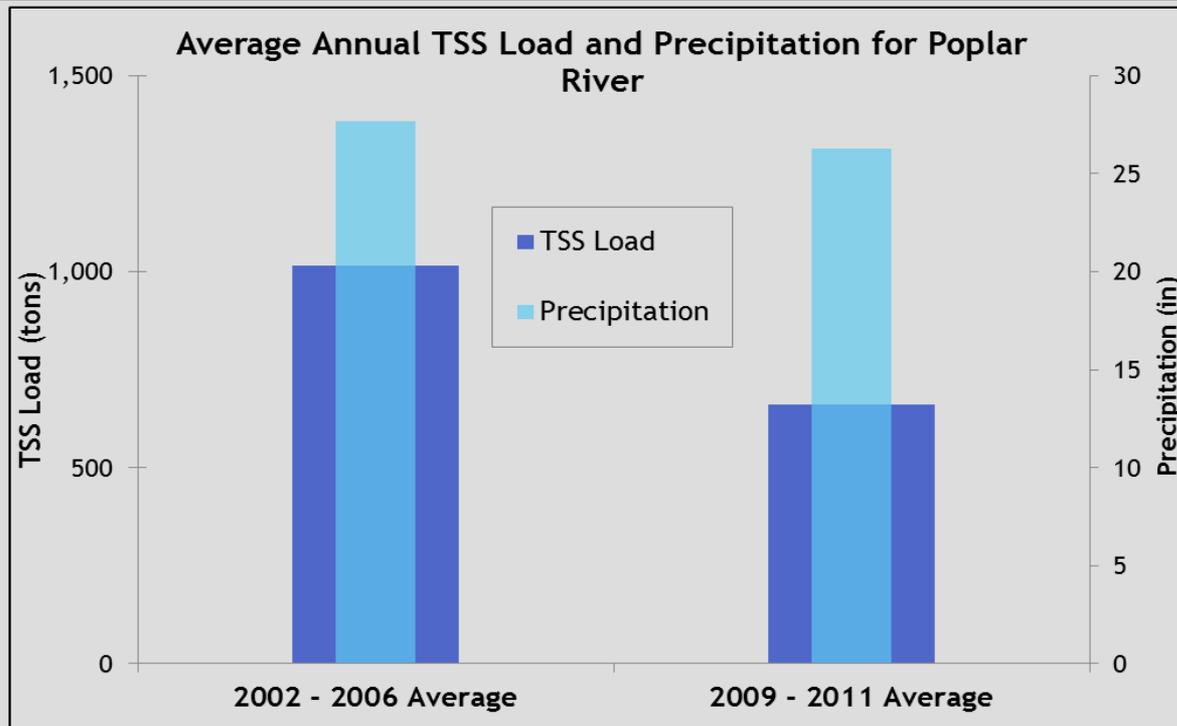
The calculated annual total suspended solids (TSS) loads are lower in recent years than in the first half of the decade.

- 2002 - 2006 about 1,000 tons per year average load
- 2009 - 2011 about 660 tons per year average load
- Suggests 35 percent decrease
- Average annual precipitation fairly similar (26.3 versus 27.7 inches).
- Expect continued decrease in sediment loading
