The Poplar River Story: Changing the Fate of One of Minnesota's Outstanding Natural Resources

2019 TRIECA Conference
Jay Michels, CPESC
Partner/Project Manager
Emmons & Olivier Resources, Inc.

March 21, 2019

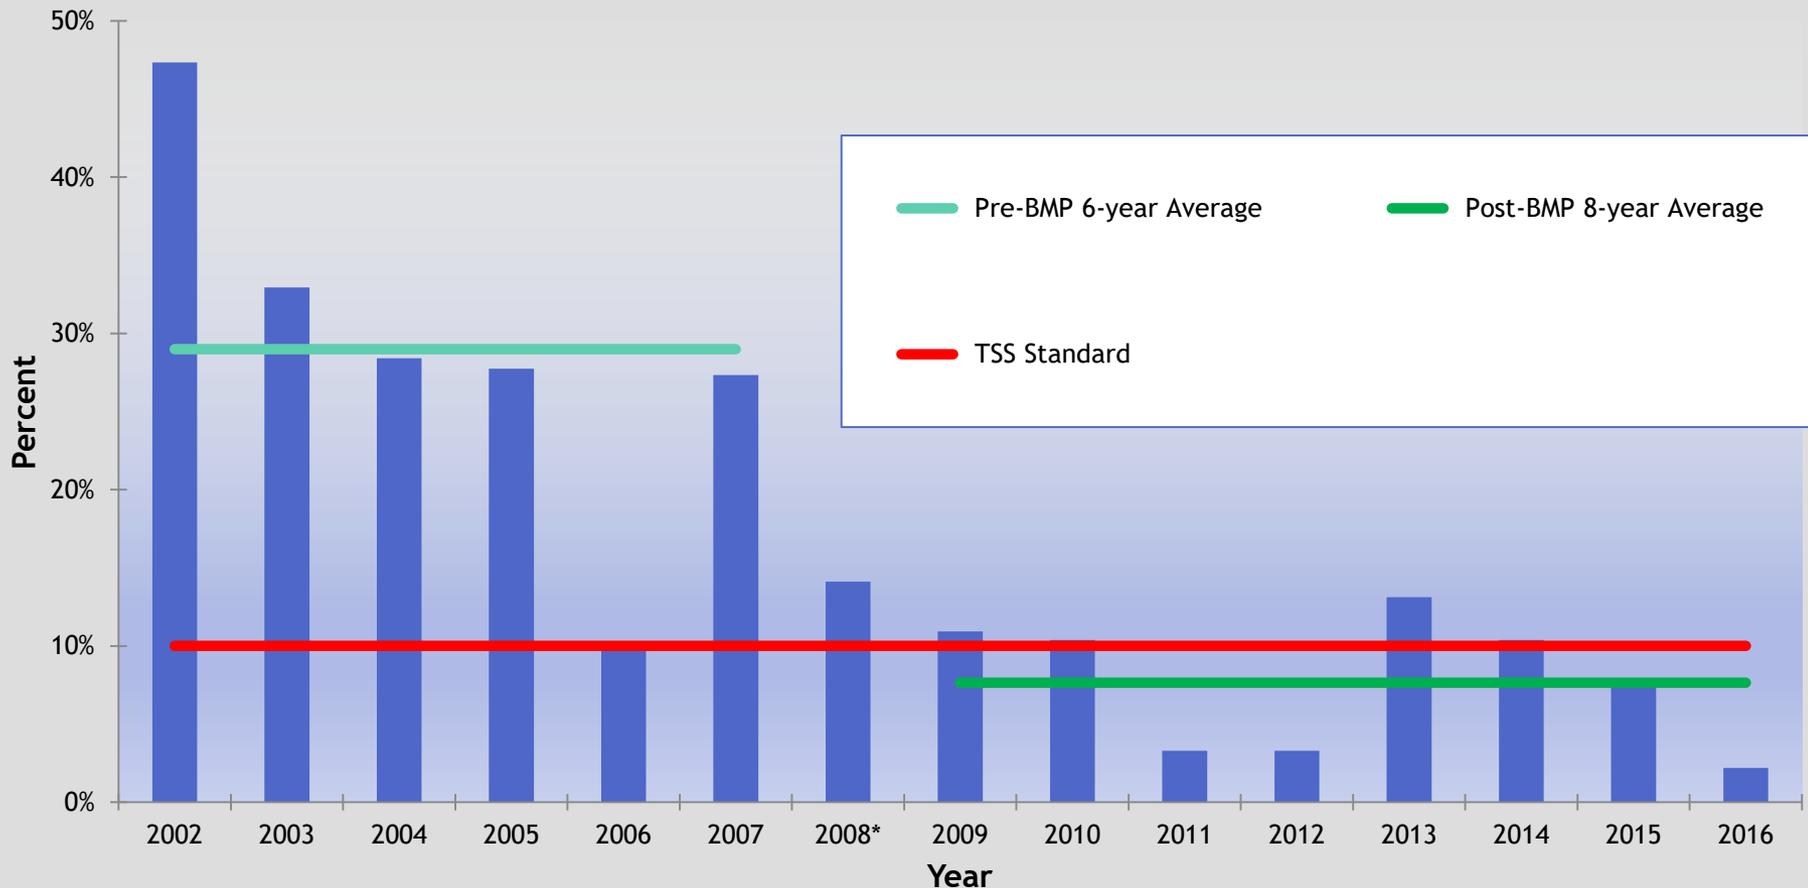
Poplar River Estimated Daily TSS Concentrations
April - September
Percent > 10 mg/L

*2008 is probably too small/low given that several events were missed.
