Green Rainwater Infrastructure: Long-term Management of the Full Urban Water Cycle March 22, 2023

Sophie Warren, P.Eng., Green Infrastructure Implementation

City of Vancouver Rain City Strategy (RCS)
Green Rainwater Infrastructure (GRI) Case Studies

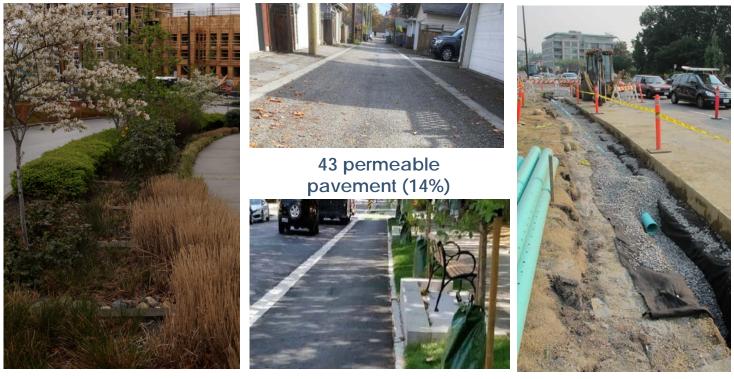
GRI Typologies in Vancouver

169 bioretention (54%)

26 Rainwater tree trenches (8%)

77 sub-surface infiltration (24%)

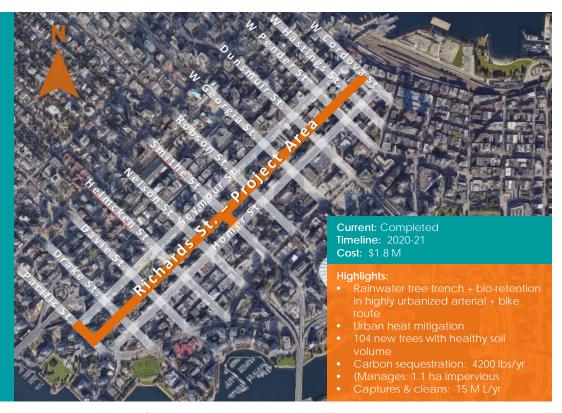
Richards Street Blue-Green System

Runoff diverted from sewers annually

15 million litres Runoff treated on-site annually

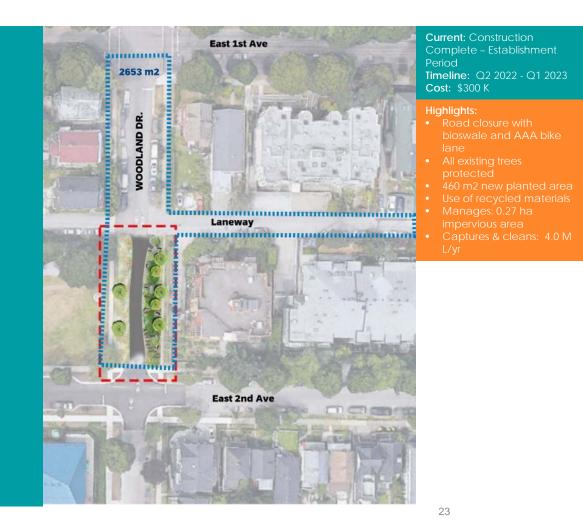
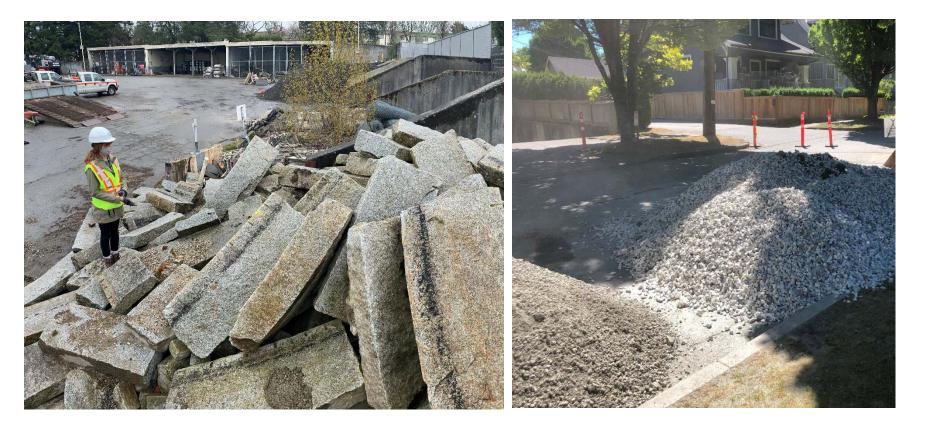
Woodland and 2nd Street Closure Bioswale

Subsurface Plan Scale: 1:75
