Balancing Act – Watercourse Restoration Beside a Closed Landfill

German Mills Creek – City of Markham

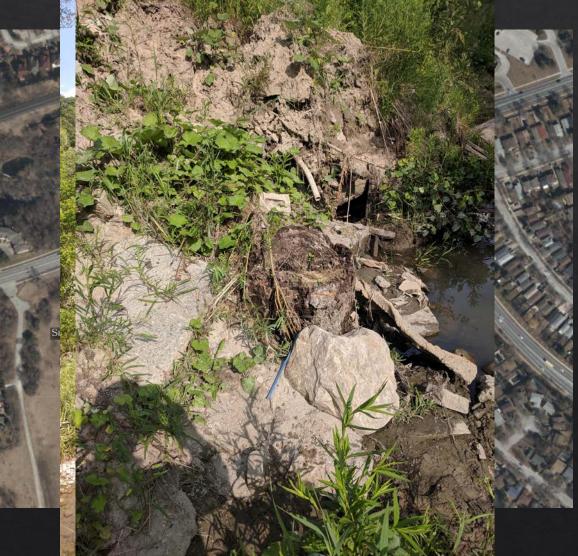
The Problem

- The site was located on German Mills
 Creek within German Mills Park which is highly utilized for passive recreation
- Watercourse erosion and slope failure +/ 5m high, 1:1 or steeper
- ♦ Located adjacent to closed Sabiston landfill
- Concern that erosion would encroach into waste, resulting in exposure to the watercourse
- Due to this concern, site was identified as higher priority and advanced for construction in 2020

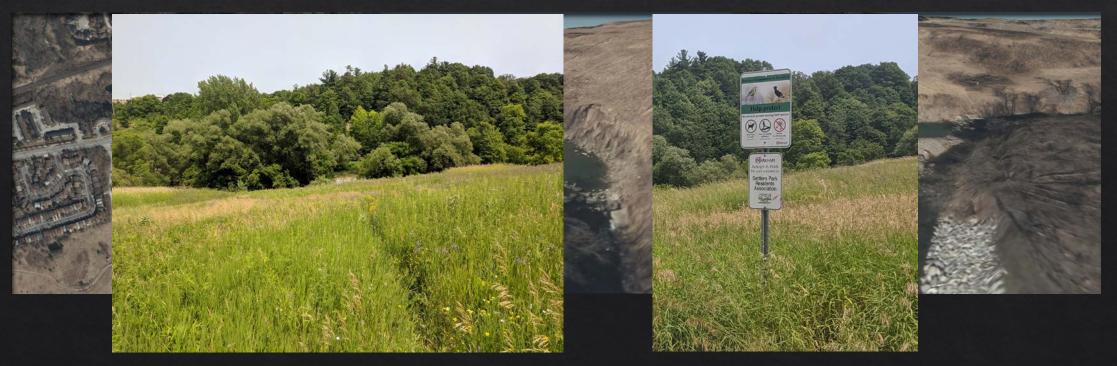
The Site

Surface of former landfill has been naturalized with native grass plantings, resulting in nesting habitat for Eastern Meadowlark, listed as an endangered species

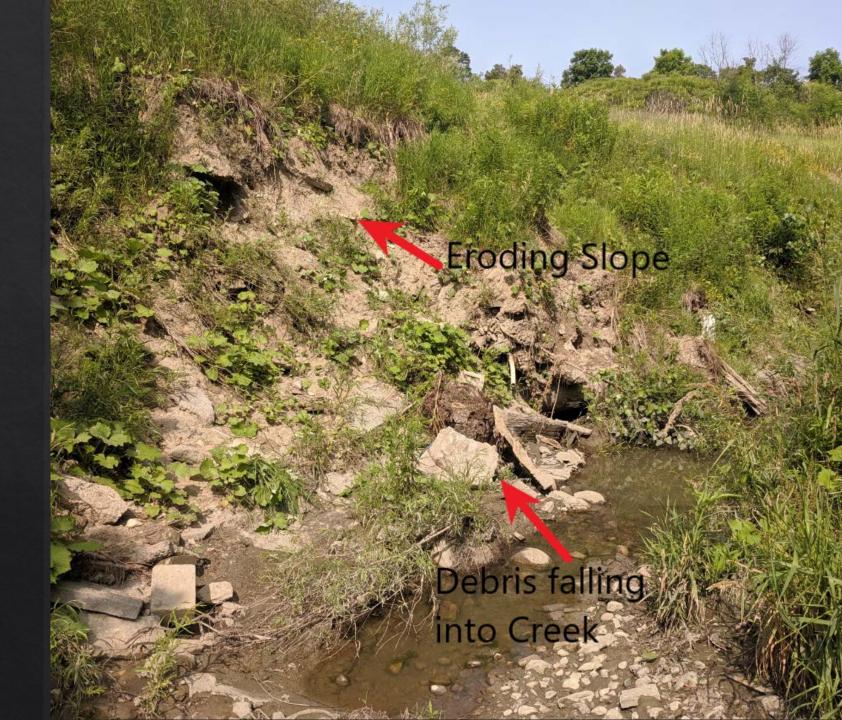
Site Specific Considerations

- German Mills Creek is a high energy, flashy system in a highly developed watershed
- Slopes at the site were quite steep (1:1 H:V), high (5 m) and actively eroding
- Site investigations showed that waste was being exposed. Testing indicated that soils adjacent to the slope were impacted
- Species at risk were identified in the project area

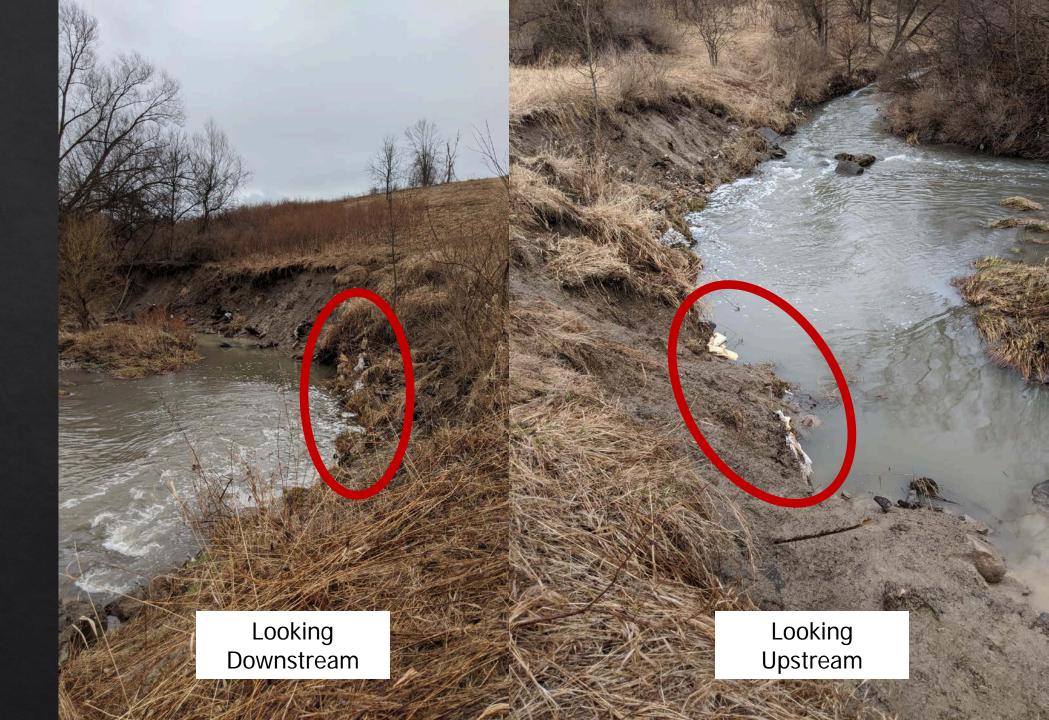
Pre-construction March 2020

Continued erosion and waste becoming exposed
