SOURCE TO STREAM

2024 Conference

Bats, Bats, and More Bats!

Stream Restoration and SWM Pond Rehabilitation Works under a
Species-at-Risk Overall Benefit Permit

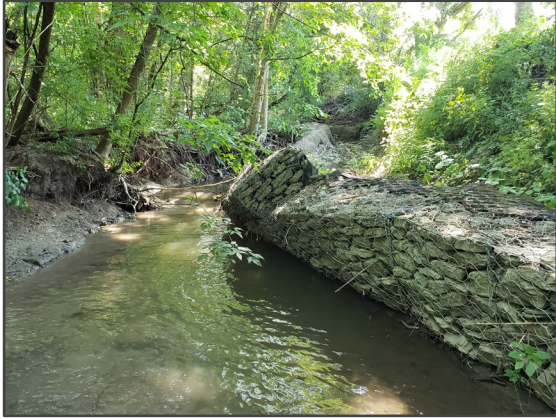
Slumping Failure Of Gabion Baskets

- Numerous degraded and failed erosion control structures
- Accumulation of sediment within culvert, restricting flow conveyance
- Highly degraded stormwater management pond filled with sediment and vegetation
- Hanging corrugated metal pipe pond outlet culvert

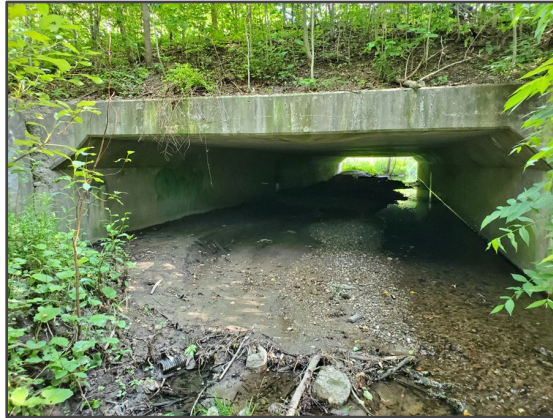
Accumulation of Sediment in Culvert

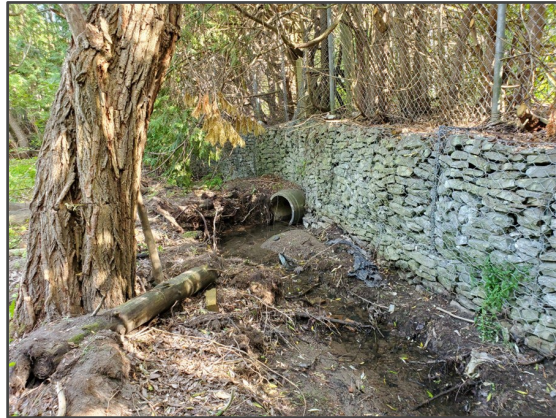
Sediment Laden Pond

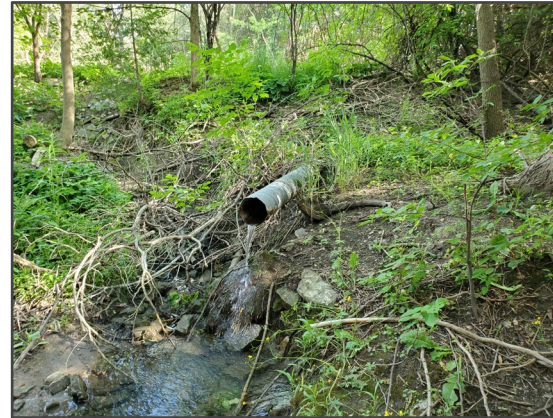
Hanging Pond Outlet Culvert

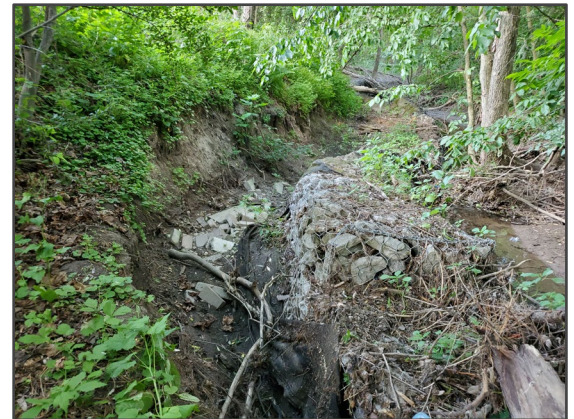
Flow Restriction Posed by Failed Gabion Baskets

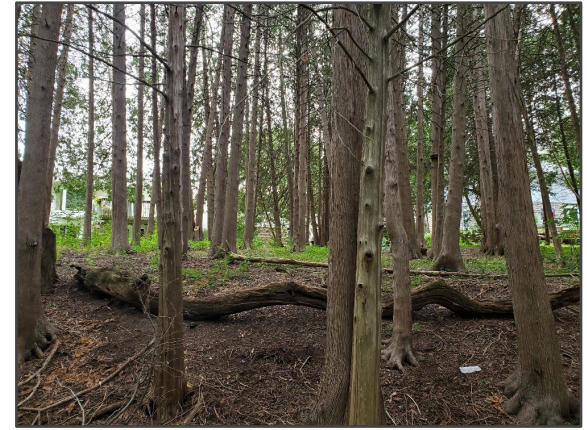
**Acoustic Monitoring Set-Up Location
Near Channel**

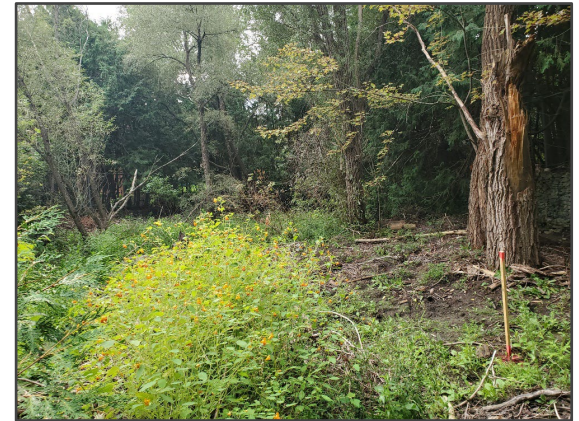
**Acoustic Monitoring Set-Up Location
within Existing Pond**

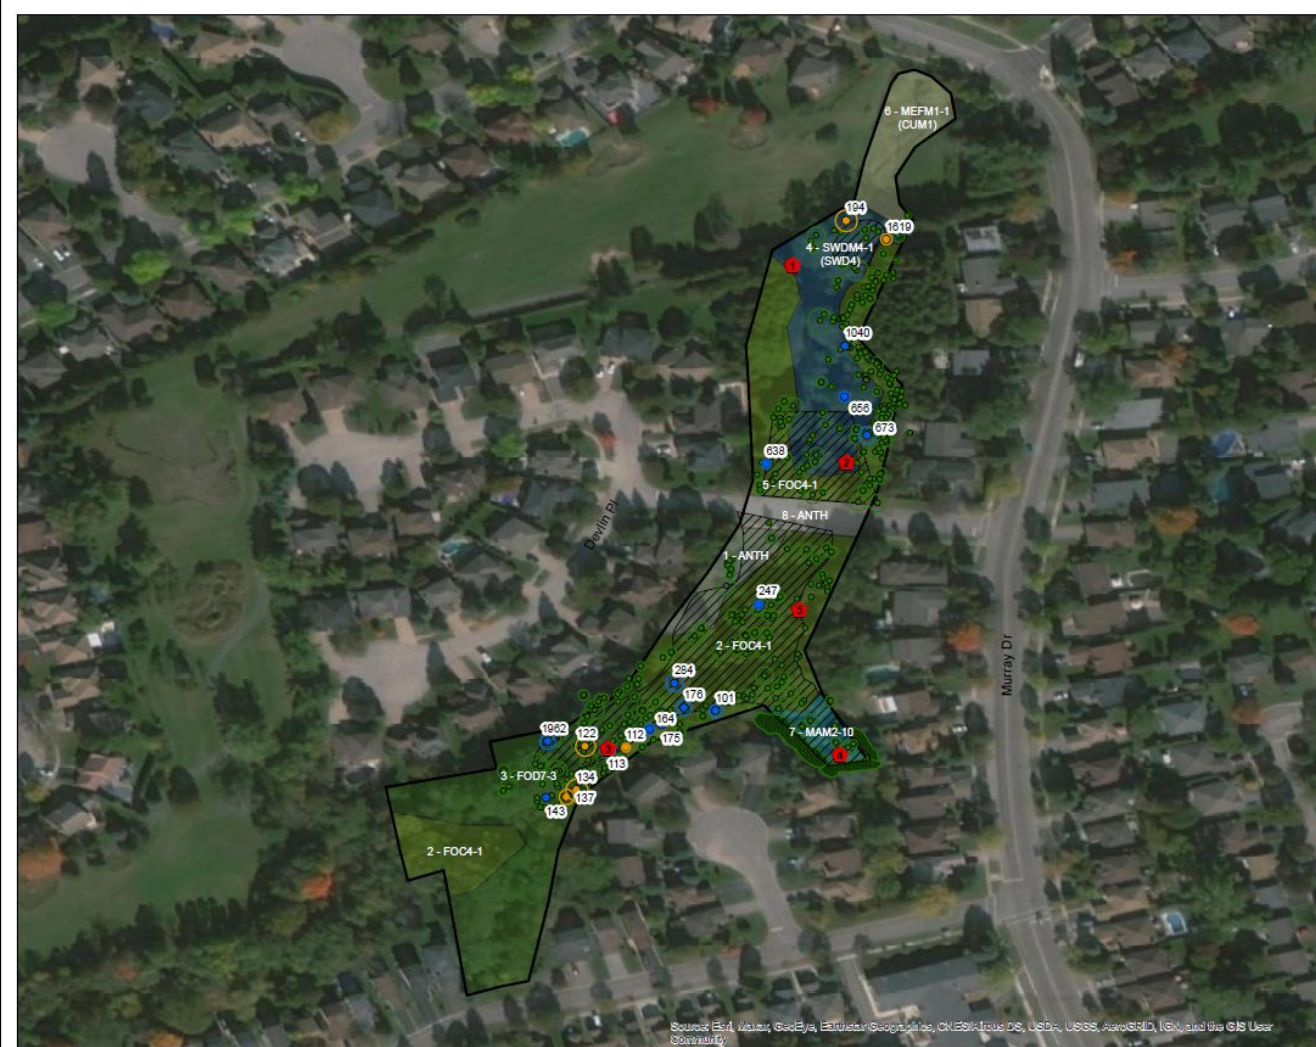
Figure 1
Species at Risk Bat Habitat Assessment

Acoustic Monitoring Station Locations

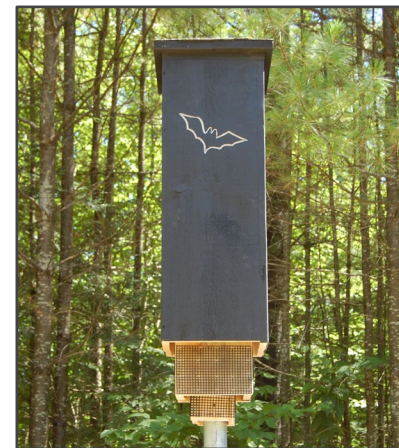
Typical Bat Rocket Box

- **Annual** maintenance / replacement of each bat box prior to the start of the active bat season
- **Two (x2)** inspections **per year**, including collection and laboratory testing of guano from below each bat box to confirm bat genus
- **Annual** inspection of tree and shrub health with a minimum survivorship of 80%
- **Annual** monitoring reports summarizing the findings of the monitoring activities

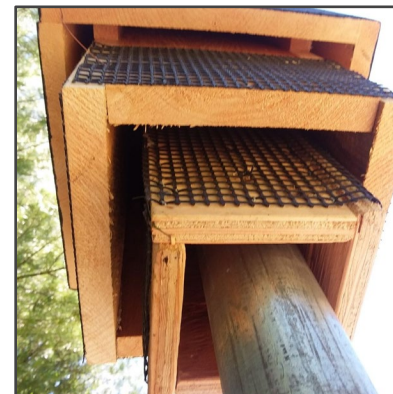
Separate Chambers within Typical Bat Rocket Box
