# City of Toronto

# Crawford Lane LID Pilot

Presented by: Abe Mouaket, Ph.D., P. Eng., Transportation Services Division

2024 Source to Stream Conference

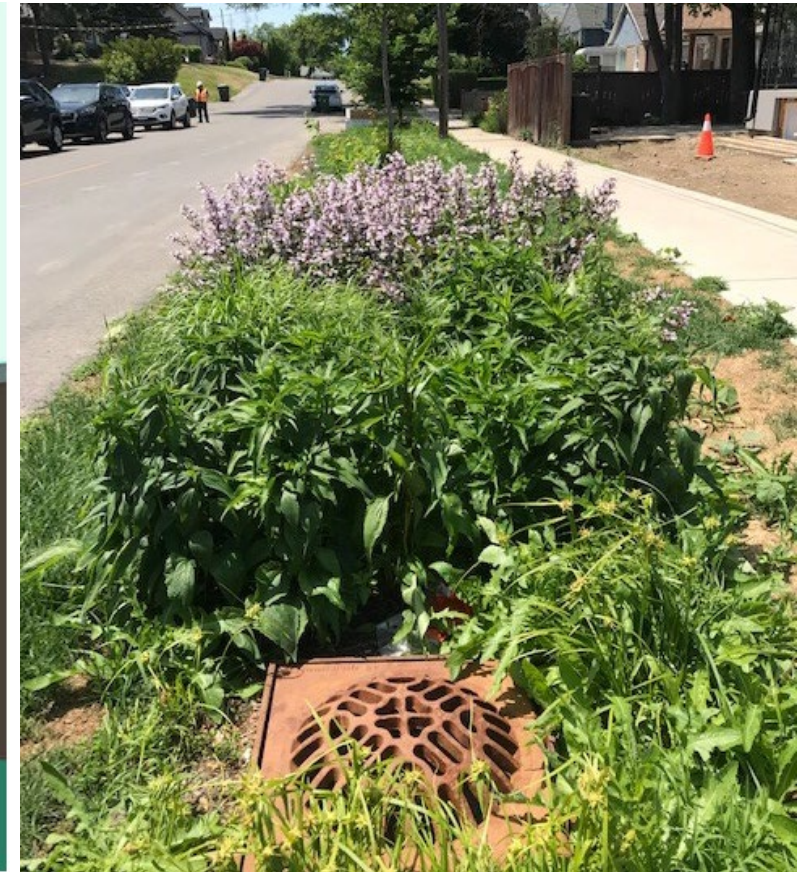
**Green Infrastructure: Bioswale**  
Location: Byng Avenue, Etobicoke

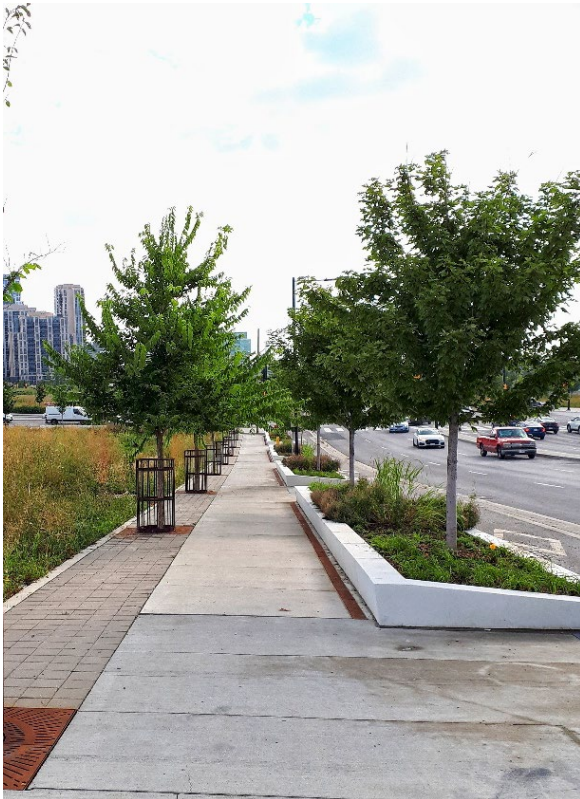
Stormwater Treen Trench: Six Points

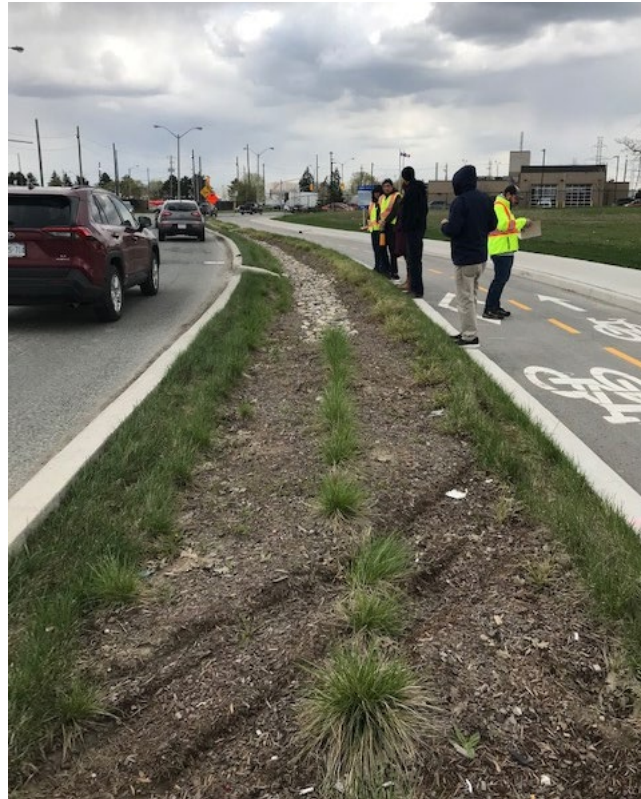
Green Gutter: Murray Ross Pkwy

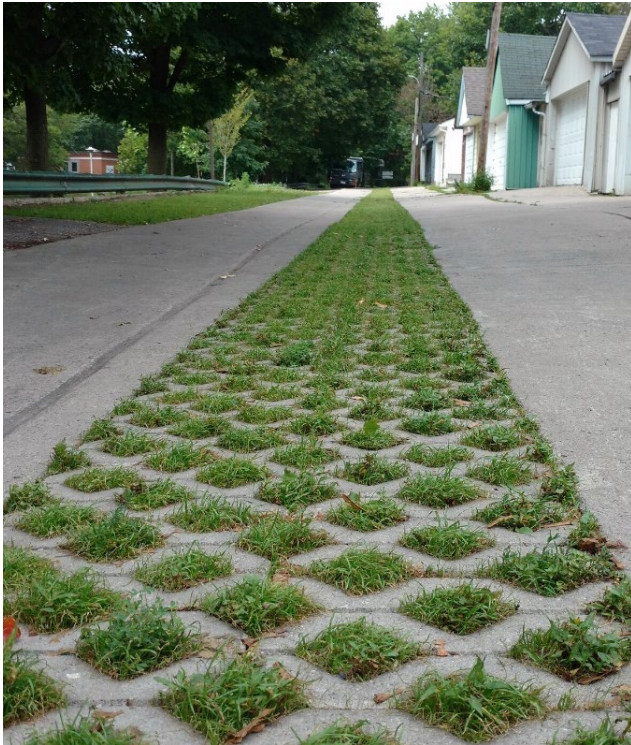
Laneway Punctures

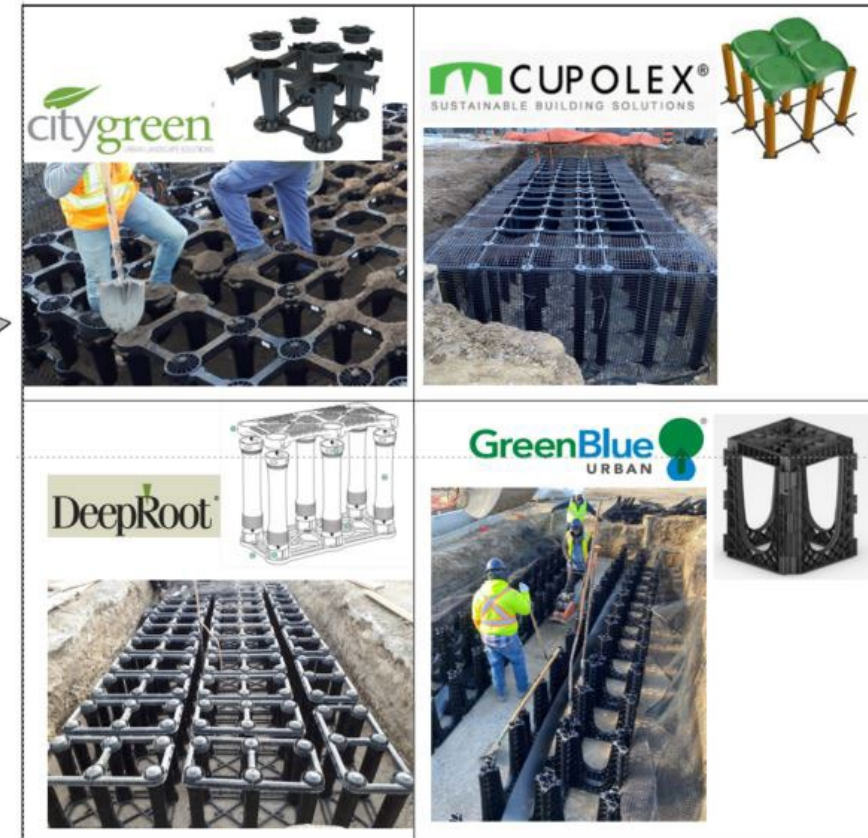
Soil Cell Evaluation

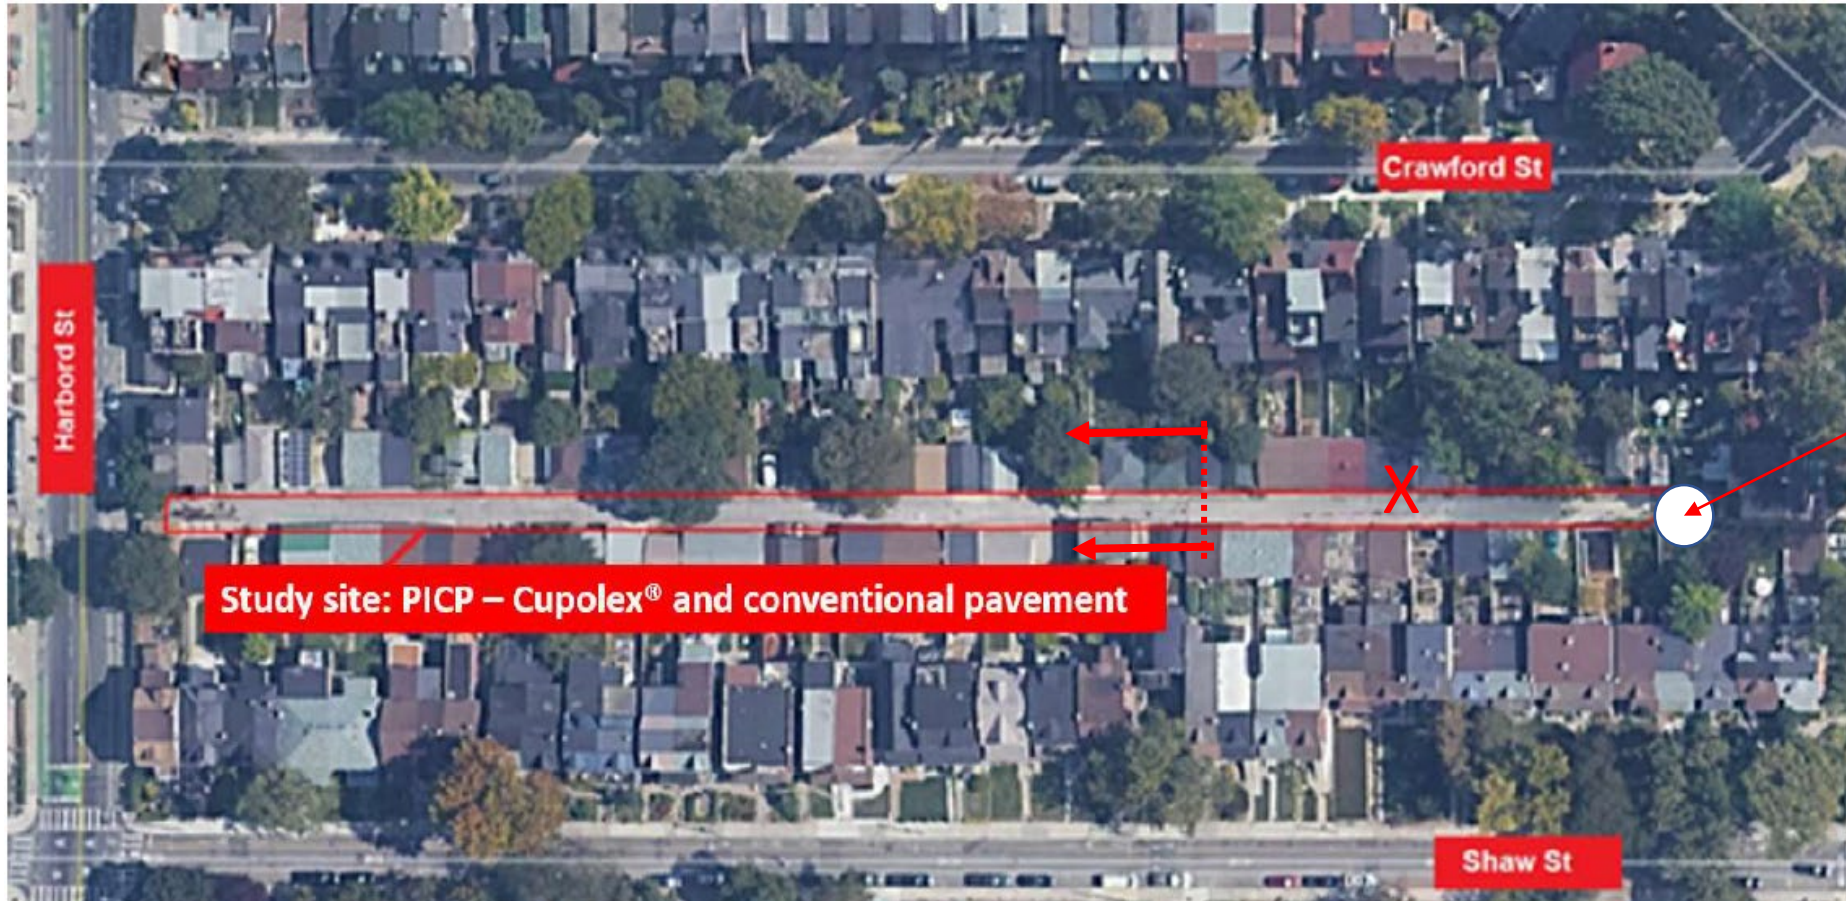
Rain Gauge

253 m long → 3 sections, each about 84 m long

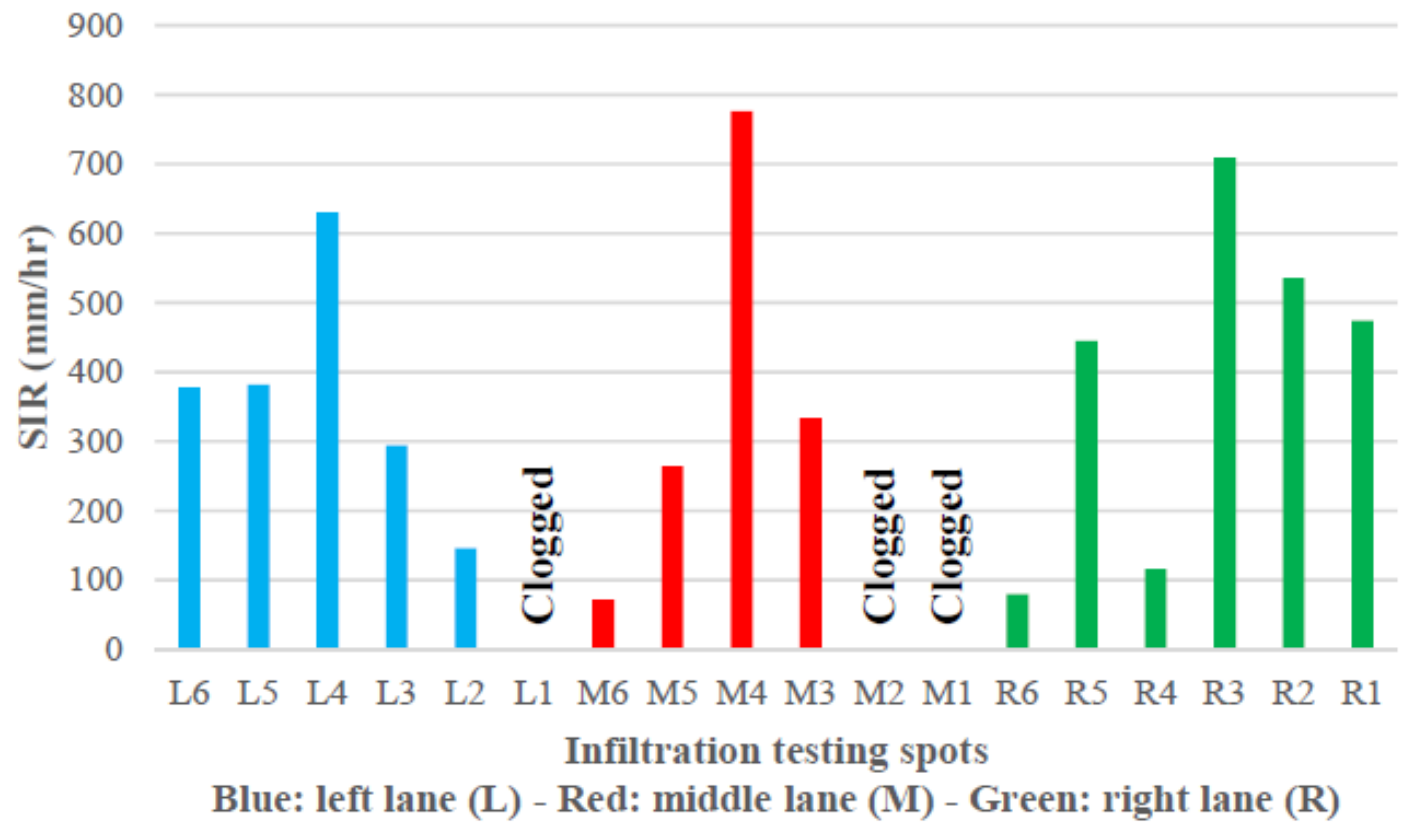
Figure 15: SIRs for the selected PICP spots

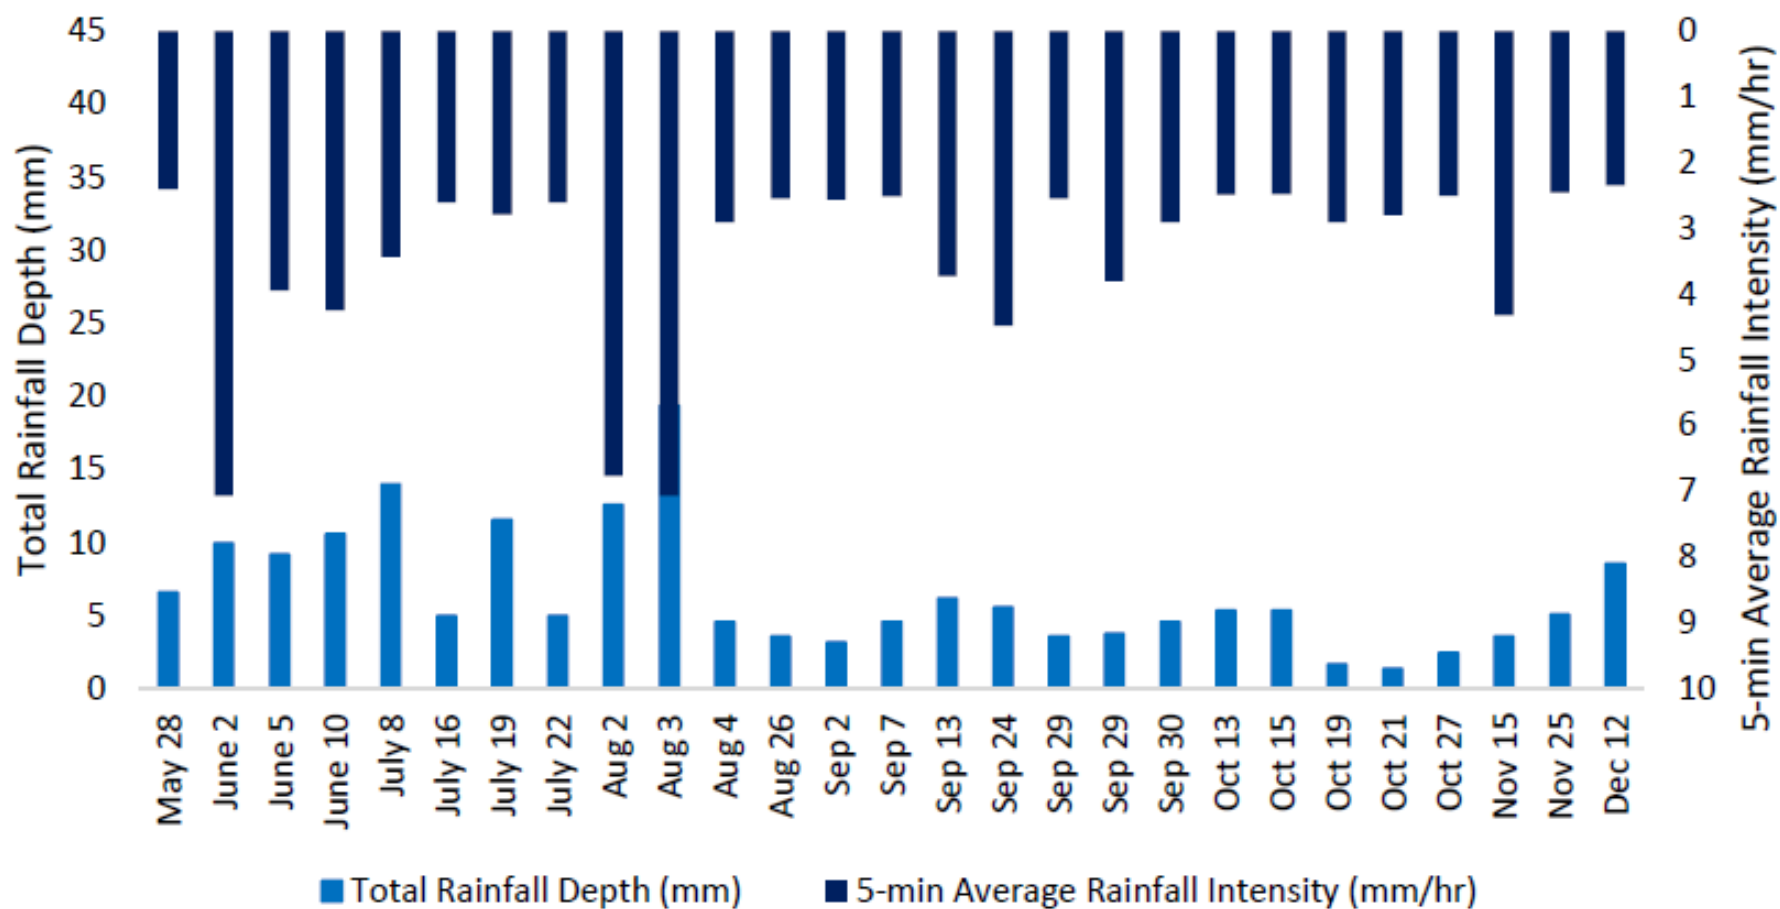
Figure 5: Total depth and 5-min average intensity for the recorded rainfall events in 2020

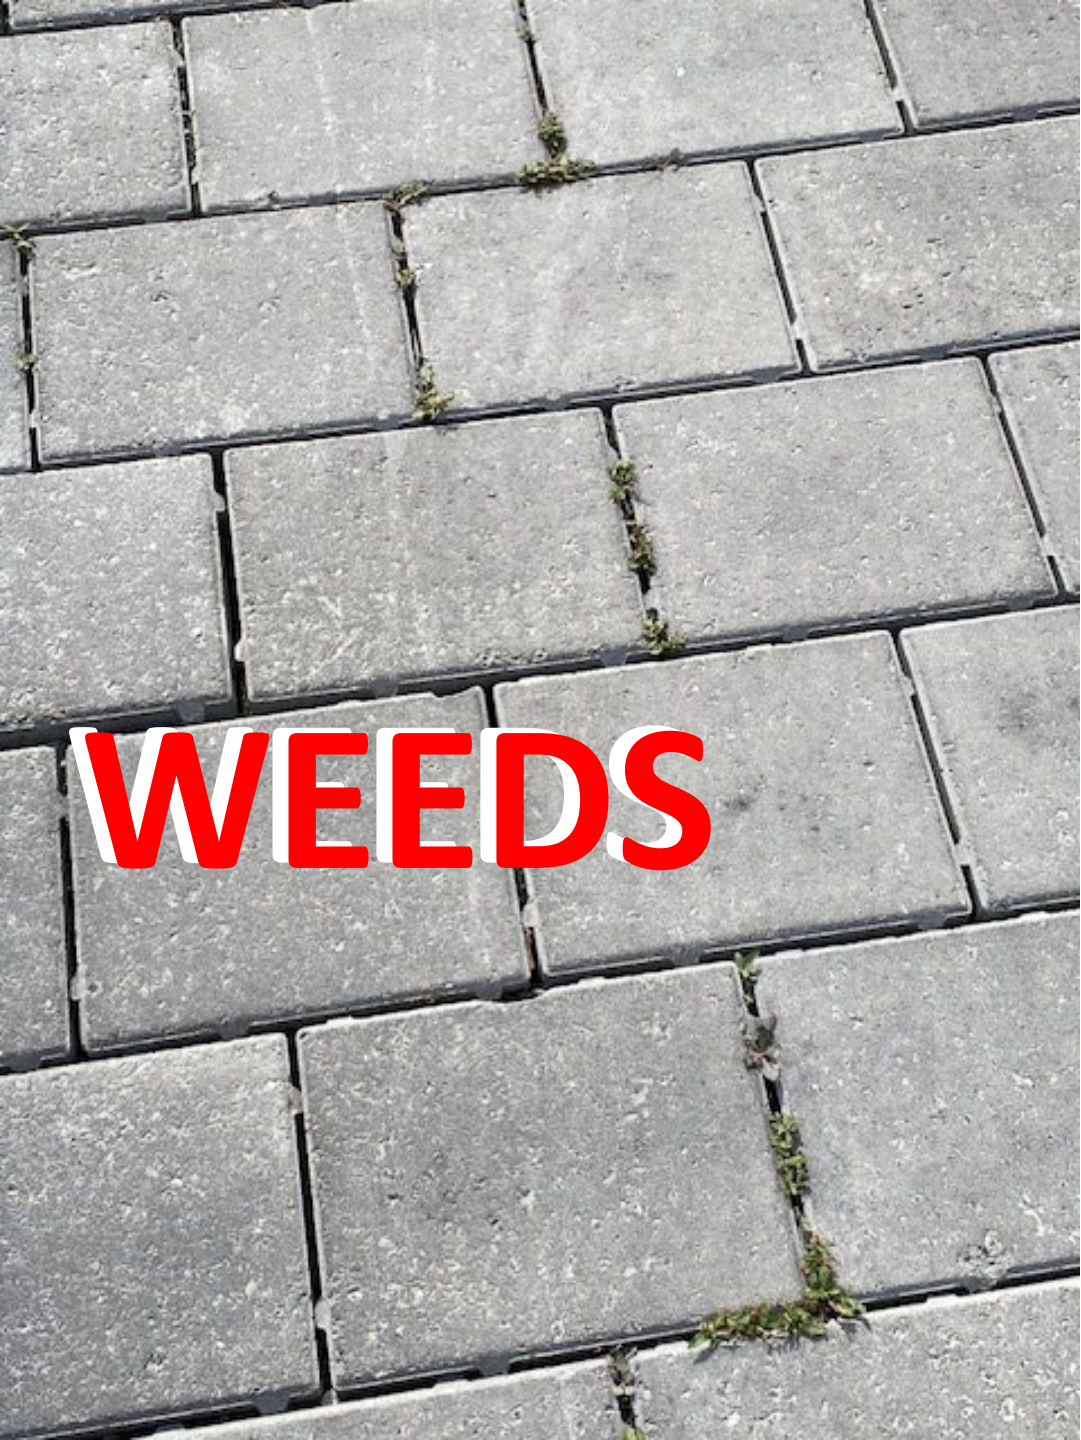
**WEEDS**

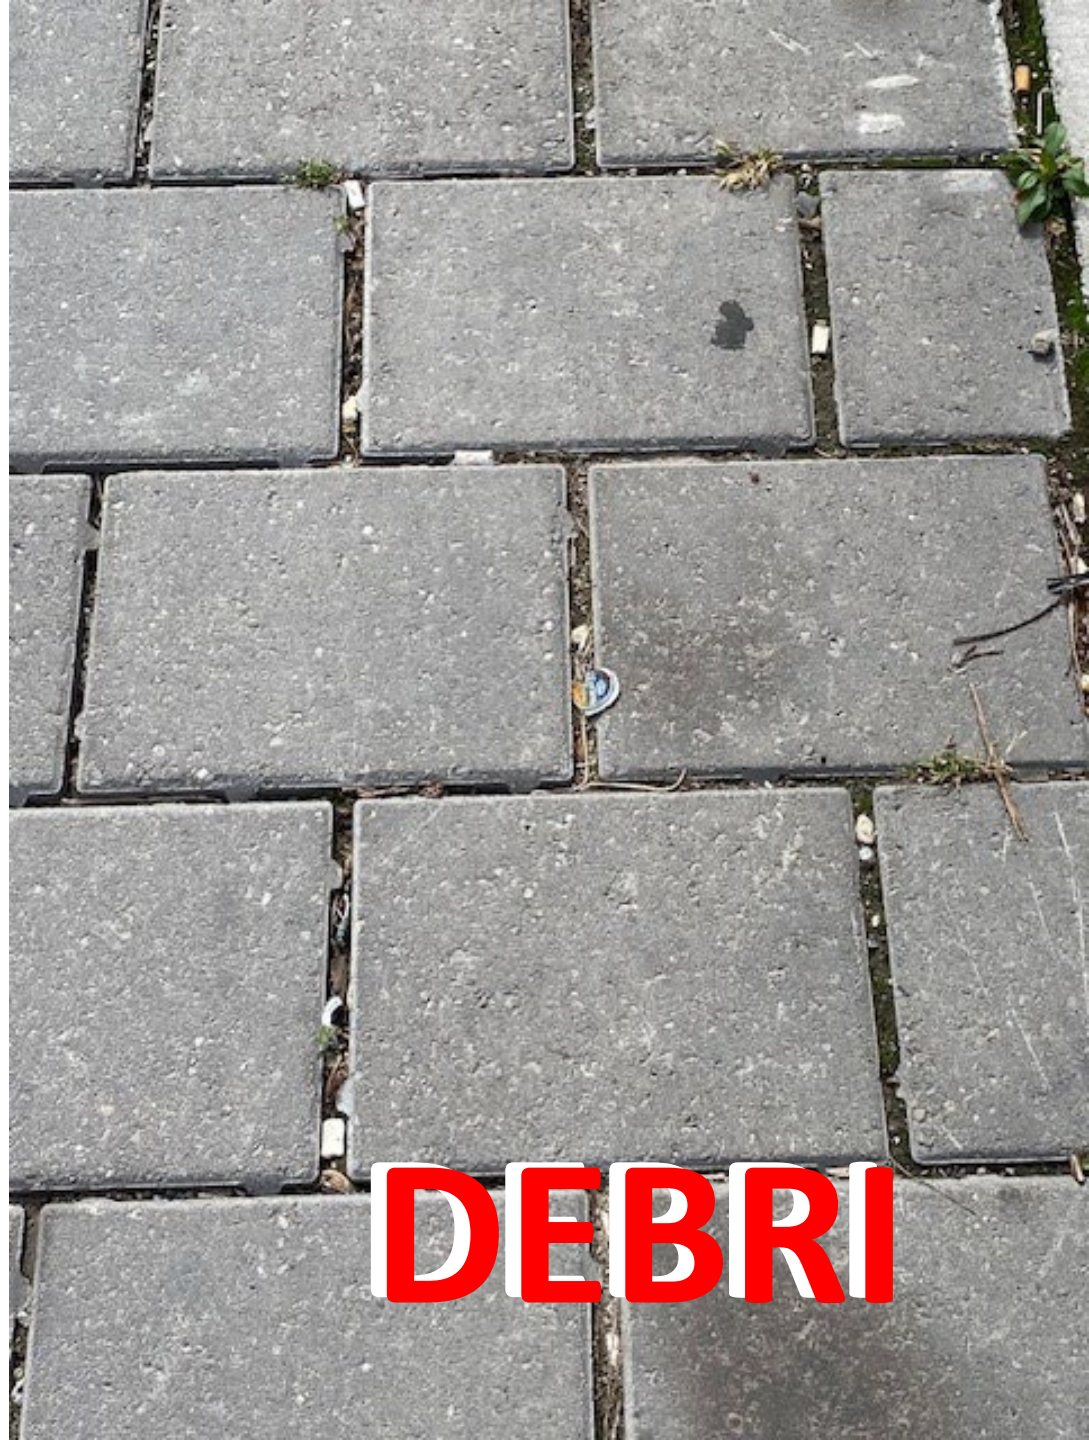
**DEBRI**

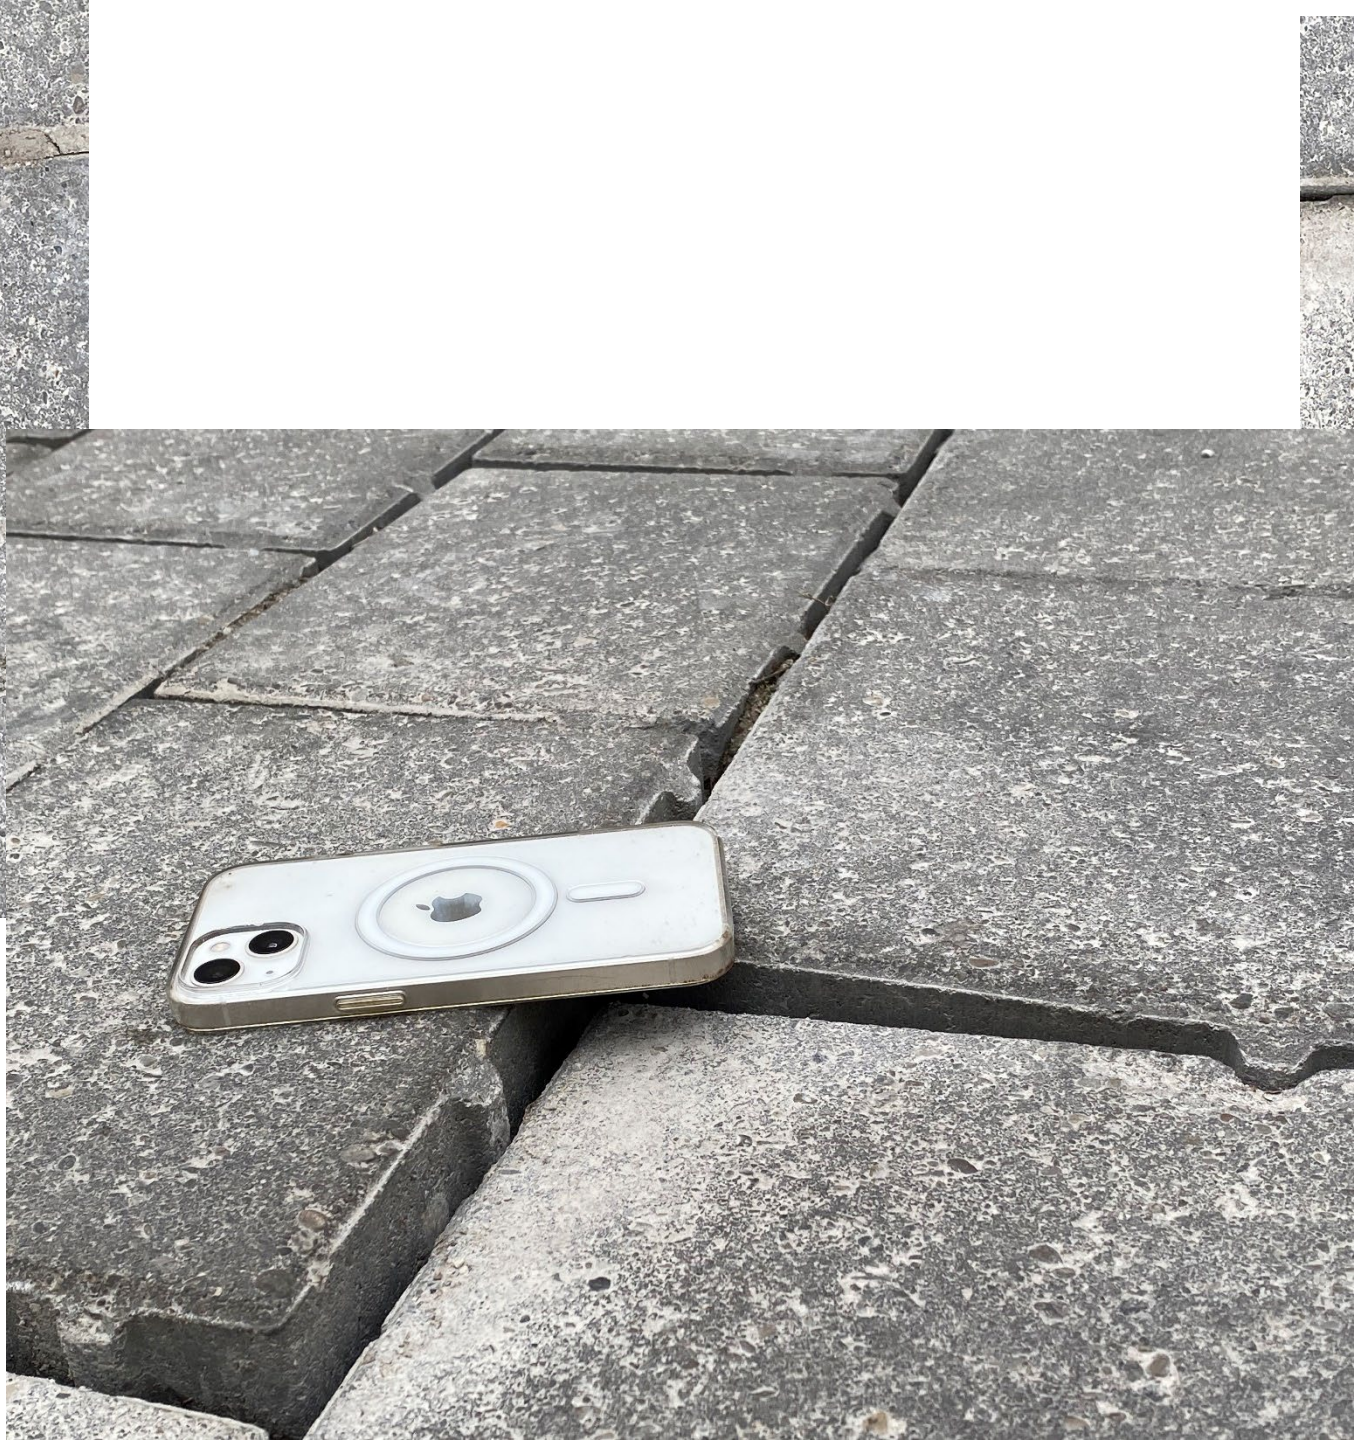
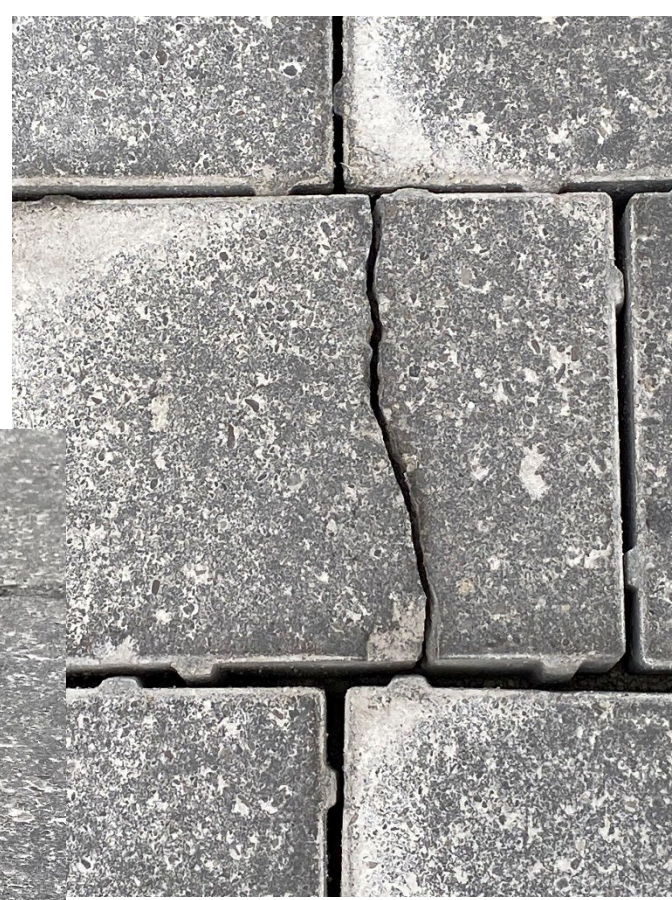
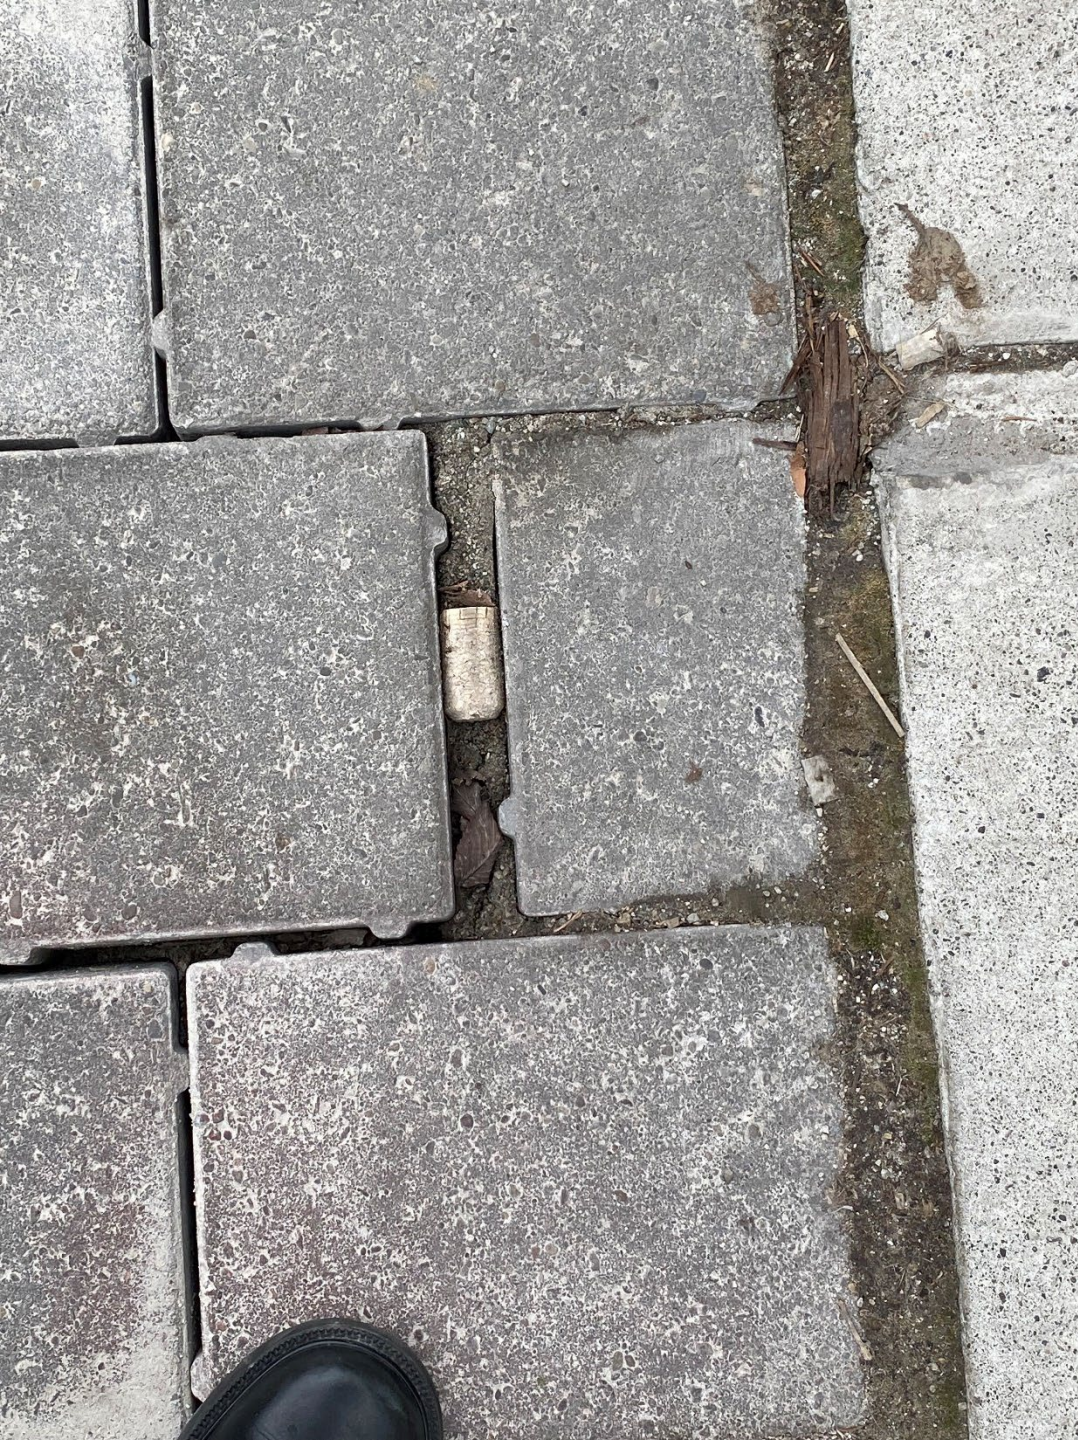
3. **PICP pavement** condition was disappointing, although City maintenance have cleaned it recently. I did not see much debris in the cracks but there are many other problems, and some affected areas are fairly sizeable. Here are the observed distresses:
  - a. The seams between the tiles has expanded to 1” in some cases.
  - b. Some tiles have lost their support and are rocking.
  - c. Some tiles have a differential settlement of 1” or greater.
  - d. One or two tiles have cracked in the middle

**Separation**

**Erosion of filtering sand**

**Mud replacement**
