SUCCESSES AND LESSONS LEARNED FROM 5 YEARS OF MONITORING RIVERBANK BIOENGINEERING PROJECTS IN CALGARY

SOURCE TO STREAM CONFERENCE

MIKE GALLANT, MSCE, P.ENG., CPESC

March 27, 2024

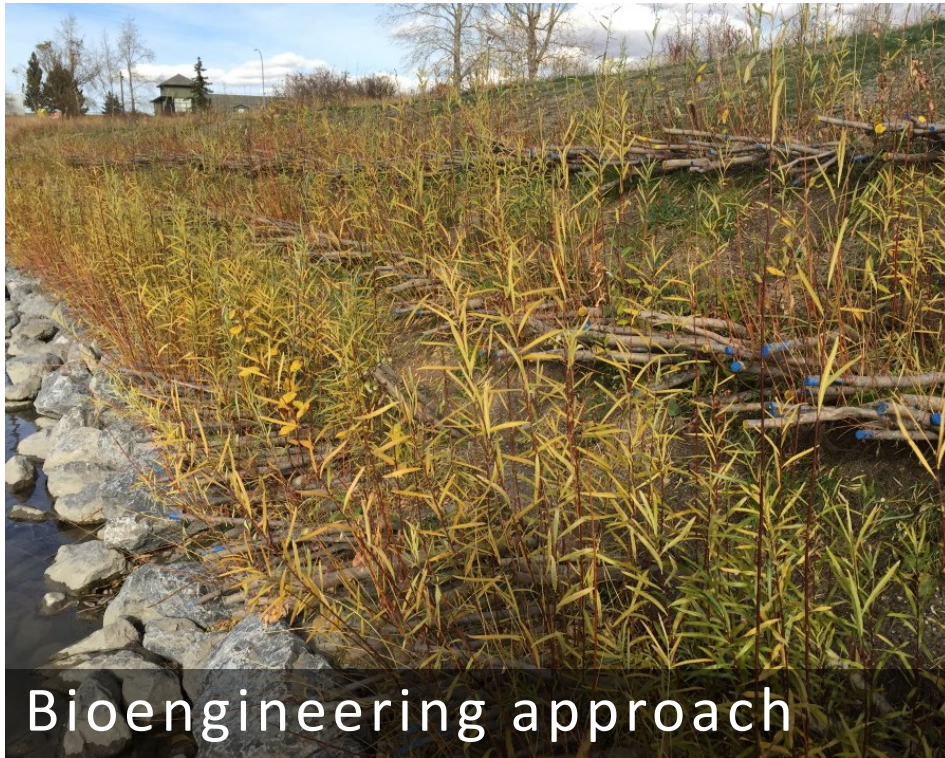
*Soil and water bioengineering is the use of living plant materials to perform some engineering function, usually **slope stabilization, erosion reduction, and vegetation establishment.***

Bioengineering approach

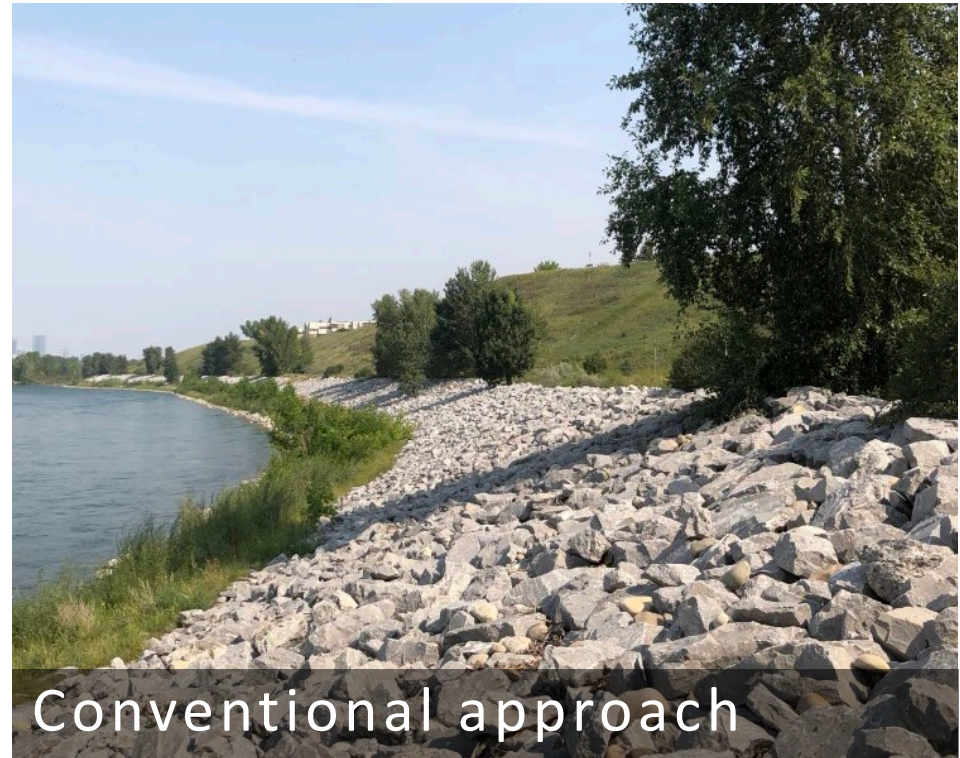
Conventional approach

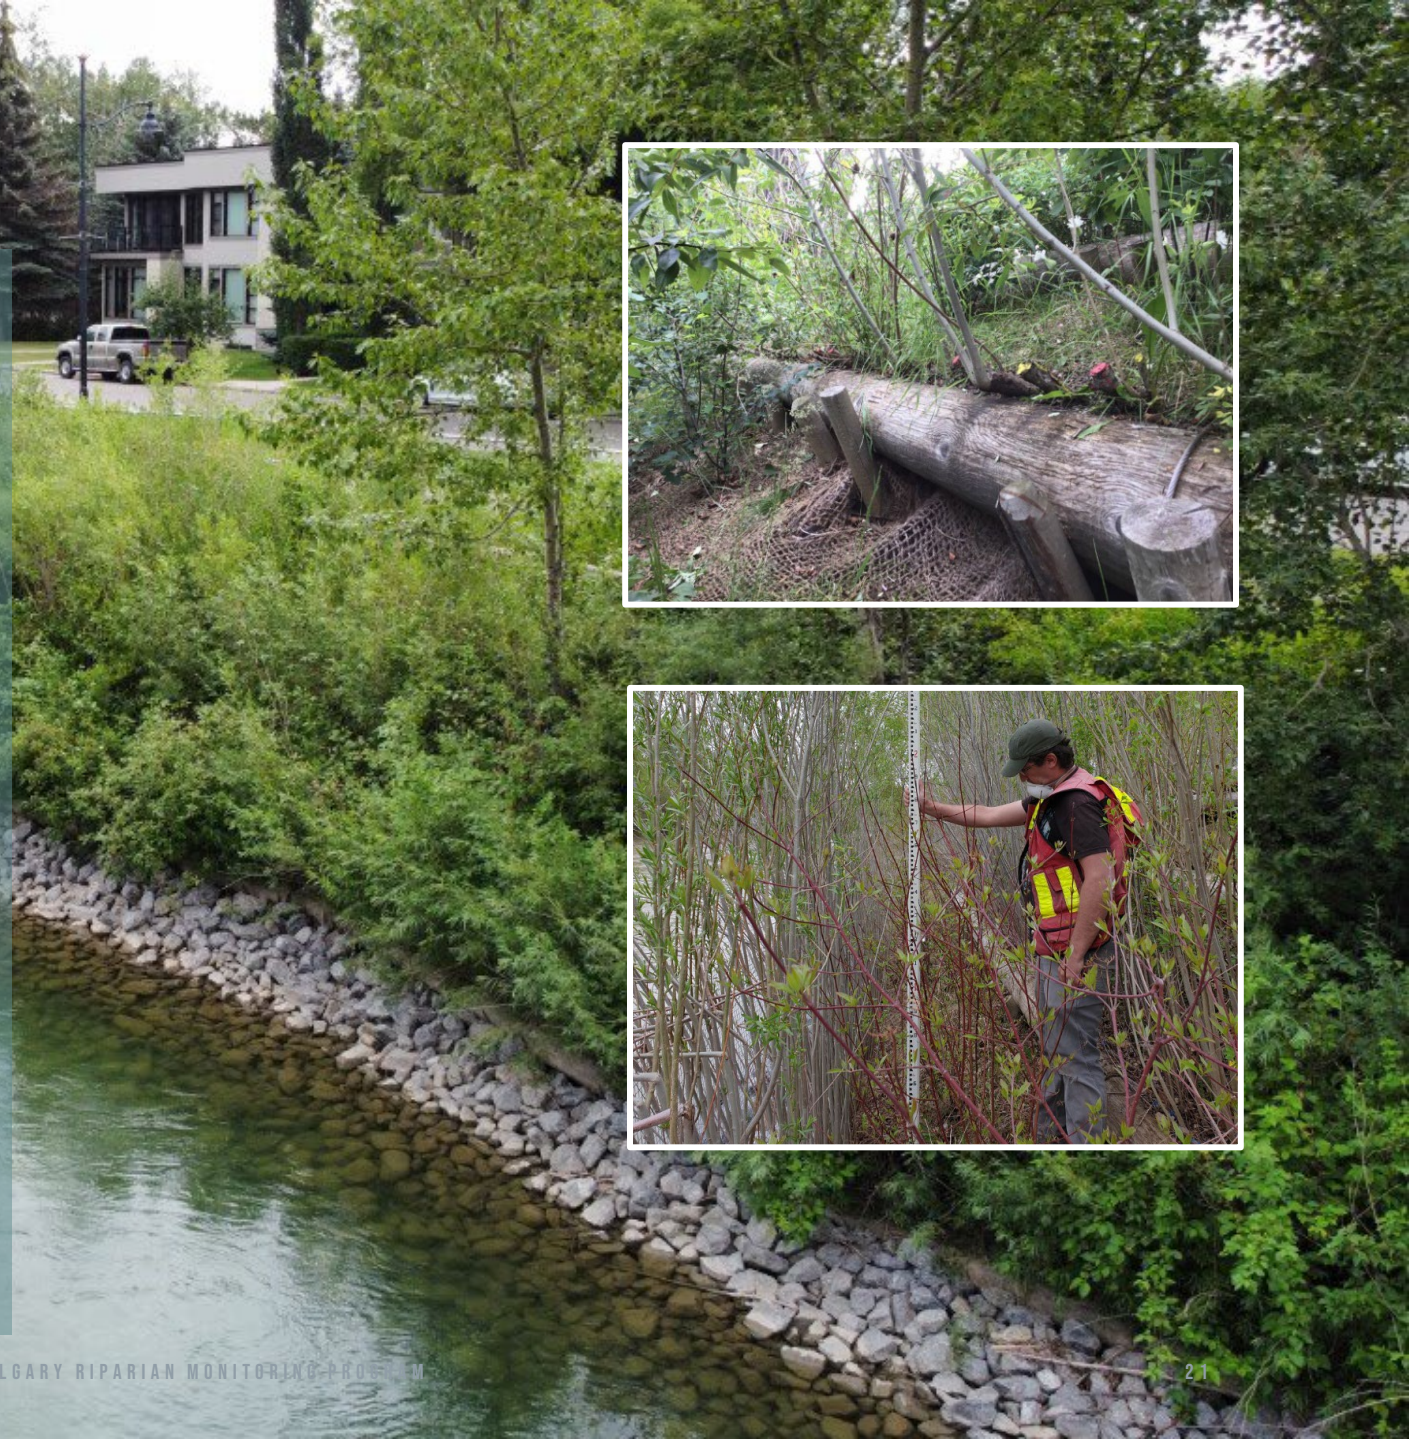
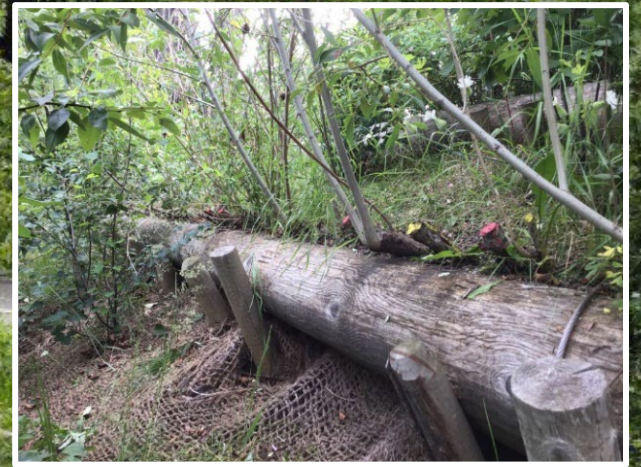
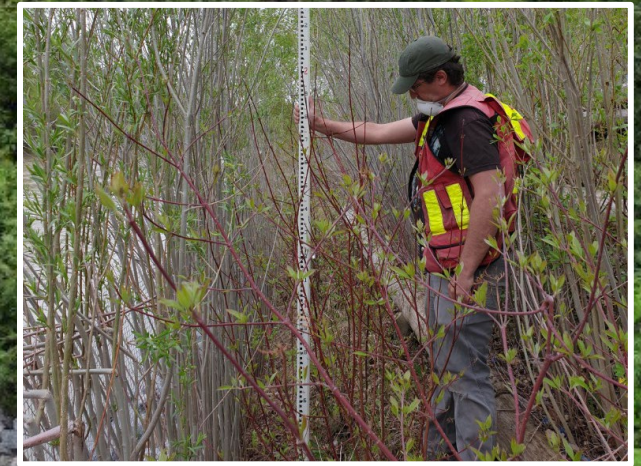
HIGHEST RATED SITE

RIVERDALE AVENUE RETAINING WALL REPLACEMENT PHASE 2 - DOWNSTREAM

LIVE GRATING WITH BRUSH LAYERS AND ROCK TOE

EXCELLENT ESTABLISHMENT OF DEEPLY ROOTED CUTTINGS

OVERALL SCORE 92/100

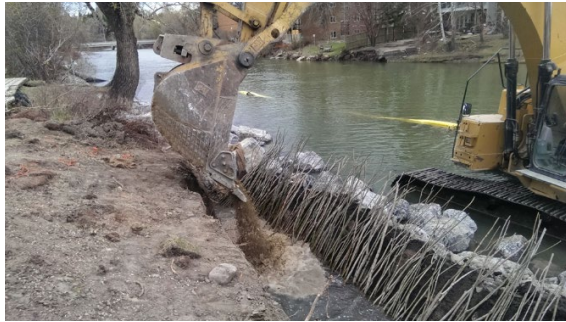
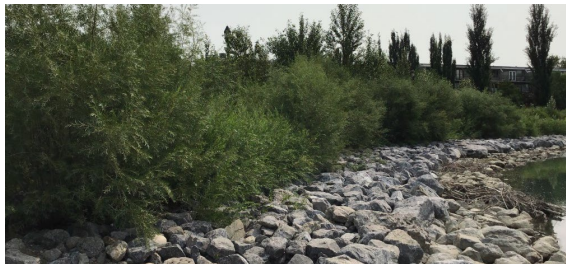
**DEEP CUTTINGS &
GOOD ACCESS TO SOIL
MOISTURE**

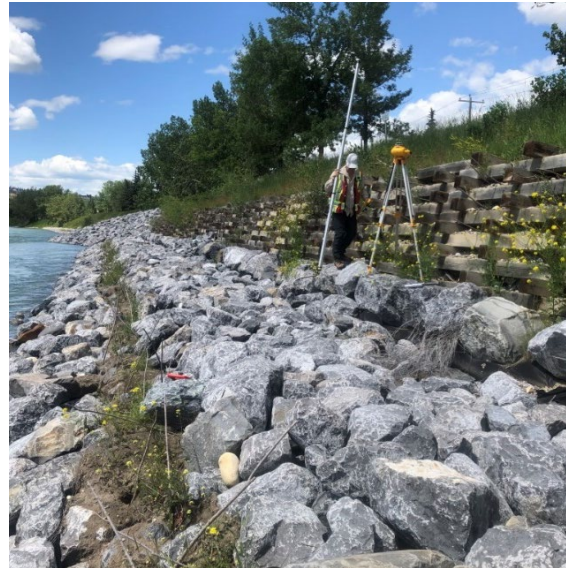
**HOT AND DRY
ASPECTS**

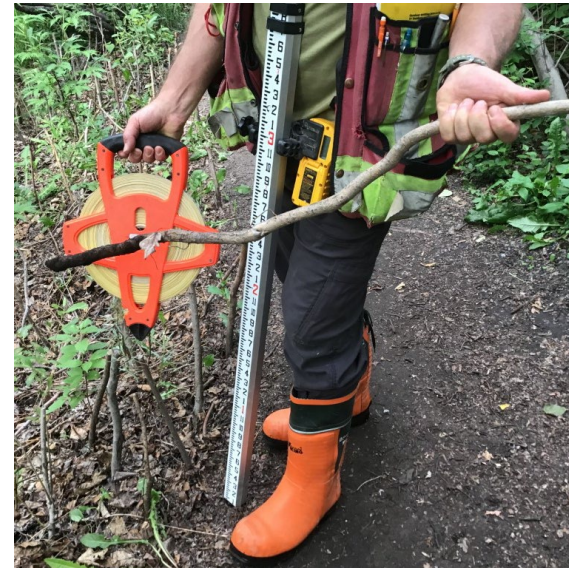
**SHALLOW &
ANAEROBIC SOILS**

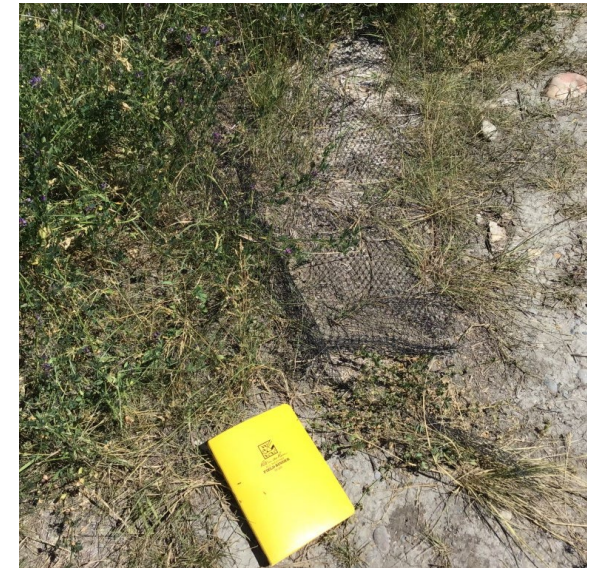
SOIL COMPACTION

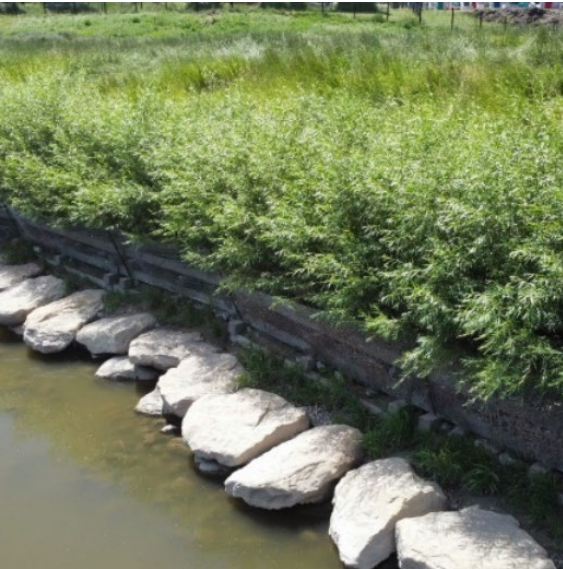
TOE PROTECTION

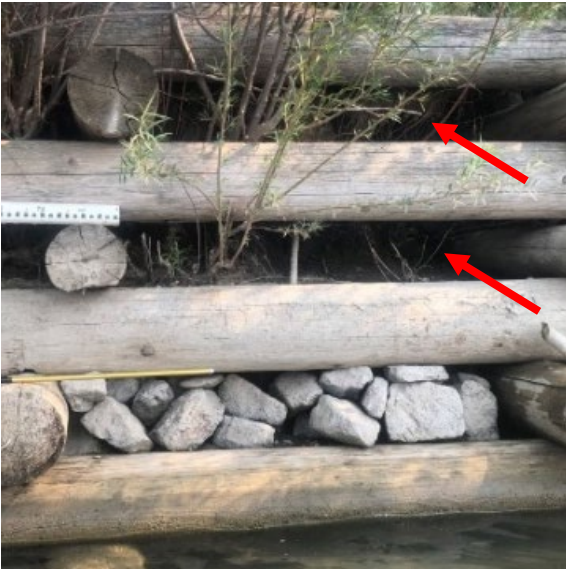
~10% OF SITES WITH MINOR EROSION

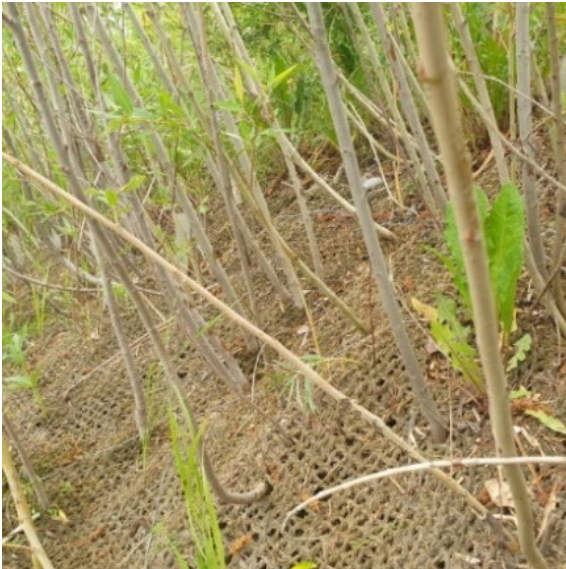
'PERMANENT' VS 'TEMPORARY' MATERIALS

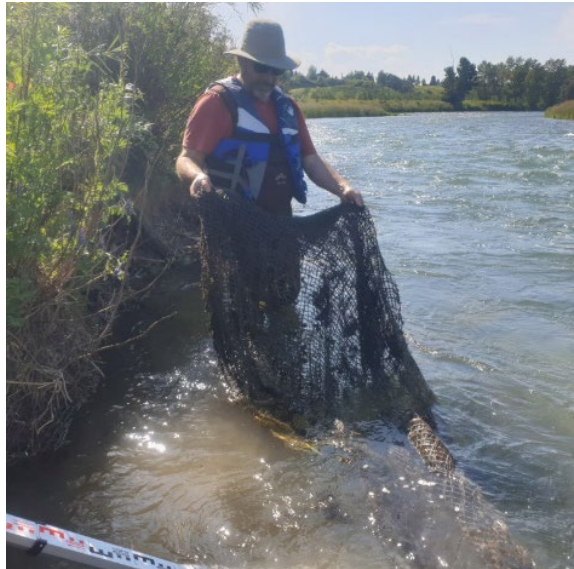
30% OF SITES WITH SYNTHETIC MATERIALS

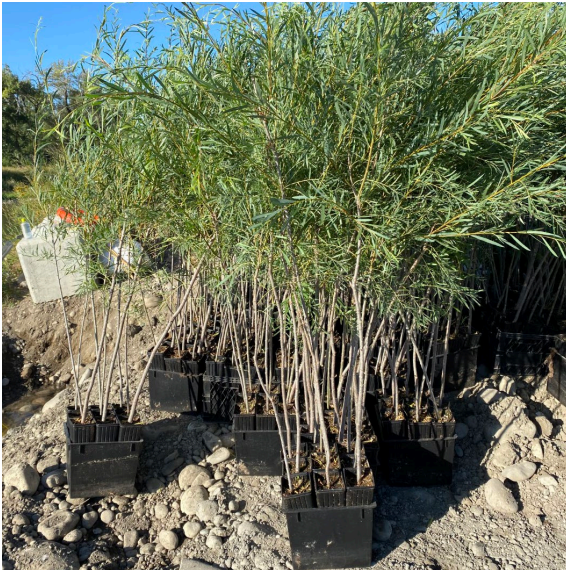
INNOVATION: TALL ROOTED CUTTINGS

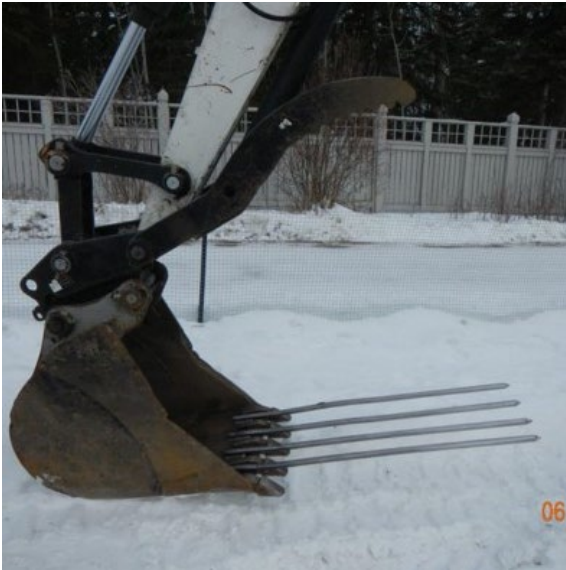
INNOVATION: CONTRACTOR METHODS

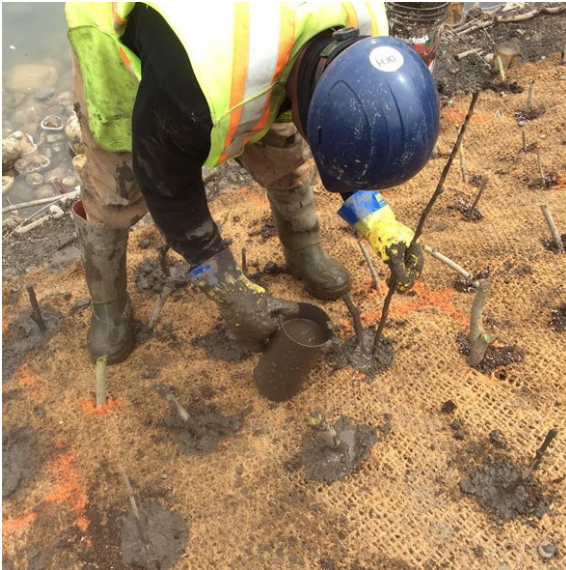
RECOMMENDED PRACTICE: SOIL AMENDMENT

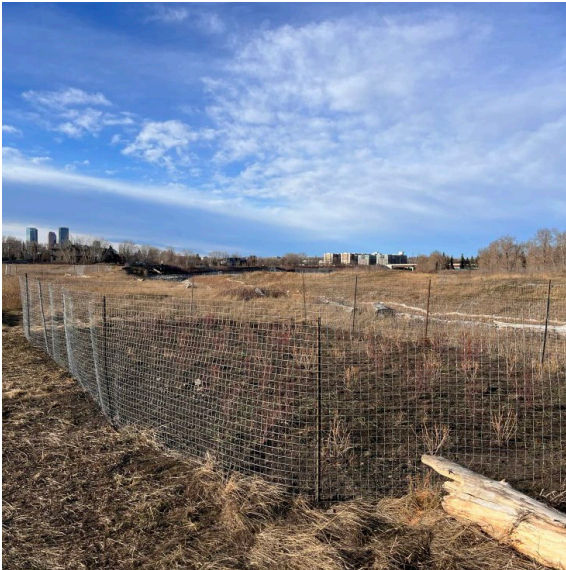
RECOMMENDED PRACTICE: FENCING

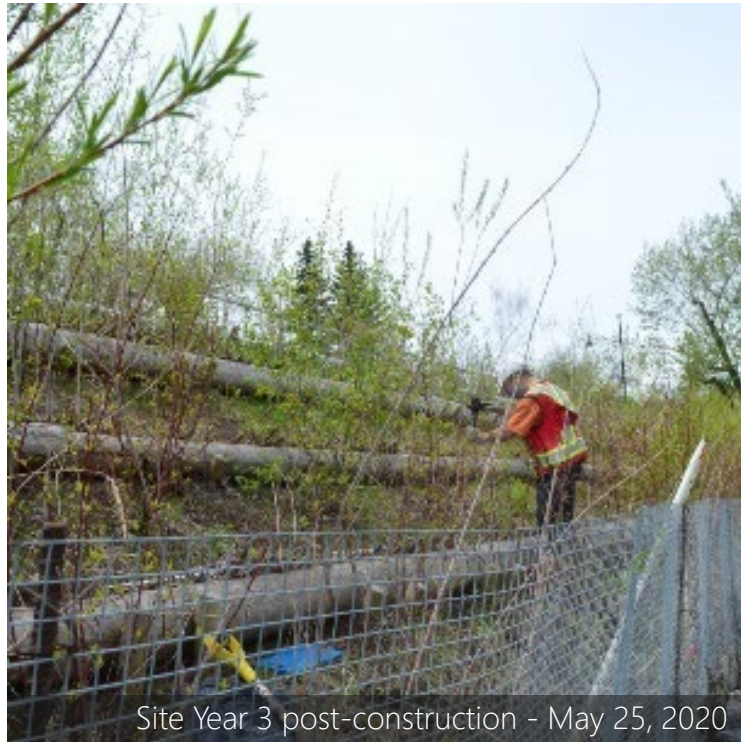
BROWSED SITE

IMPORTANCE OF FENCING

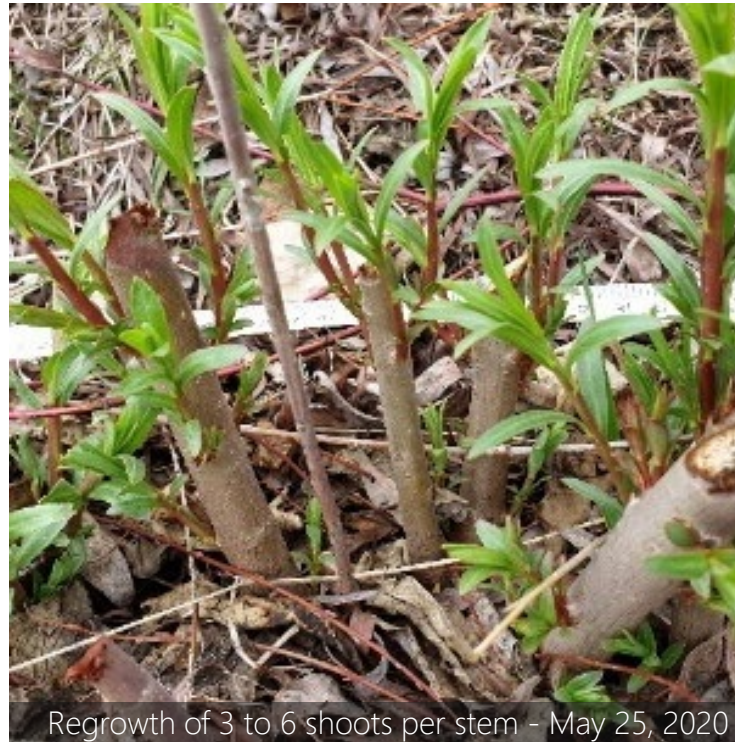
SHOOTS REGROWING

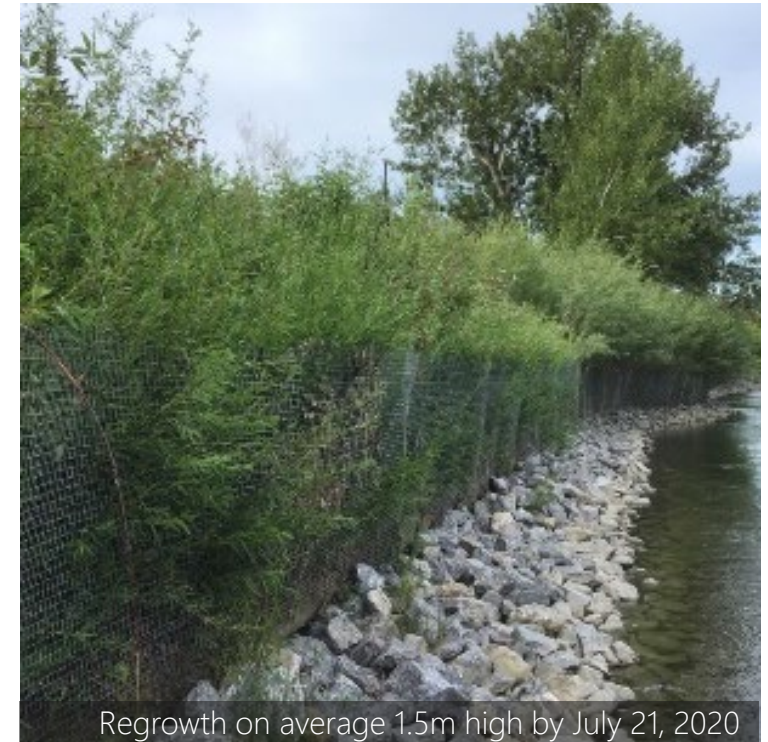
VEGETATION REGROWTH

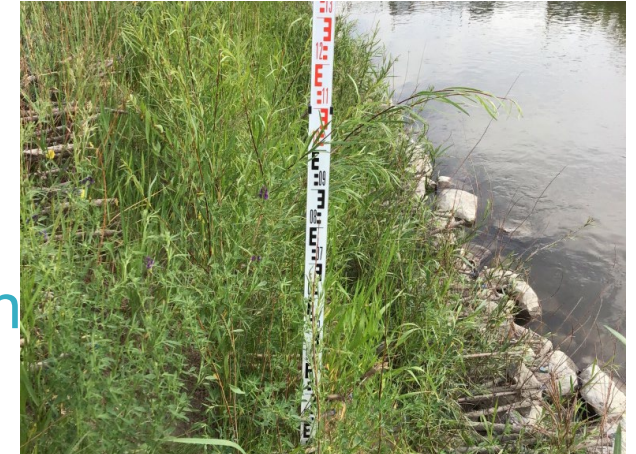
- Compare RMP data to new site data
 - Balsam poplar live cuttings: good in Year 1 but lagging in Year 3
- Identifies trajectory of planted vegetation
- Helps identify if mitigation measures may be needed at the site
- Same data available for bioengineering techniques

Species	Post-Construction Year	RMP Shoot Length Data			Measured Average Shoot Length (cm)
		25 th PCTL	Mean	75 th PCTL	
		(cm)	(cm)	(cm)	
Balsam poplar (<i>Populus balsamifera</i>)	1	26	44	56	58
Balsam poplar (<i>Populus balsamifera</i>)	3	67	99	129	68
