# bentway staging grounds

Prepared for TRCA – source to stream

# The Bentway Staging Grounds Monitoring

Presented by: Alexis Maglalang and Josh Harskamp

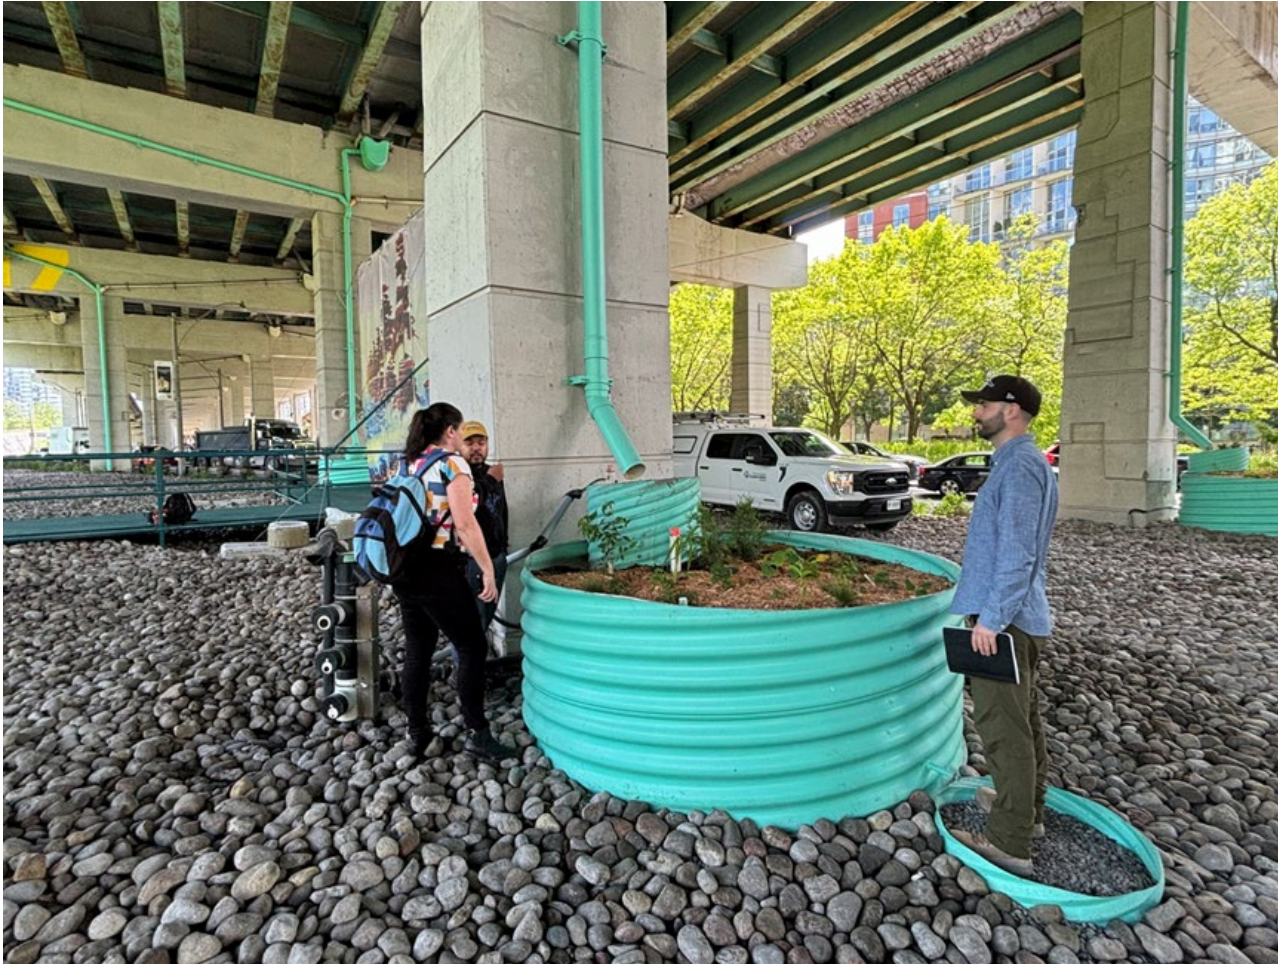
# Bentway Staging Grounds Planters

Each pillar at the Staging Grounds consists of a planter designed with two chambers to capture and treat stormwater runoff conveyed through downspouts fed by catchbasins on the Gardiner Expressway

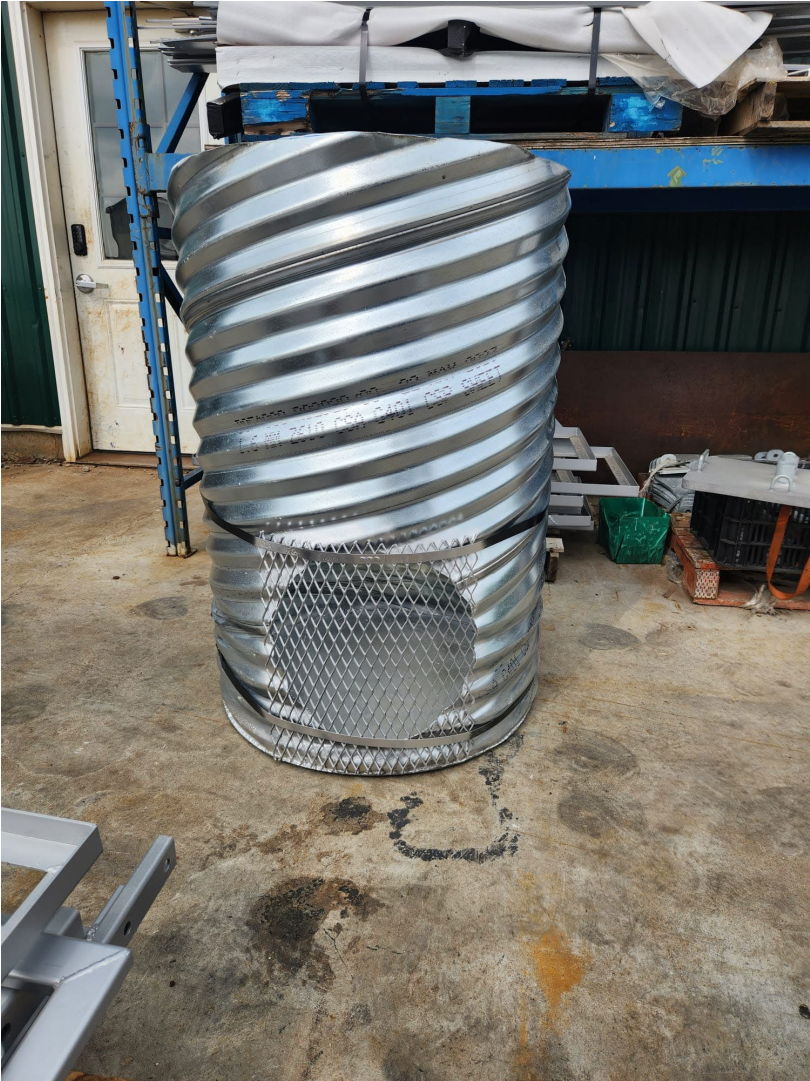
Figure 1: Profile view of Planter

# Inlet Chamber

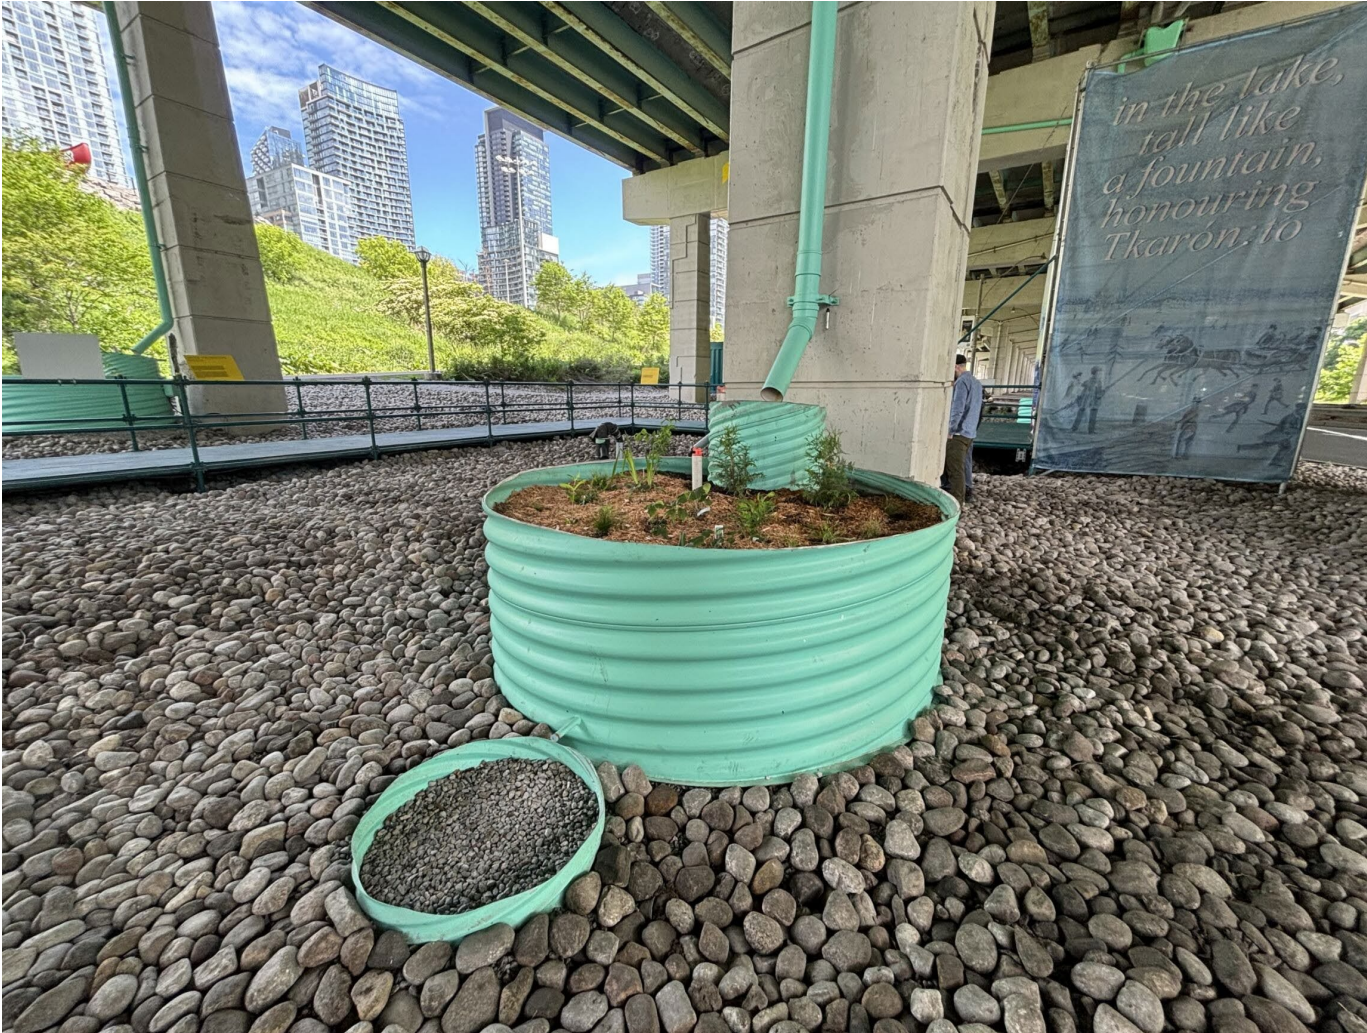
# Key Monitoring Objectives

1. Evaluate the effectiveness of the planters in treating and reducing runoff volumes, while providing sufficient moisture to planting beds
2. Assess the level of maintenance required to keep the system operational
3. Provide insights into design improvements to promote enhanced system function from a treatment and maintenance perspective.

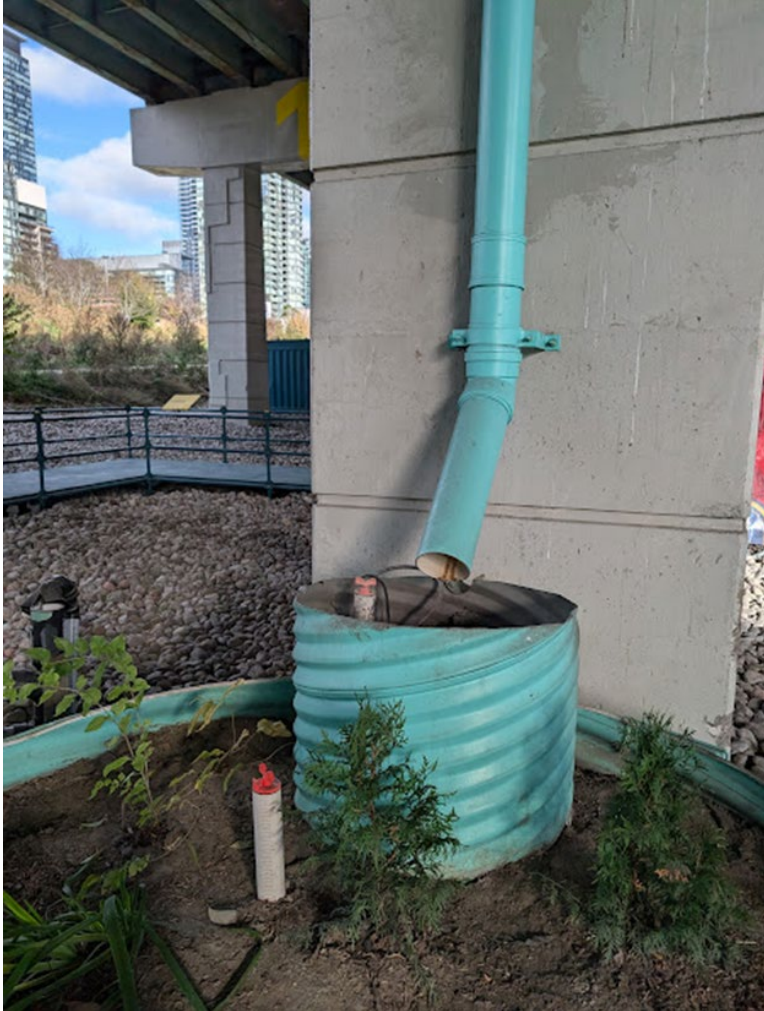
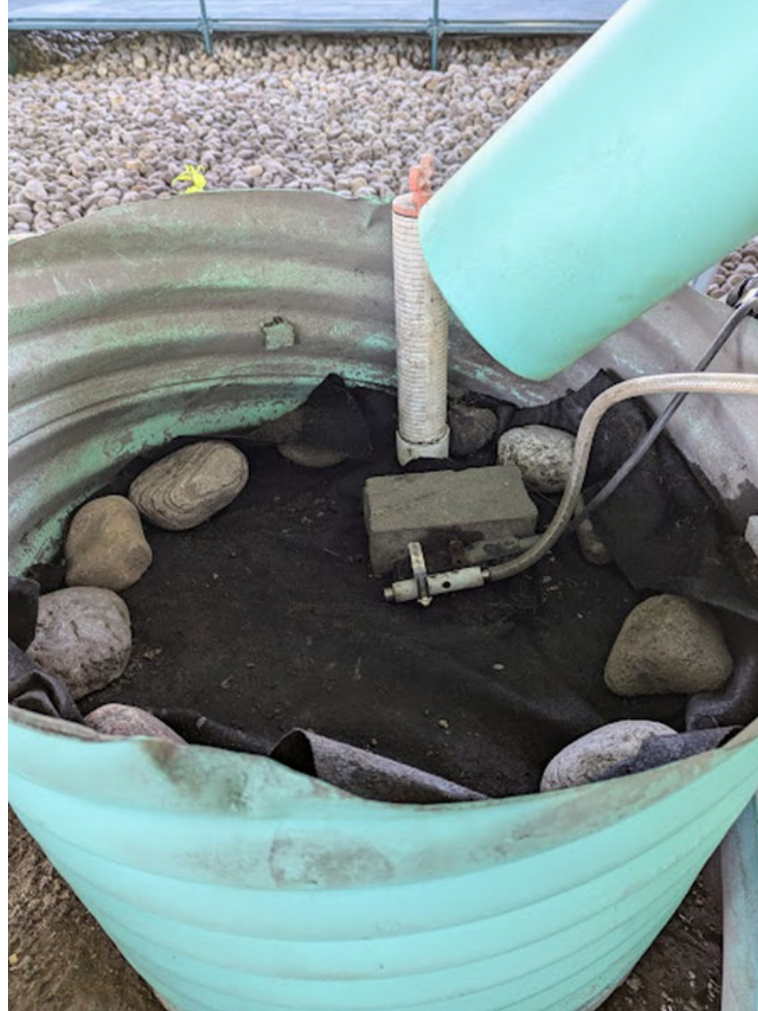
- Precipitation data was collected from a local TRCA gauge
- Monitoring Wells
  - Ponding level at the Inlet Chamber
  - Planter has a monitoring well to measure water level in the full depth of storage

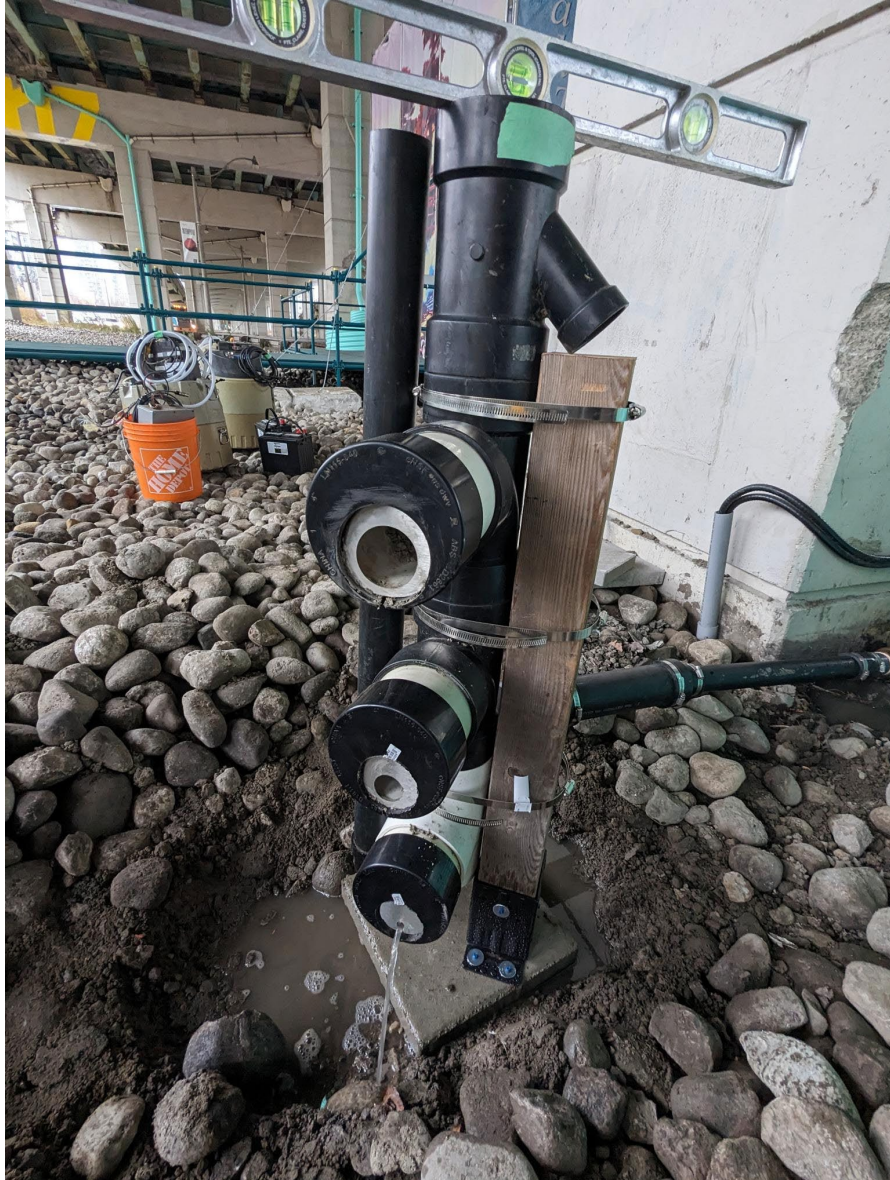
- Inlet volume was determined using rainfall and drainage area
- Outlet volume and flow rates were measured using a stilling well with a calibrated orifice standpipe, connected at the 2" drain pipe (outlet) at the back of the planter
- The lowest orifice was levelled to be at the same height of the 1" outlet spout at the front of the planter

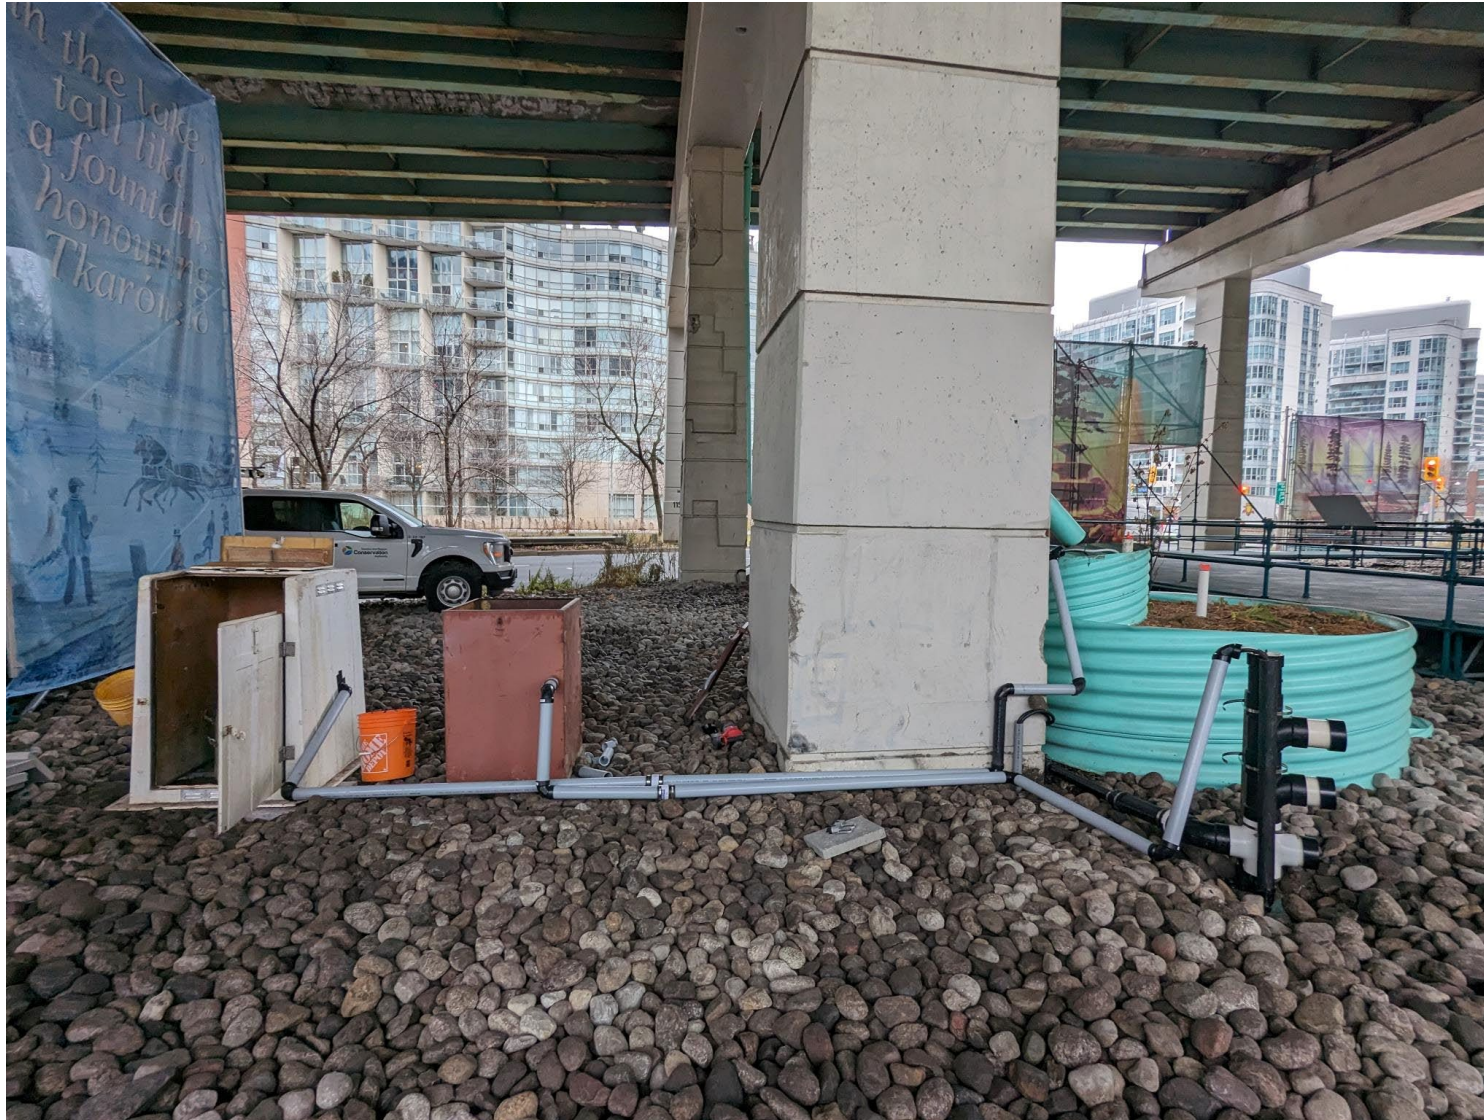
Water quality samples were collected at the inlet and outlet of the south planter by ISCO automated water samplers contained in locked enclosures, triggered during rain events by water level changes

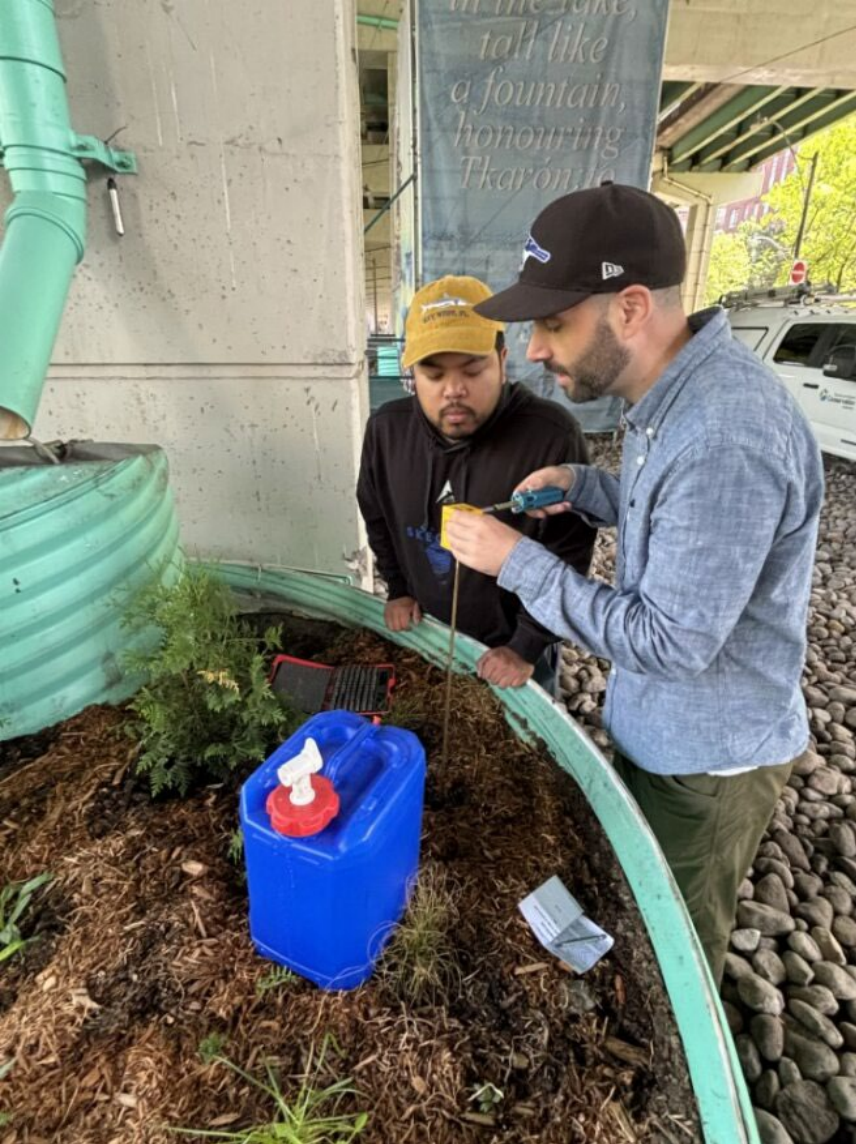
- Soil moisture was monitored at the main planter and a second adjacent planter using a soil moisture probe
- Measurements were taken in a linear pattern from the inlet to the outer edge of the planter
- Taken at depths of 30cm and 60cm to assess the vertical distribution of moisture provided by the reservoir through the wicking cones

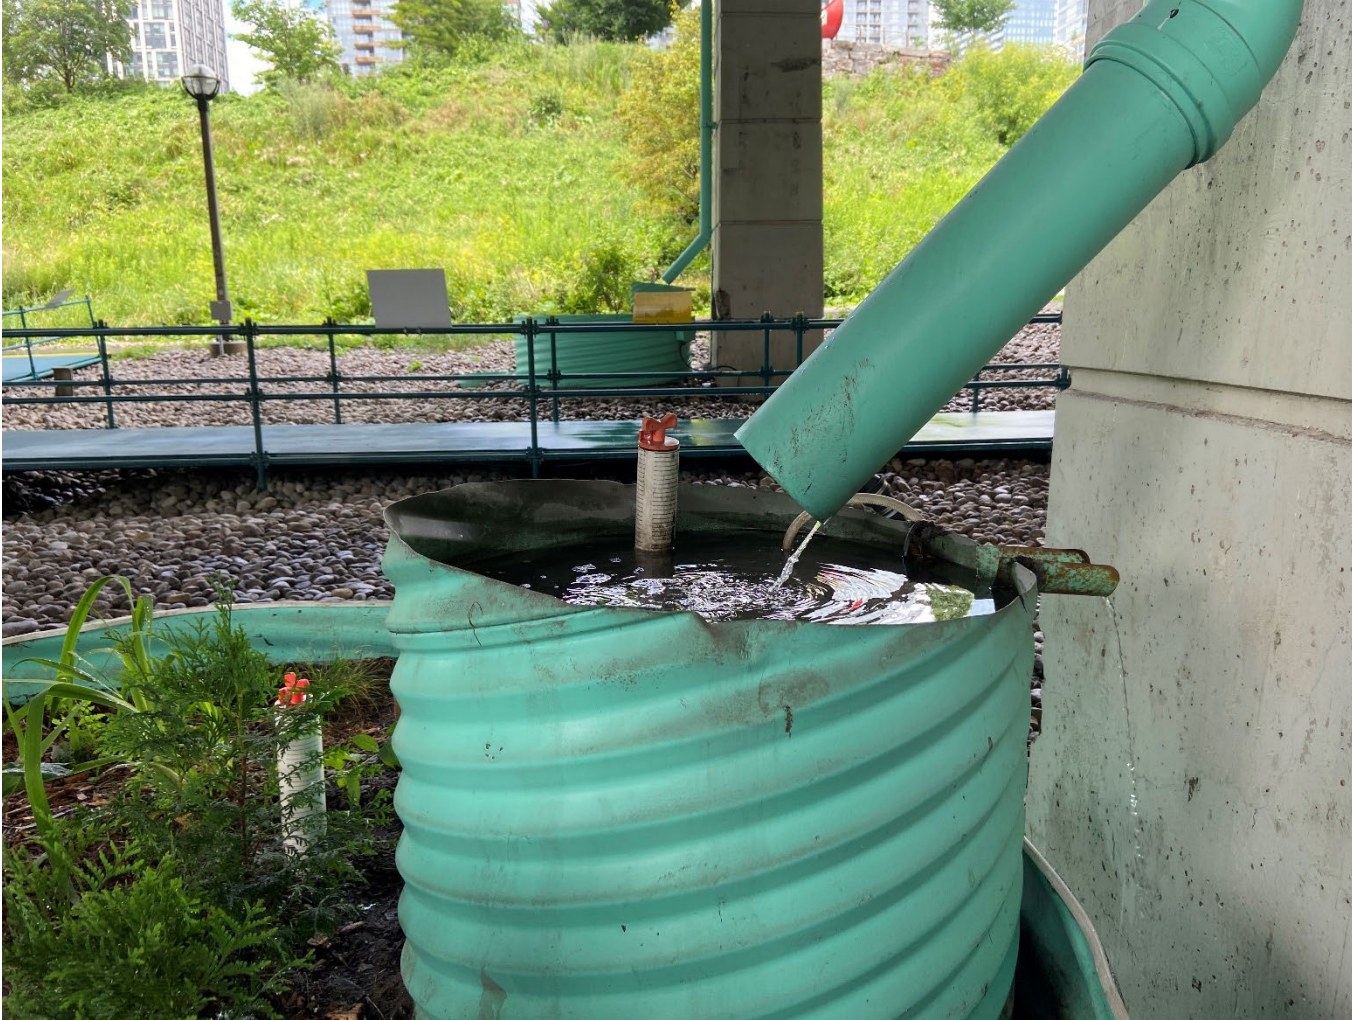
- Monitored at the Main Planter - inlet chamber and outlet orifice
- Total of 10 paired samples from precipitation events between January 2024 to November 2024
- Water quality results compared to established water quality guidelines
- Preliminary findings for Total Suspended Solids (TSS), Oil & Grease and Chloride

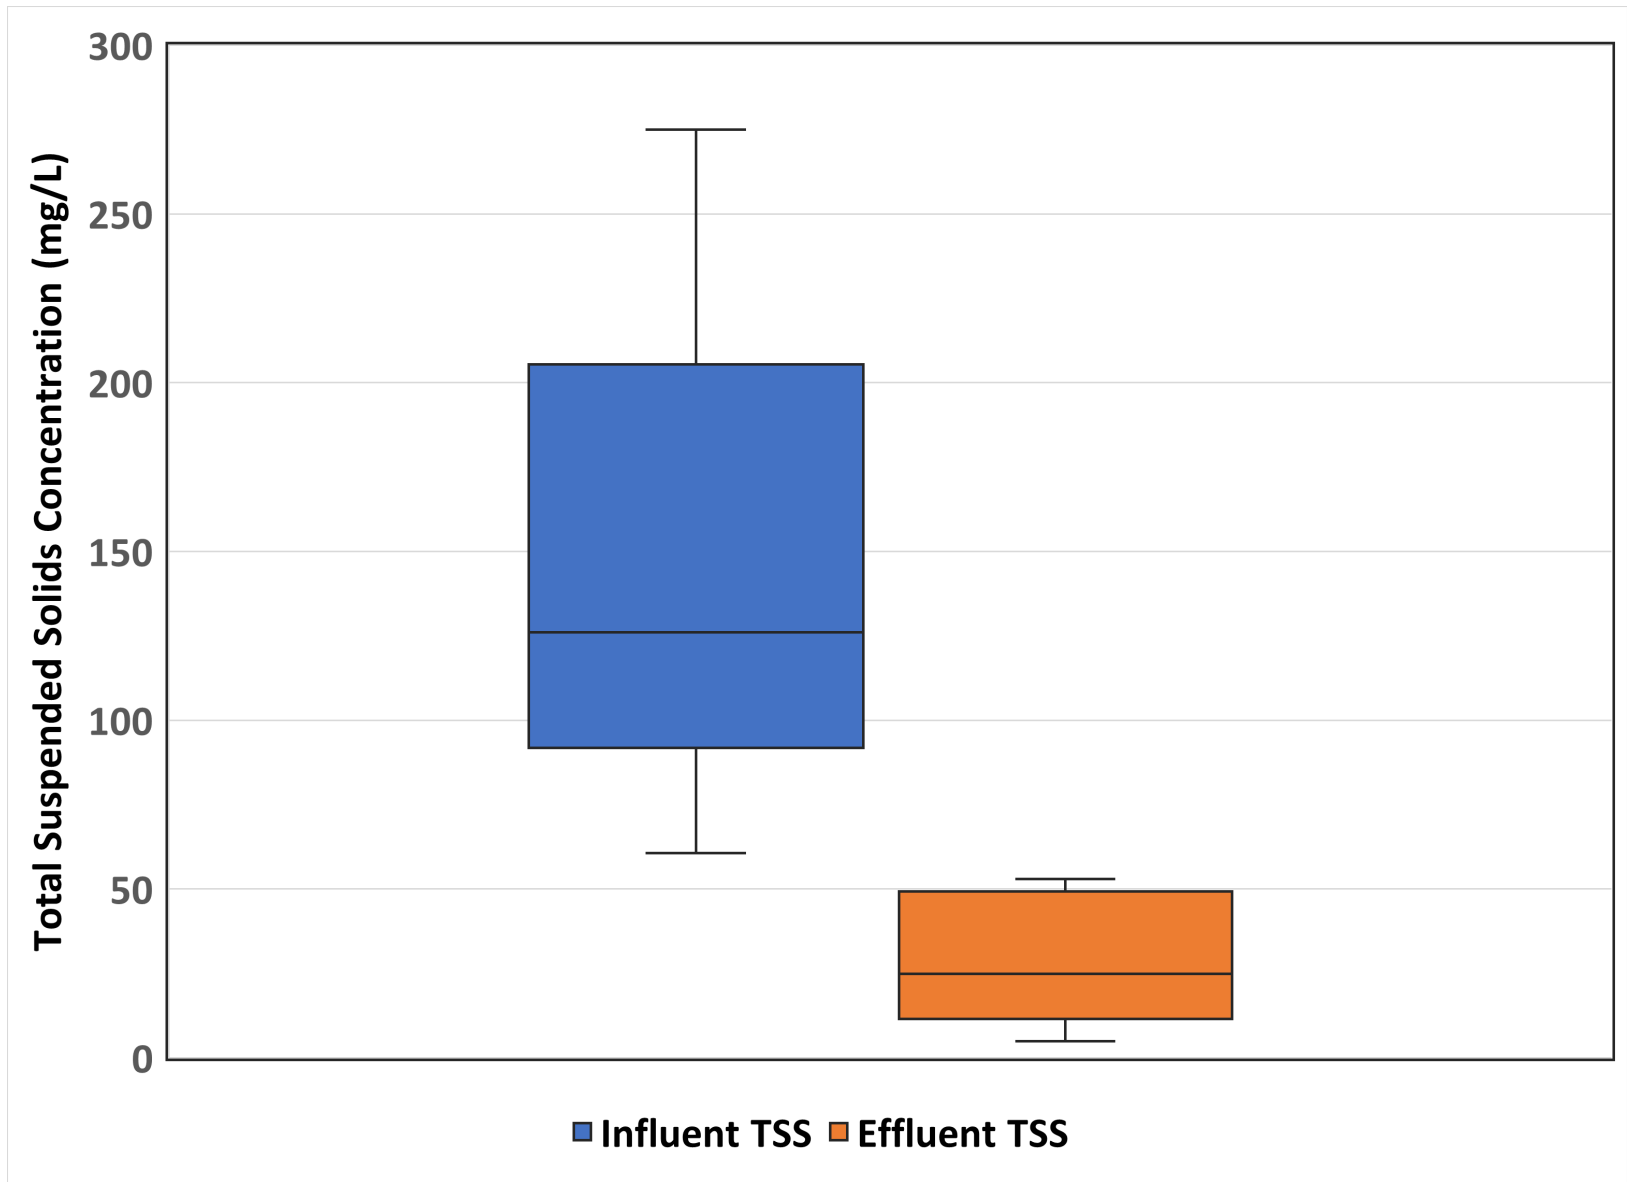
# Water Quality – Total Suspended Solids

**TSS: 79% Reduction**

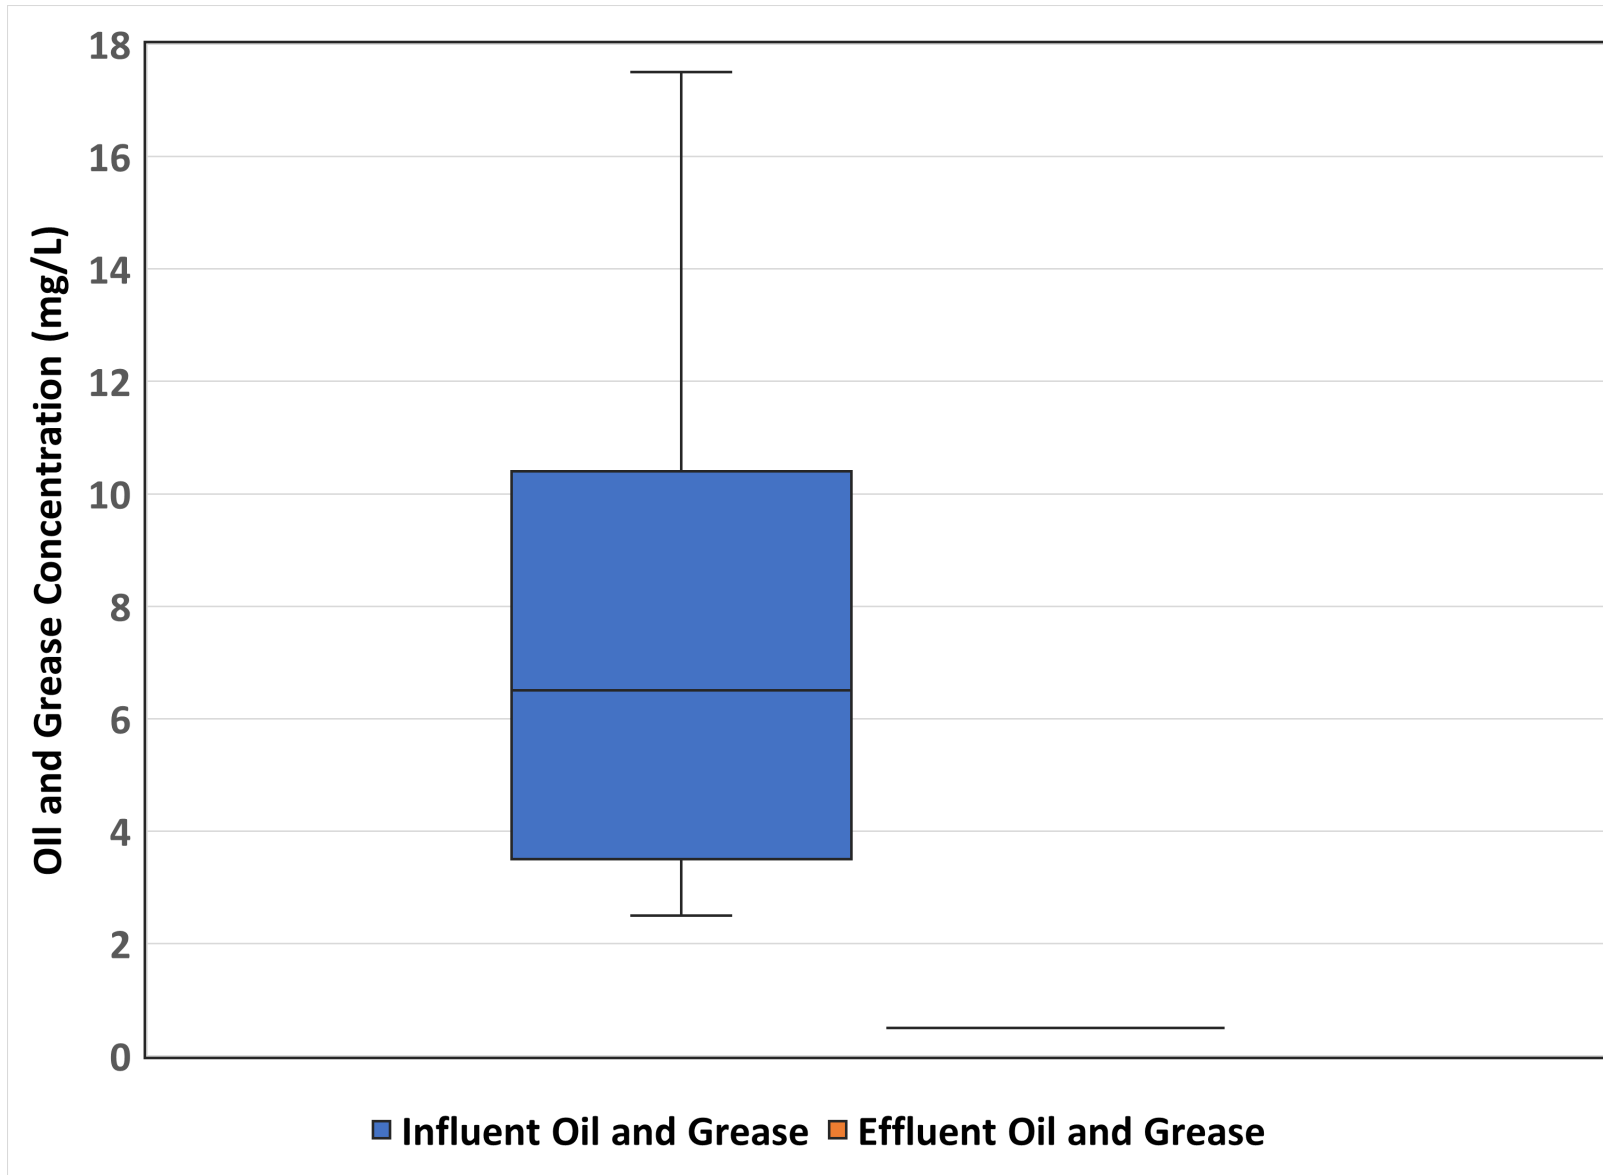
# Water Quality – Oil and Grease

**Oil and grease: 81%  
Reduction**

**Two samples at the  
outlet with  
concentration > 1mg/L**

**(1.6mg/L and 2.8mg/L)**

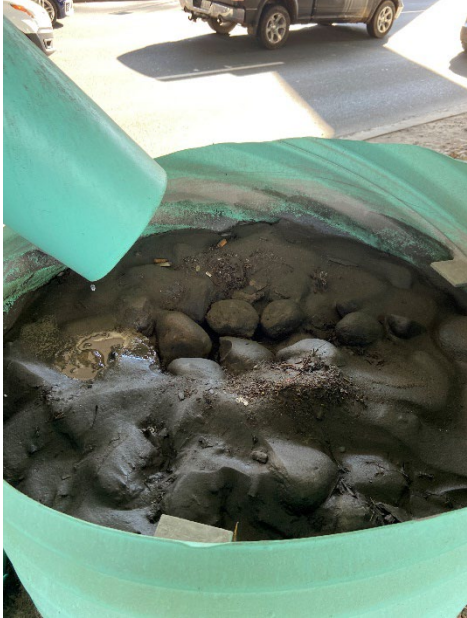
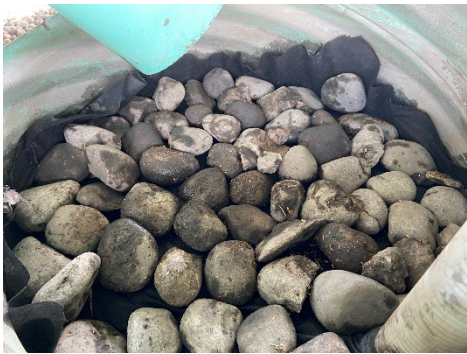
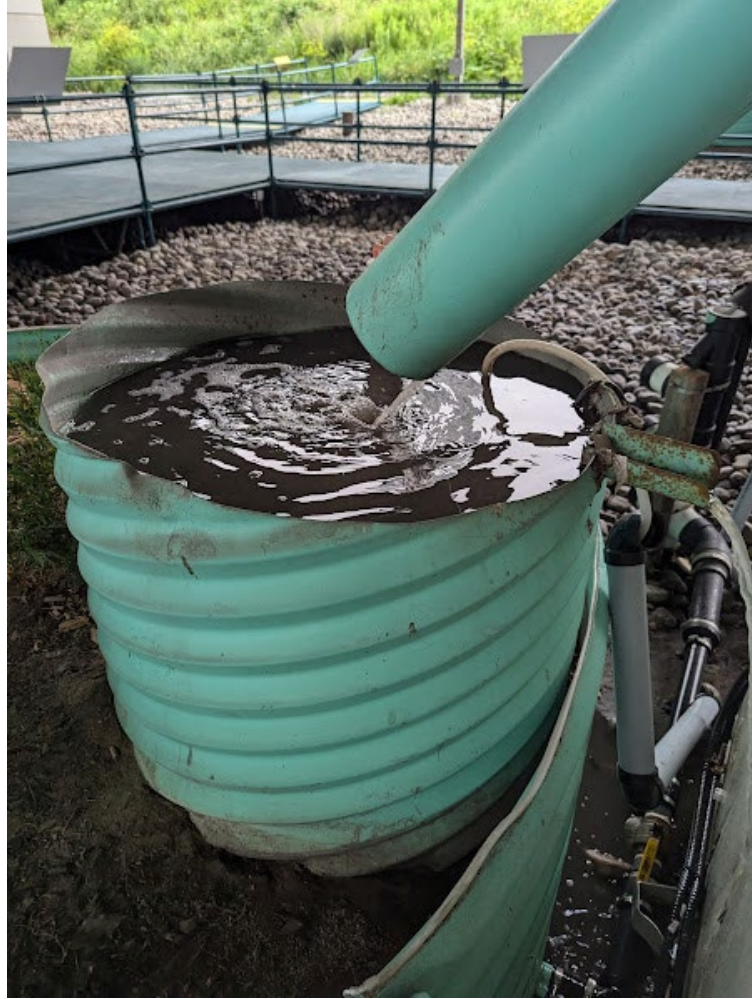
# Maintenance & Field Observations

- Overflows at the inlet chamber, volume not being retained within the planter system and causing erosion on the top layer of the planter
- Due to combination of chamber sizing, low rate of flow of filter cloth, clogging from sediment
- May 2024, geotextile filter changed to higher flow rate, some river rocks were removed
- Bentway continued to maintain the inlet chambers at the Staging Grounds

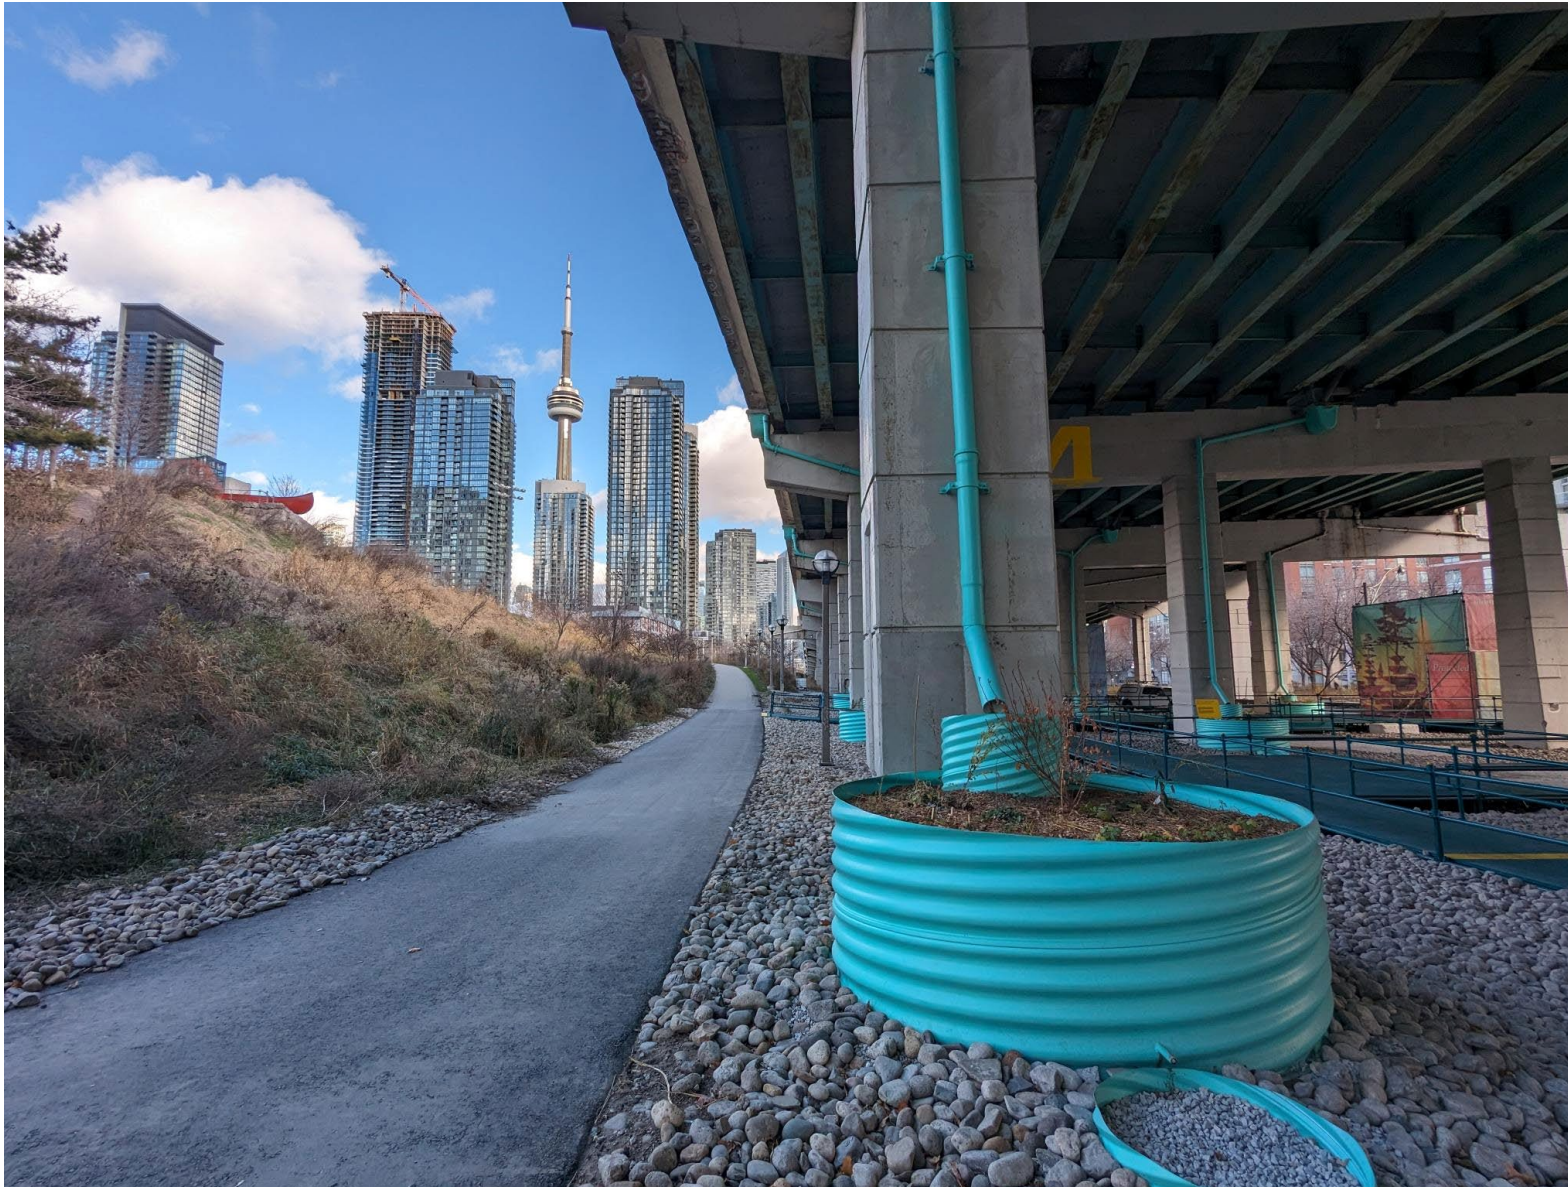
# Key Takeaways & Future Growth

- Future designs or retrofits
- Easier maintenance
- Sizing of chamber and planters
- Incorporating the planters in a treatment train approach for future work
