# **When Creek Meets Valley Wall: Prioritizing Erosion Mitigation alongside the Oshawa Landfill**

**TRIECA conference**

**March 22-23, 2017**

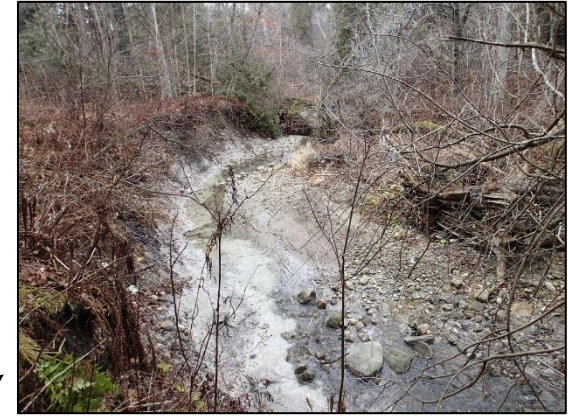
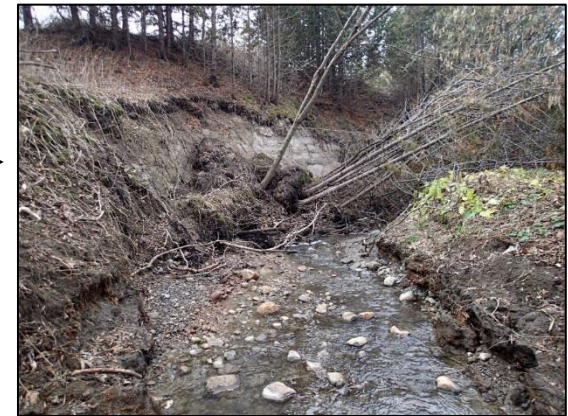
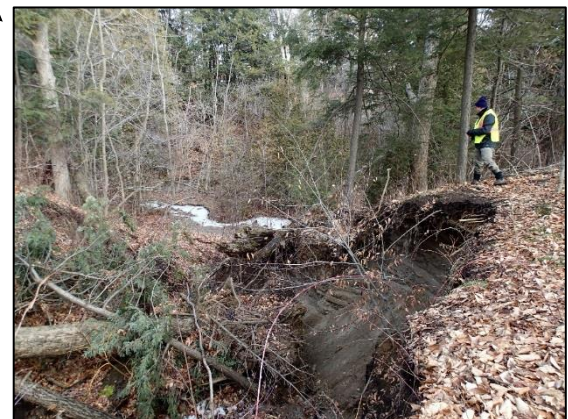
- Principal drivers of instability
  - Channel down-cutting and migration
  - Groundwater seepage and piping of fine sediments
  - Uncontrolled surface runoff
