Stantec

March 22, 2018

To Pipe or Not to Pipe -
Erosion Issues and
Solutions in an Urban
Watercourse in
Edmonton

Heather Amirault

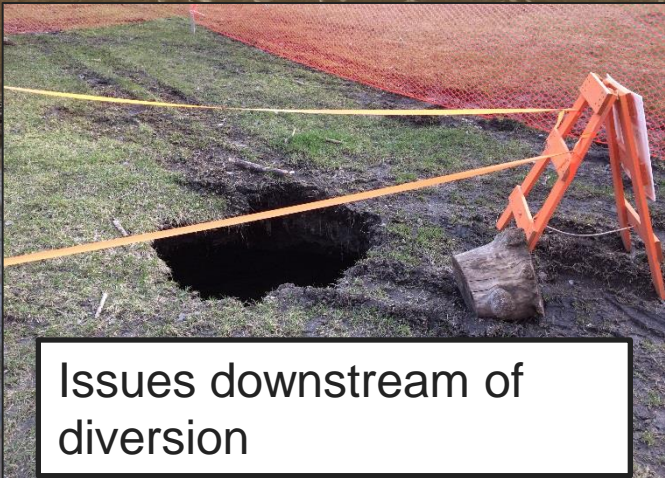
Issues downstream of diversion

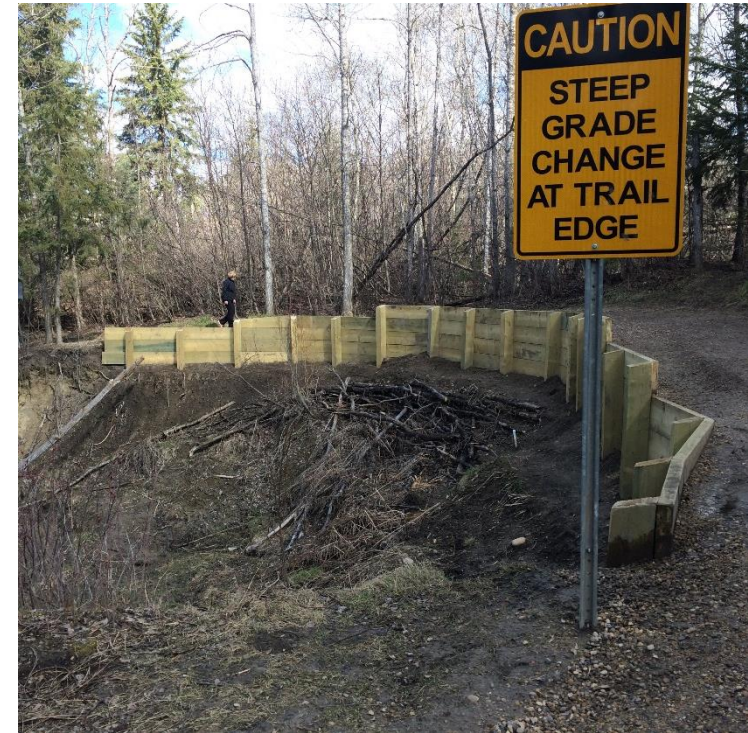
Creek Impacts

- Incision
- Over widening
- Bank Erosion
- Utility Exposure
- Public Safety Risk
- Infrastructure Damage

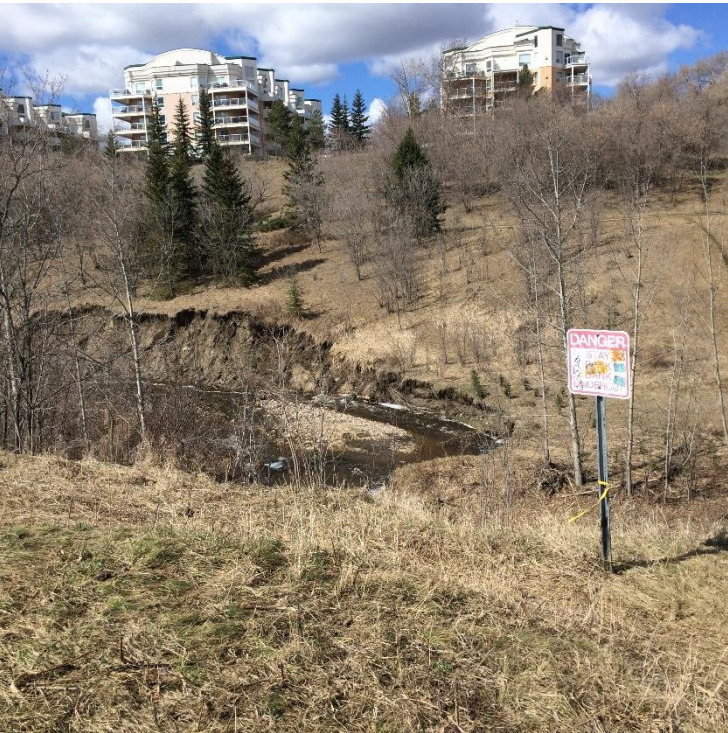
- Consulting report evaluating erosion sites
- 64 erosion sites with \$74M of repair works in study reach
- Permanent options listed as:
 1. Grade control structures
 2. Diversion tunnel extension (\$30M)

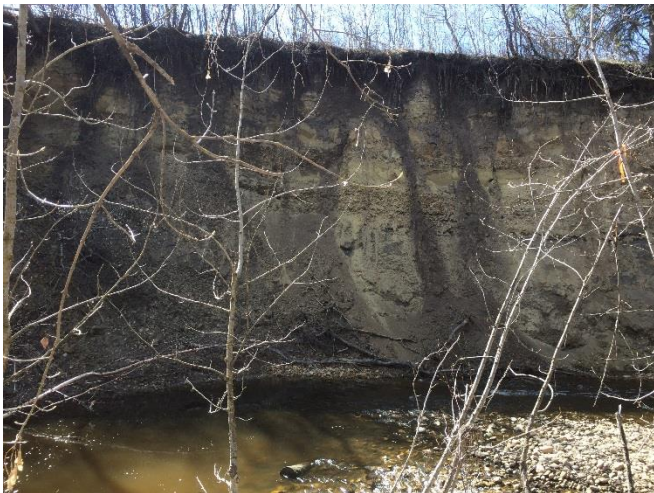
Stream: Mill Creek Location: b/w bridge 234 + 233
 Station: Observers: HA + DL
 Date: May 4 2017 Stream Type: Valley Type:

Study Bank Height / Bankfull Height (C)				BEHI Score (Fig. 3-7)	
Study Bank Height (ft) =	9 (A)	Bankfull Height (ft) =	1.5 (B)	(A) / (B) = 6 (C)	10
Root Depth / Study Bank Height (E)					
Root Depth (ft) =	0.5 (D)	Study Bank Height (ft) =	9 (A)	(D) / (A) = 0.06 (E)	10
Weighted Root Density (G)					
Root Density as % =	27 (F)	(F) x (E) =	0 (G)	10	
Bank Angle (H)					
Bank Angle as Degrees =		(H)		10	
Surface Protection (I)					
Surface Protection as % =	0 (I)			10	
Bank Material Adjustment:					
Bedrock (Overall Very Low BEHI)					
Boulders (Overall Low BEHI)					
Cobble (Subtract 10 points if uniform med. to large cobble)					
Gravel or Composite Matrix (Add 5-10 points depending on percentage of bank material that is composed of sand)					
Sand (Add 10 points)					
Silt/Clay (No adjustment)					
Bank Material Adjustment					
Stratification Adjustment					
Add 5-10 points, depending on position of unstable layers in relation to bankfull stage				5

Very Low Low Moderate High Very High Extreme					
3 - 9.5 10 - 19.5 20 - 29.5 30 - 39.5 40 - 45 46 - 50					
Adjective Rating and Total Score				Extreme 55	
Bank Sketch

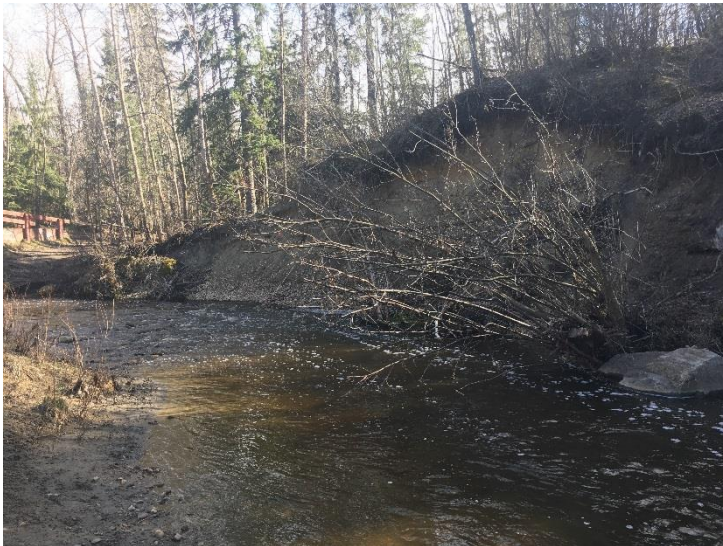
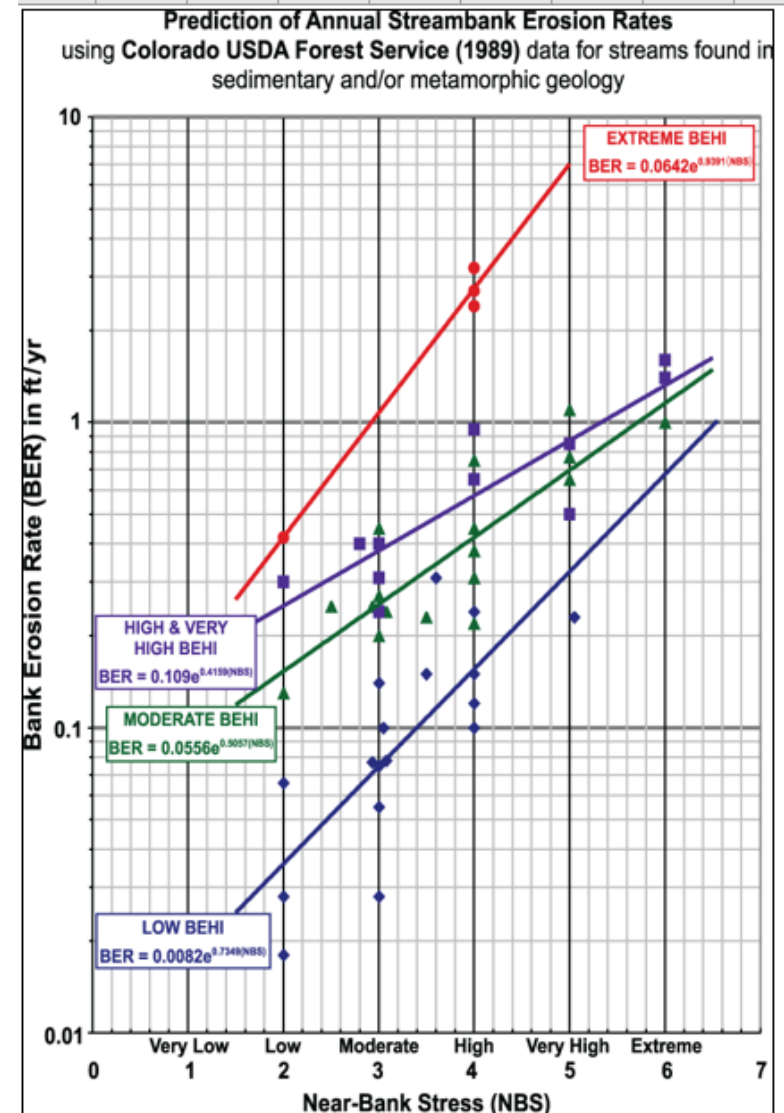
- NBS based on proximity of thalweg to the bank – the closer the thalweg the higher the near bank shear stress
- Use graph to determine bank erosion rate

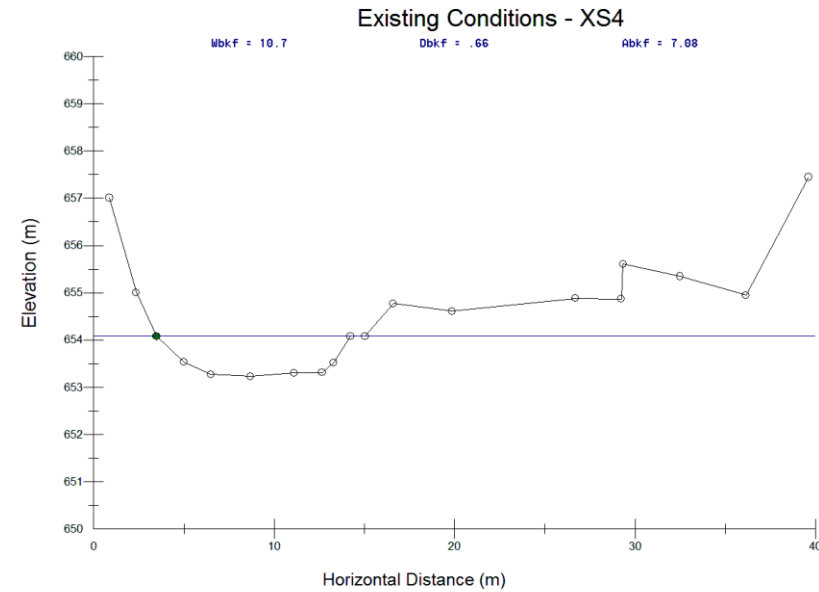
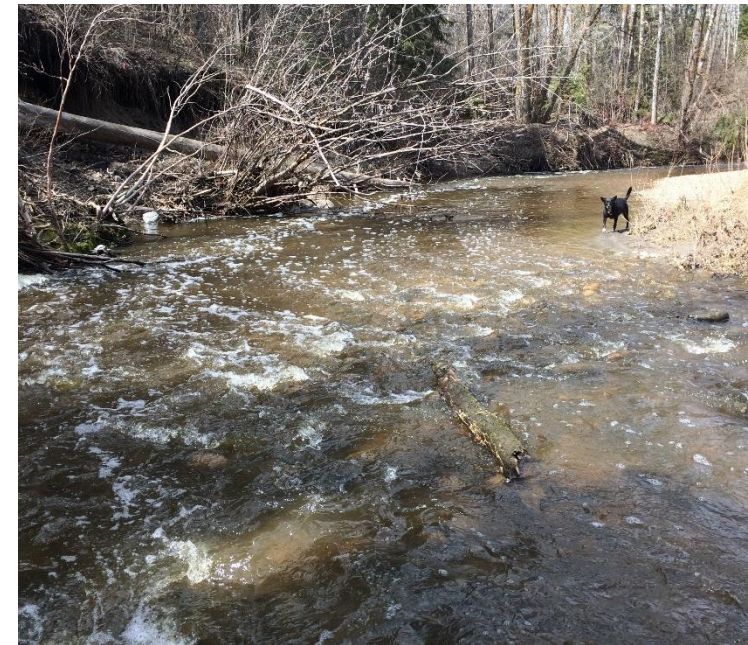
Cross-Section 4 Shields Numbers and Grain Mobility

Discharge (m³/s)	Sediment Size Range (mm)	D50 Stable (Y/N)*	D84 Stable (Y/N)*
3.1	27.2 – 90.7	Y	Y
6	37.3 – 124.2	Y	Y
8.4	43.7 – 70.8	N	Y
10	47.5 – 158.4	N	Y
36.1	87.5 – 291.8	N	N
