TRIECA | 2019 CONFERENCE

OPTIMIZING OPERATIONS AND MAINTENANCE OF LID BMPS

Mike Isensee, CPESC
MSCWMO Administrator
misensee@mnwcd.org
651-330-8220 Ext. 22

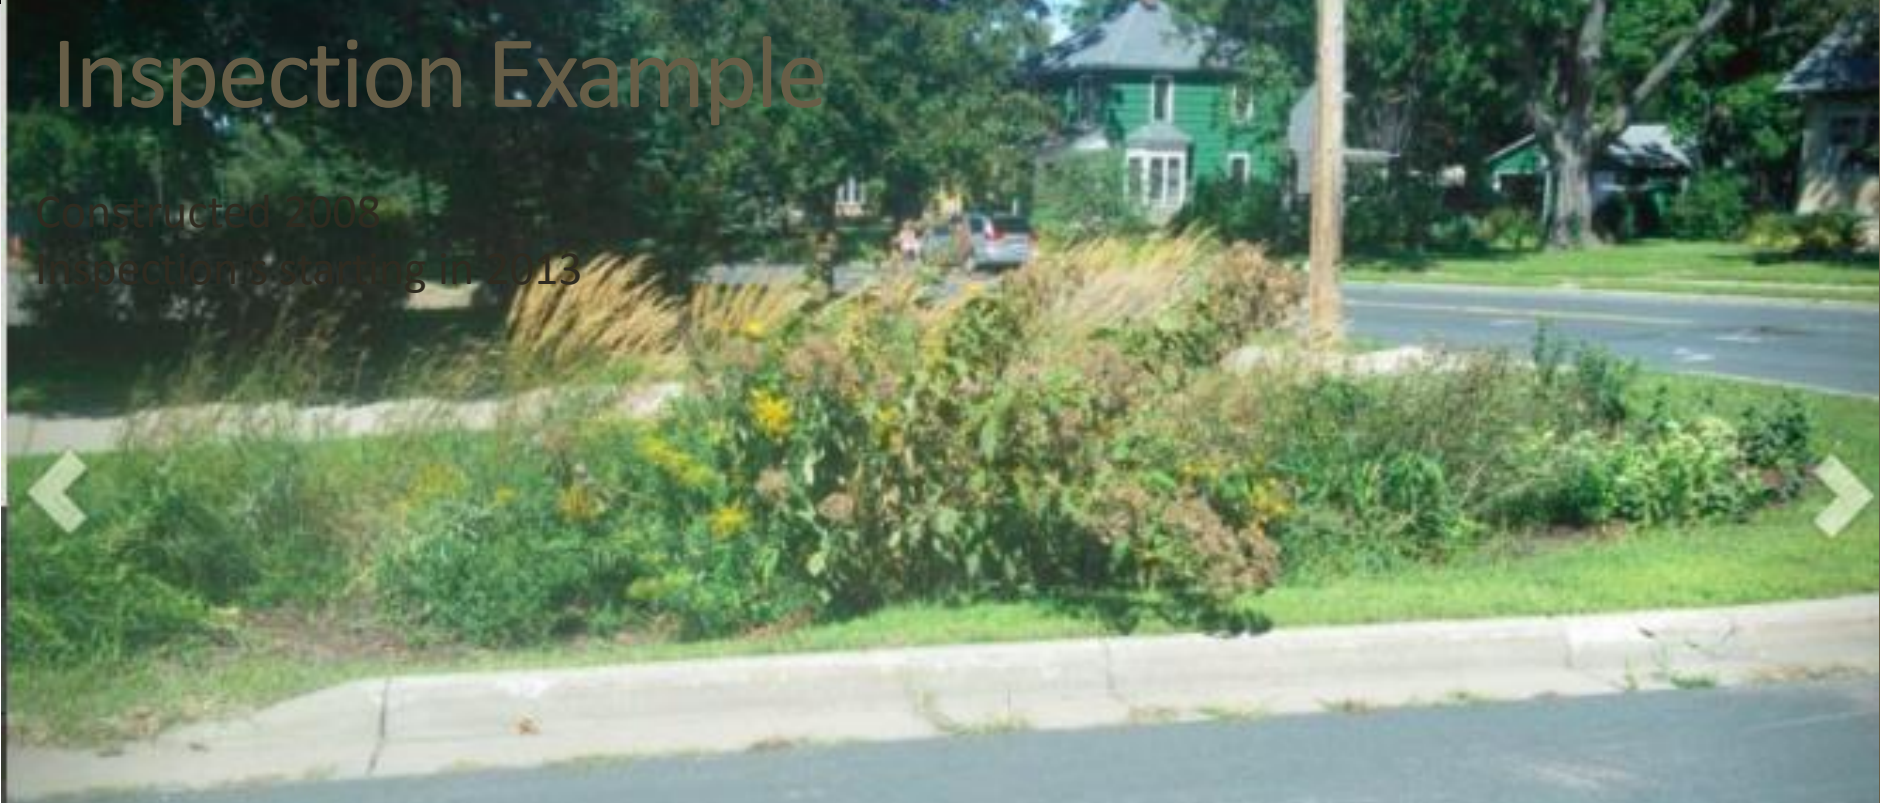
Inspection Example

Constructed 2008

Inspections starting in 2013

Date	Maintenance Needed	Maintenance Priority	Pre-Treatment Maintenance Required	Inlets Maintenance Required	Inlet Maintenance Comment	Vegetative Management Required	Vegetative Management Comment	Mulching Required
11/18/2013	Yes	C Partially Functioning	Yes	Remove Sediment	Sediment has built up and stormwater is bypassing.	Weeding	Very weedy. Weeding needed.	No
9/9/2014	Yes	D Nonfunctional	Yes	Remove Sediment	Inlet sod is blocking water from entering the basin.	Weeding	Raingarden is becoming overgrown, weeding is necessary.	No
8/25/2015	Yes	D Nonfunctional	Yes	Remove Sediment	Sod is prohibiting water from entering the basin. Remove sod and lower inlet elevation and placing new sod.	Weeding	Weeding needed on the west side of the basin. Plant replacement needed on the east side of the basin. Needs 20 additional plants.	1 Inch Thick

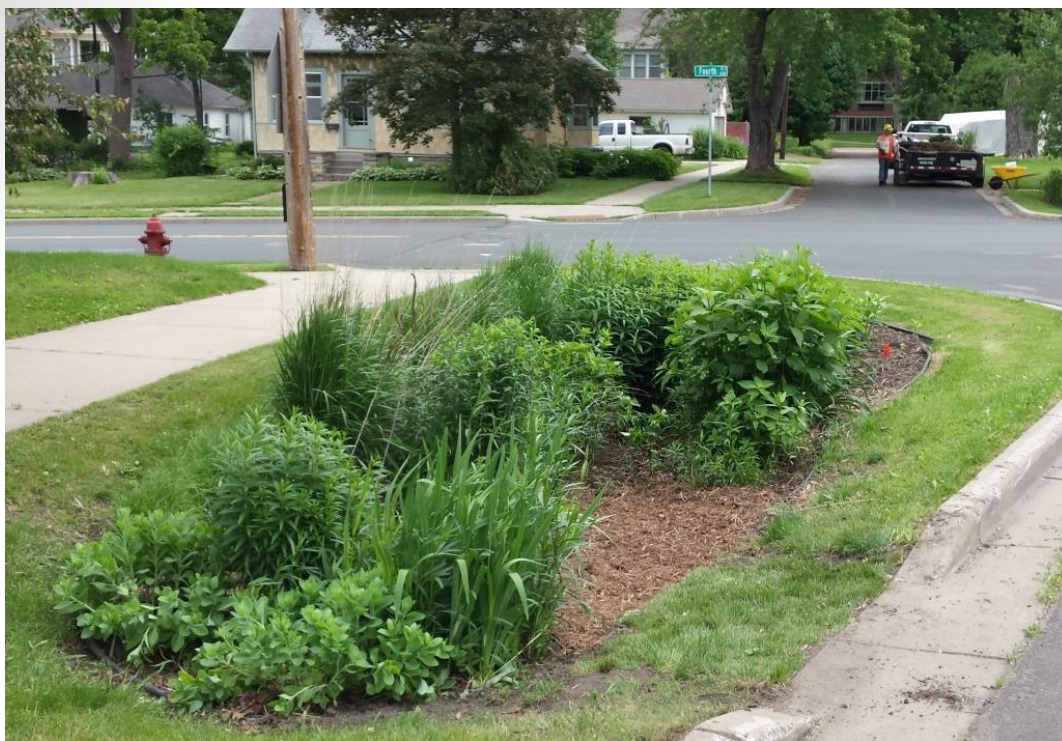
2015 Weed Control, Inlet
sod replacement, Weed
Control, Plant
Replacement, Mulching,
Inlet sod watering.

2016 Annual Maintenance

2017 Annual Maintenance

Date	Maintenance Needed	Maintenance Priority	Pre-Treatment Maintenance Required	Inlets Maintenance Required	Inlet Maintenance Comment	Vegetative Management Required	Vegetative Management Comment	Mulching Required
8/25/2015	Yes	D Nonfunctional	Yes	Remove Sediment	Sod is prohibiting water from entering the basin. Remove sod and lower inlet elevation and placing new sod.	Weeding	Weeding needed on the west side of the basin. Plant replacement needed on the east side of the basin. Needs 20 additional plants.	2 Inch Thick
7/8/2016	Yes	B Aesthetics	No	No	No	Plants	20 Additional plants needed.	No
7/11/2017	No

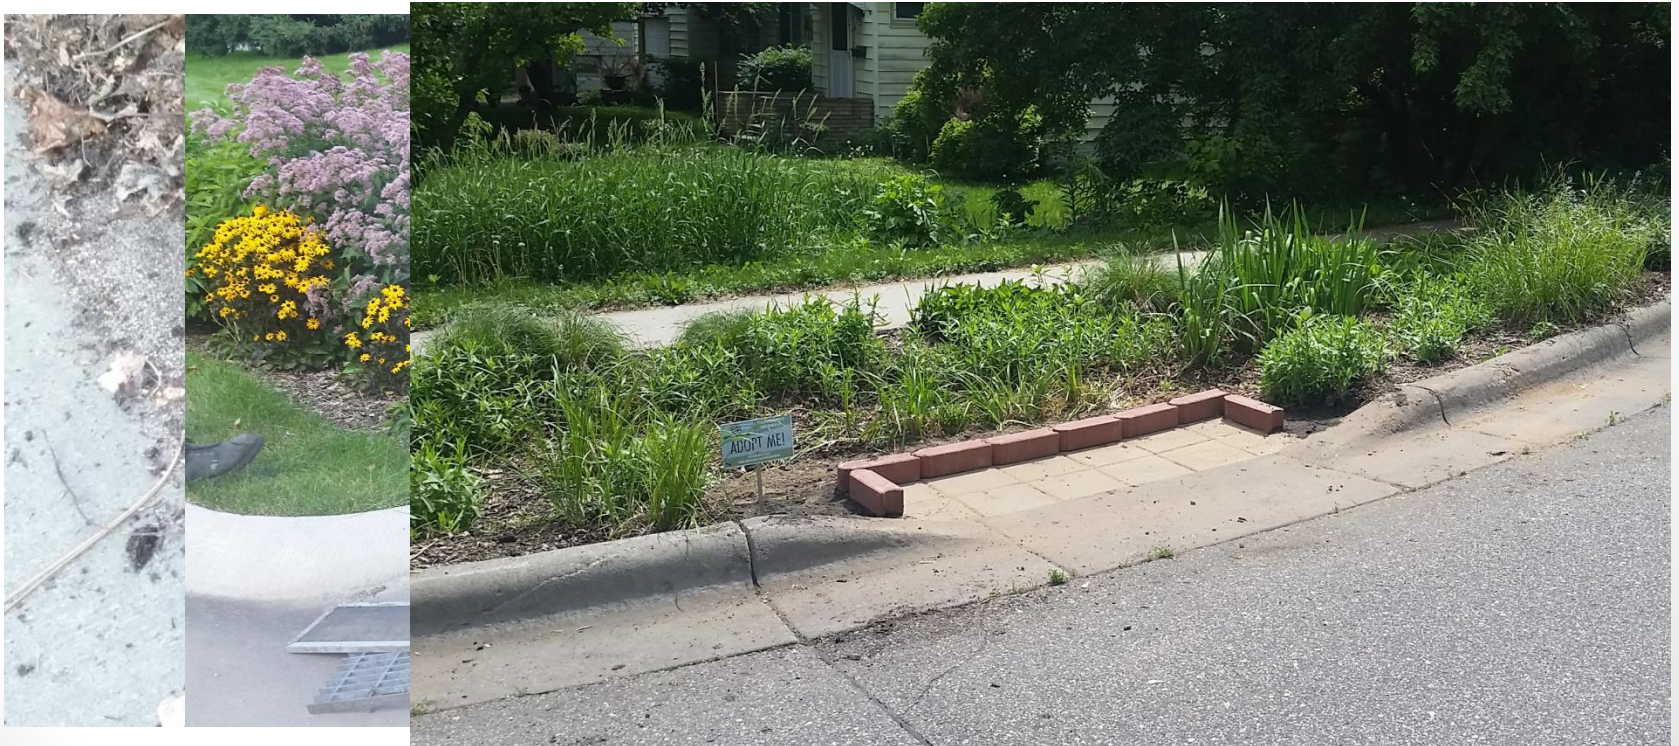
Inlets

- Rock Inlets: 1 hour per maintenance visit.
- 46 hours in 2016 picking rock.

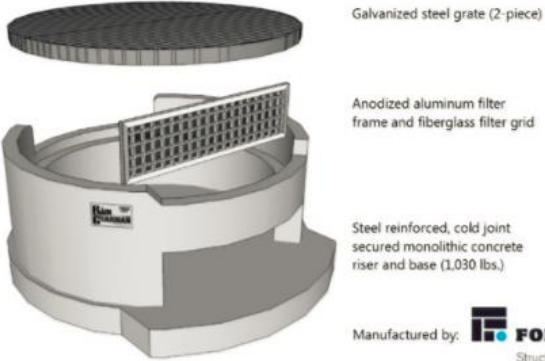
Rain Guardian—Turret

Standard exterior dimensions:

46" x 50" base, 19.5" total height

Light-Duty Rated (541 lb. concentrated load)—Contact ACD

Heavy-Duty Rated (2,456 lb. concentrated load)—Contact ACD

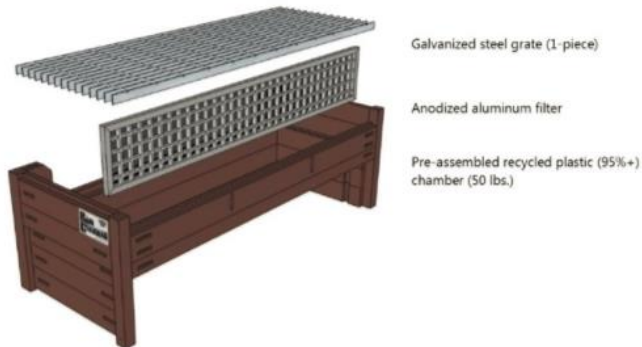
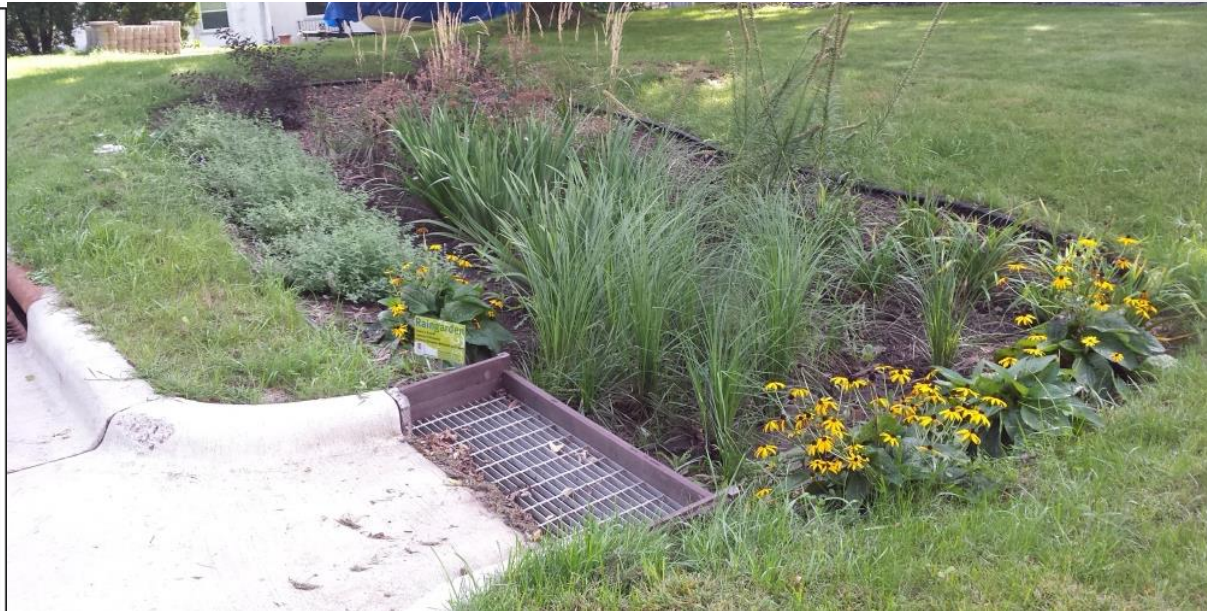
Rain Guardian—Bunker

Standard exterior dimensions:

51.25"L x 20"W x 15.75"H

Light-Duty Rated (316 lb. concentrated load)—Contact ACD

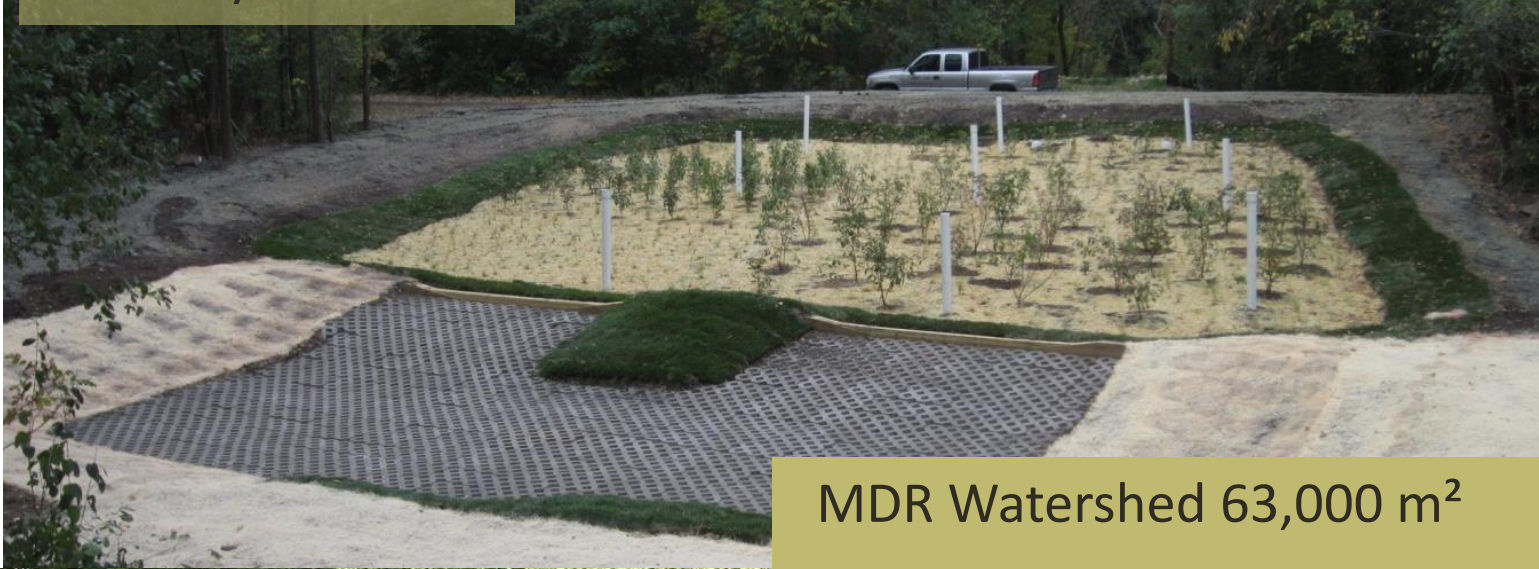
Forebays

MDR Watershed 63,000 m²

Year 4 = 13 m² sediment

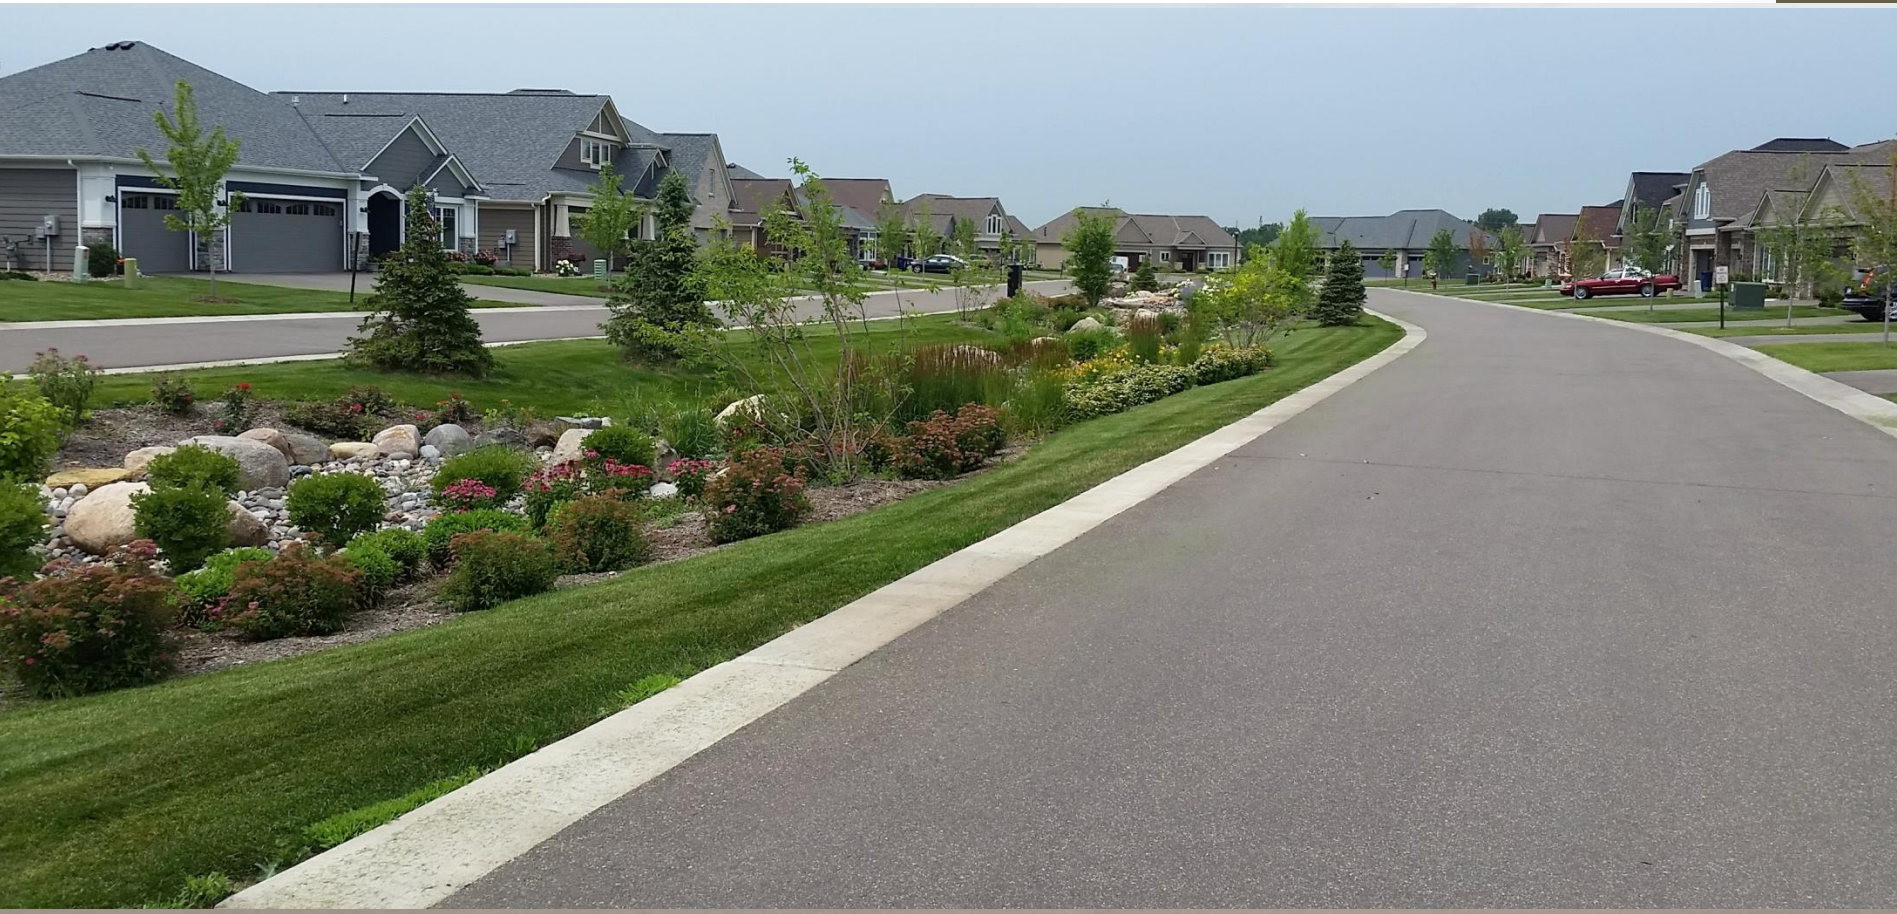
Construction Standards

Excavation within 3.0' of final grade prohibited until contributing drainage area is fully stabilized.

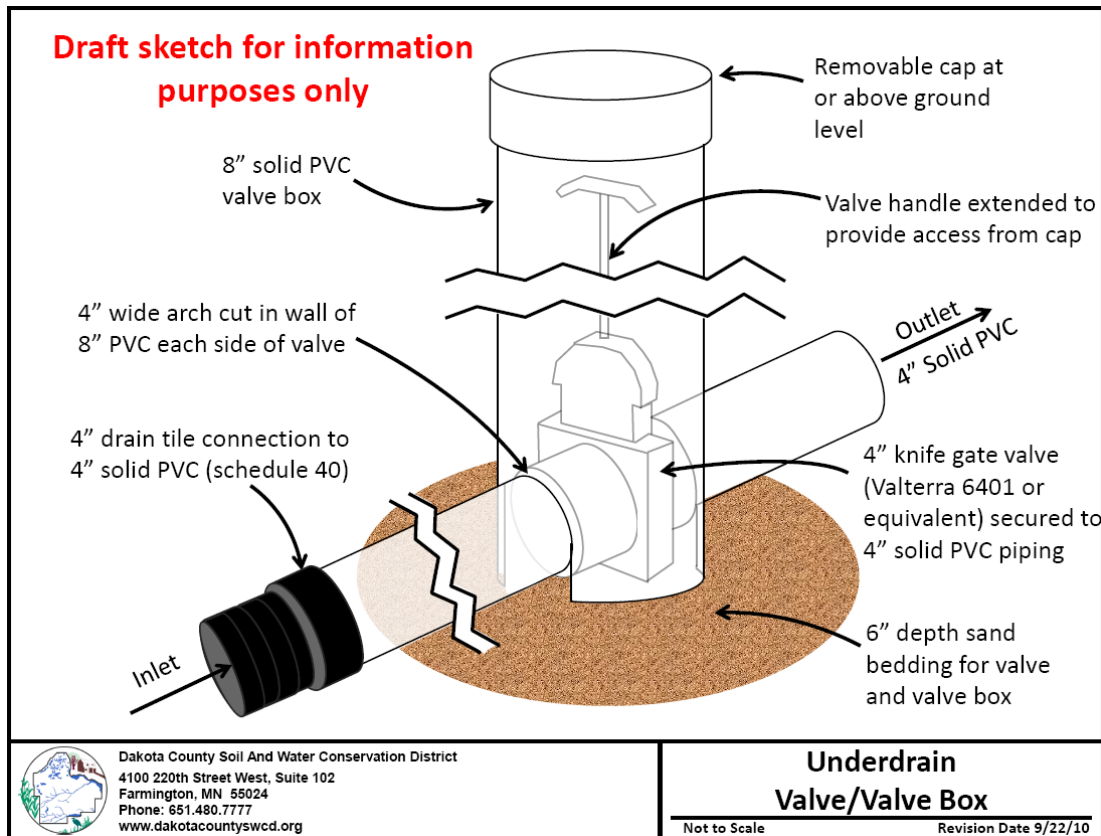
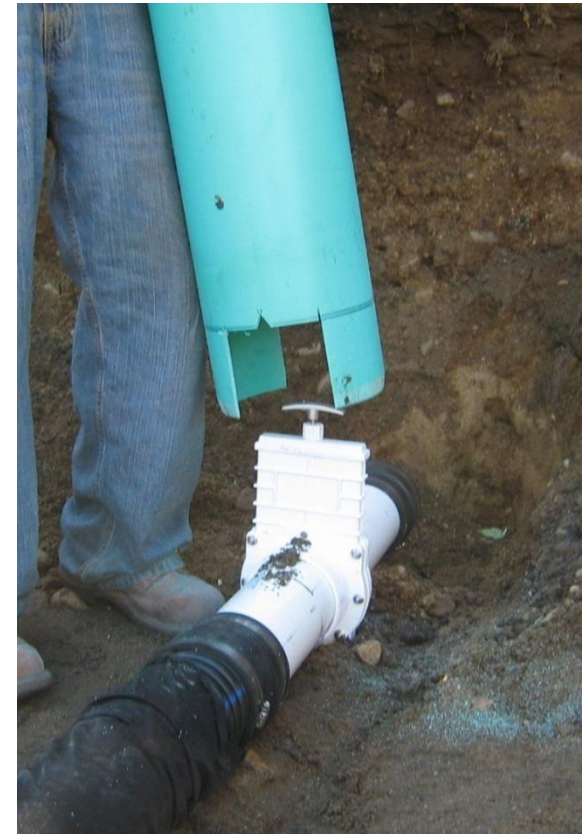
Underdrains with Gate Valves

Underdrain suspended 1.0' off the bottom of excavation bedded in bioretention soil media with gate valve
